Report on the investigation of  
the fatal contact between the dive workboat

***Karin***

and a recreational diver  
in Scapa Flow, Orkney Islands, Scotland  
on 28 September 2023

REPORT NO 16/2025

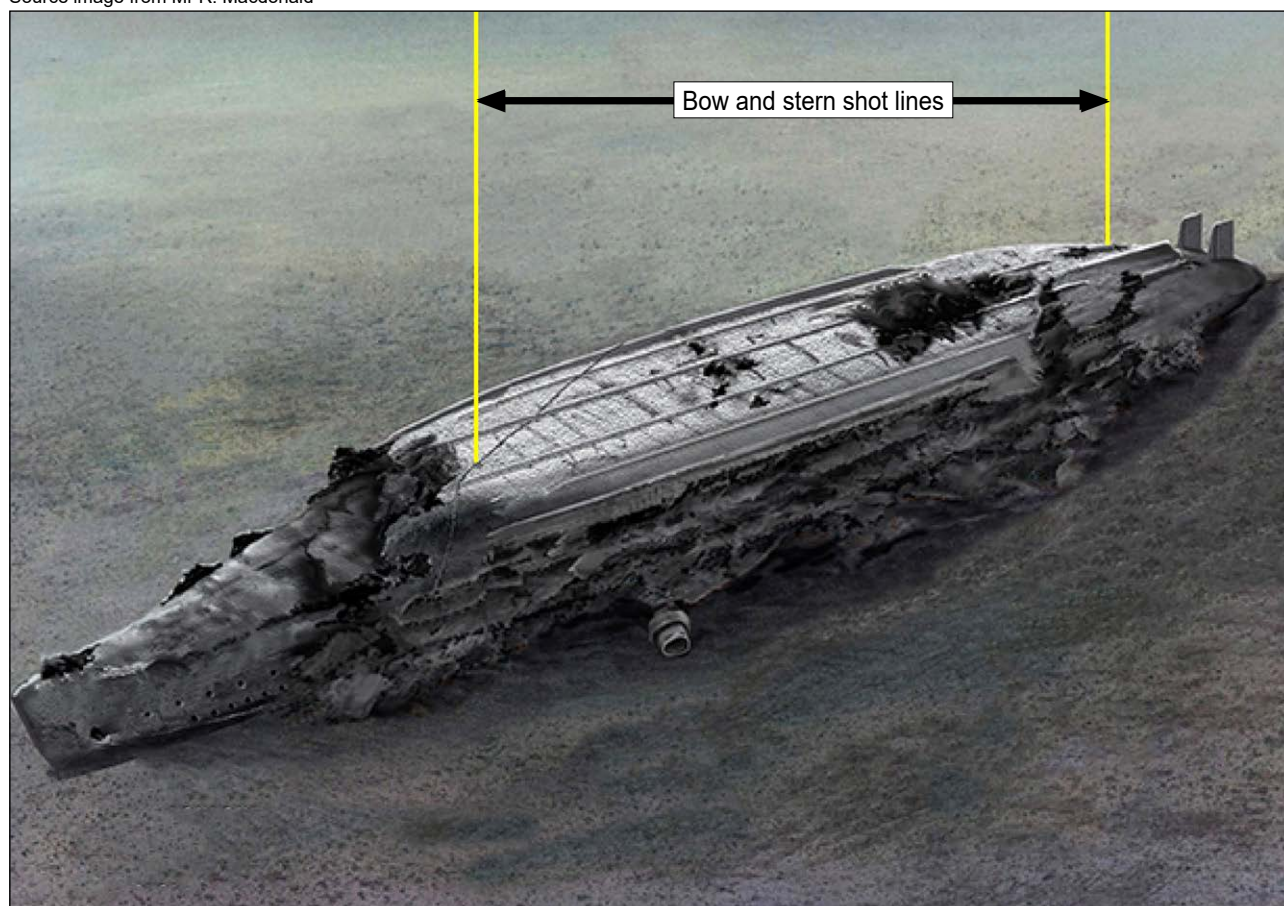
**Figure 2:** SMS *Markgraf* with shot lines

At 0942, *Jean Elaine* arrived at the wreck site of SMS *Markgraf* (*Markgraf*). The wreck was marked on the surface by two shot line<sup>3</sup> marker buoys, one at the bow and one at the stern (**Figure 2**). Nine of the 12 divers on board had completed their final preparation checks before they entered the water in three separate groups; three of the divers remained on board.

The first three divers started their descent at 0955, using the bow shot line, followed shortly after by four divers using the aft shot line. At 0958, *Jean Elaine* transited from east to west of the wreck, passing over the seven submerged divers as it did so. At 1000, diver 1 and diver 2 entered the water and swam down to the wreck via the bow shot line (**Figure 3**); their dive was scheduled to last approximately 45 minutes.

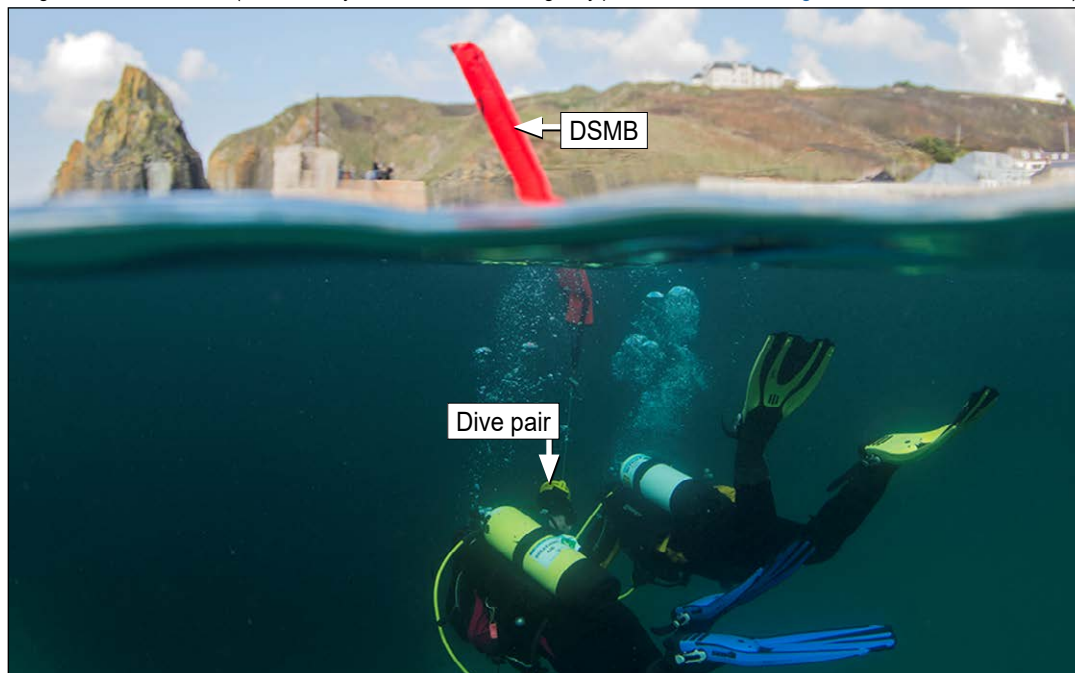
**Figure 7: A typical DSMB in use**

A DSMB is an inflatable tube or buoy about 1.4m in length with a 20cm circumference and typically orange in colour. DSMBs are deployed by ascending divers towards the end of a dive and inflated using the diver's air supply (**Figure 7**). DSMBs are typically connected to a hand reel to enable the user to control the length of line being payed out or reeled in and keep it taut in line with the depth of water (**Figure 8**). DSMBs assist support craft to locate and monitor divers' locations, and in doing so reduce the risk of contact and injury.

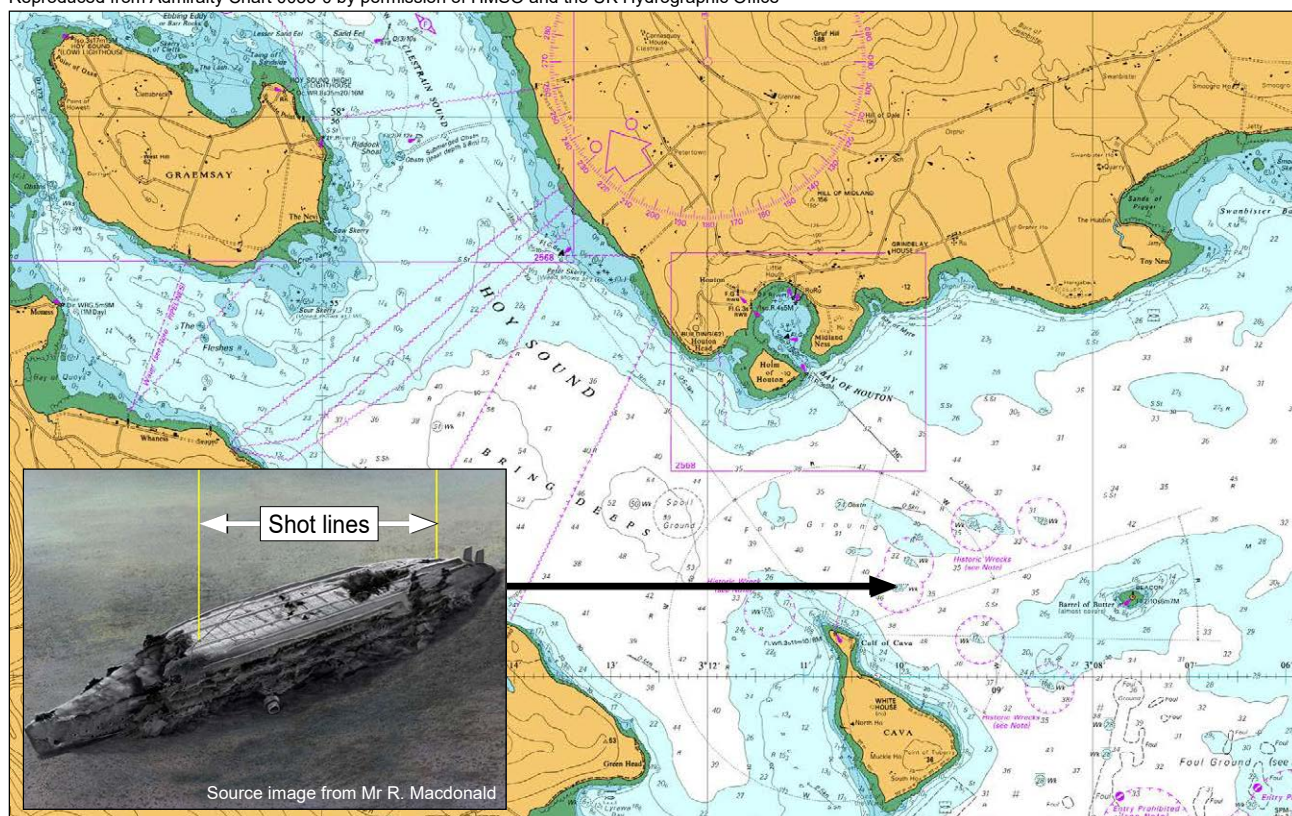
**Figure 1: SMS Markgraf**

On the morning of 28 September 2023, a recreational diver carrying out decompression stops died, almost certainly as a result of being struck by the rotating propeller of the UK registered diving support boat *Karin*. The diver was diving from a second dive boat that was also supporting divers exploring the wreck of the German battleship SMS *Markgraf* (**Figure 1**), which was lying at a depth of 45m in Scapa Flow, Orkney Islands, Scotland.

The diver and their dive buddy had ascended to their final scheduled decompression stop 3m below the surface. The divers were conducting a drift decompression away from the available shot line<sup>1</sup> but their presence was indicated by their delayed surface marker buoy (DSMB)<sup>2</sup>, the line of which was clipped to the casualty's dive vest (**Figure 2**). The DSMB was visible to the second dive boat waiting on the other side of the wreck site, but it was not sighted by *Karin*'s crew before *Karin* motored over it.
