Pond Creek		ok-0710-r-003		Sedimentation Risk Index 44																					
<u>Common:</u>	9.9mi NE of Crestview		<u>County:</u>	Okaloosa																					
<u>Drainage:</u>	Shoal River	<u>GPS:</u> 30.834014, -86.428345	<u>PLSS(T-R-S):</u>	4N-22-22																					
<u>Land owner:</u>	Odessa Jackson		<u>Parcel No.:</u>	1																					
			<u>Road Name:</u>	Lake Ella Rd

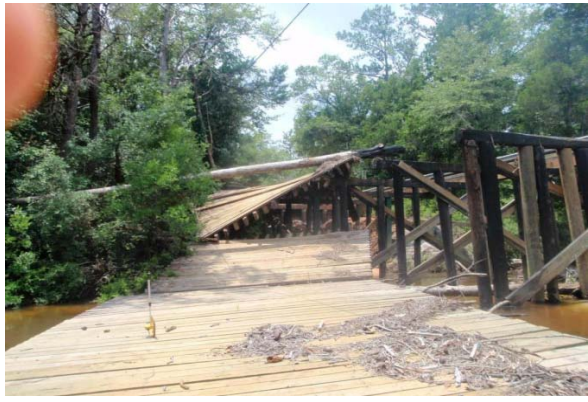
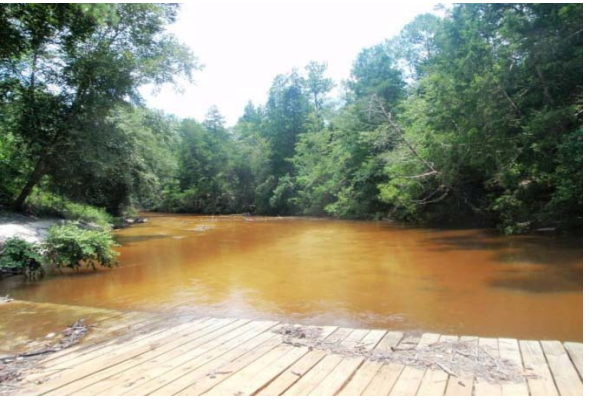
Crossing Structure- Rt Approach		DS																							
Risk Factor	Ranking	Score

Notes: Bridge blew out in March 2009 rainstorm; has not been repaired. 0.1 mi DS from Juniper Creek
