Yellow River		co-1102-r-001	Sedimentation Risk Index 48																																																																		
<u>Common:</u> 1.8mi SW of Five Points <u>Drainage:</u> Blackwater Bay <u>GPS:</u> 31.428717623,-86.330150140 <u>Land owner:</u> Royce & Barbara Harrison-US, W&T Mitchell –DS East, Lucky Hack – DS West		<u>County:</u> Covington <u>State:</u> Alabama <u>PLSS (T-R-S):</u> 6N-17E-35 <u>Parcel No.:</u> Unknown <u>Road Name:</u> Prestwood Rd

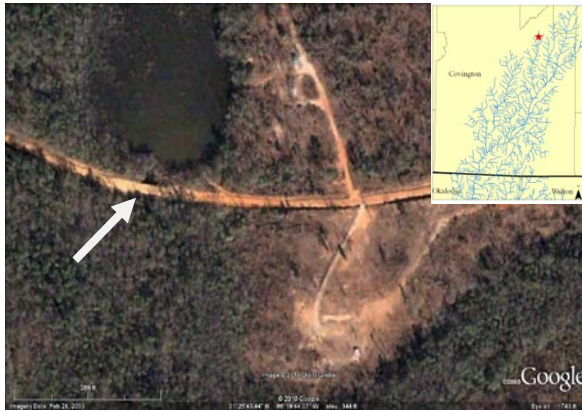
Crossing Structure: US		DS																																																																			
<table border="1"> <thead> <tr> <th>Risk Factor</th> <th>Ranking</th> <th>Score</th> </tr> </thead> <tbody> <tr><td>US Channel Morph</td><td>BEAVER DAM</td><td>3</td></tr> <tr><td>DS Channel Morph</td><td>WETLAND</td><td>5</td></tr> <tr><td>DS Bank Alteration</td><td>MINOR/PARTIAL</td><td>3</td></tr> <tr><td>Upstream Skew Angle</td><td><5°</td><td>5</td></tr> <tr><td>Crossing fill condition</td><td>Fair/Rip Rap</td><td>3</td></tr> <tr><td>Inlet/Outlet Condition</td><td>No Impairment</td><td>5</td></tr> <tr><td>Road Approach Material</td><td>All Sand/Clay</td><td>3</td></tr> <tr><td>Potential Eroded Volume Mean</td><td>21-40 y³</td><td>3</td></tr> <tr><td>Approach Slope Mean</td><td><2%</td><td>5</td></tr> <tr><td>Soil K Factor</td><td><0.20</td><td>5</td></tr> <tr><td>Upstream Rt Outlet</td><td>Vegetated</td><td>1</td></tr> <tr><td>Upstream Lt Outlet</td><td>Vegetated</td><td>1</td></tr> <tr><td>Upstream Rt Ditch</td><td>Bare soil</td><td>0</td></tr> <tr><td>Upstream Lt Ditch</td><td>Vegetated</td><td>1</td></tr> <tr><td>Downstream Rt Outlet</td><td>Vegetated</td><td>1</td></tr> <tr><td>Downstream Lt Outlet</td><td>Vegetated</td><td>1</td></tr> <tr><td>Downstream Rt Ditch</td><td>Bare soil</td><td>0</td></tr> <tr><td>Downstream Lt Ditch</td><td>Bare soil</td><td>0</td></tr> <tr><td>Outlet Total</td><td>Improved Outlet System</td><td>5</td></tr> <tr><td>Ditches Total</td><td>Partially Improved Drainage System</td><td>3</td></tr> <tr><td>SRI Total</td><td>Low Risk</td><td>48</td></tr> </tbody> </table>		Risk Factor	Ranking	Score	US Channel Morph	BEAVER DAM	3	DS Channel Morph	WETLAND	5	DS Bank Alteration	MINOR/PARTIAL	3	Upstream Skew Angle	<5°	5	Crossing fill condition	Fair/Rip Rap	3	Inlet/Outlet Condition	No Impairment	5	Road Approach Material	All Sand/Clay	3	Potential Eroded Volume Mean	21-40 y ³	3	Approach Slope Mean	<2%	5	Soil K Factor	<0.20	5	Upstream Rt Outlet	Vegetated	1	Upstream Lt Outlet	Vegetated	1	Upstream Rt Ditch	Bare soil	0	Upstream Lt Ditch	Vegetated	1	Downstream Rt Outlet	Vegetated	1	Downstream Lt Outlet	Vegetated	1	Downstream Rt Ditch	Bare soil	0	Downstream Lt Ditch	Bare soil	0	Outlet Total	Improved Outlet System	5	Ditches Total	Partially Improved Drainage System	3	SRI Total	Low Risk	48
