Unnamed tributary		co-0907-r-003	Sedimentation Risk Index 42																																																																		
<u>Common:</u> 7.1mi NW of Opp <u>Drainage:</u> Yellow River <u>GPS:</u> 31.320859074, -86.367395487 <u>Land owner:</u> Bonnie Worley, Tr. -US, Roy Jr. & Sybil Weaver -DS		<u>County:</u> Covington <u>State:</u> Alabama <u>PLSS (T-R-S):</u> 4N-17E-17 <u>Parcel No.:</u> 2; 1 <u>Road Name:</u> Old Dragstrip Rd

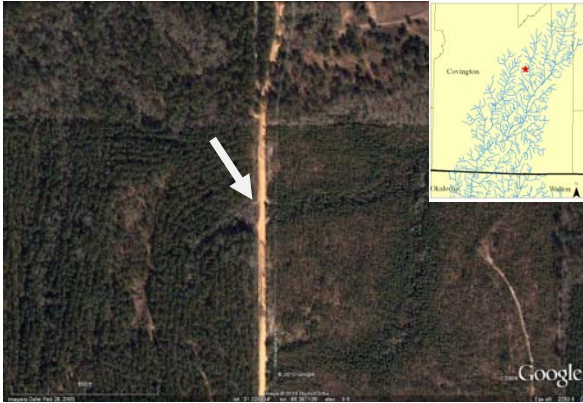
Ditches Total	Unimproved Drainage System	1																																																																			
SRI Total	Medium Risk	42																																																																			
Additional Site Features <u>Crossing Type and Quantity:</u> Culvert, 1 <u>Crossing Materials:</u> PVC <u>Soil Types:</u> CdB, CdC, FuB, MBA, OrB, OrC <u>Rt Approach Prism Fill:</u> 0.25in <u>Lt Approach Prism Fill:</u> 0.25in

Notes: Excessive erosion over culvert.
