Good Springs Creek		co-1102-r-005	Sedimentation Risk Index 44																																																																		
<u>Common:</u> 2.0mi S of Five Points <u>Drainage:</u> Poley Creek <u>GPS:</u> 31.410927205,-86.301856745 <u>Land owner:</u> Charles & Stacy Hinds		<u>County:</u> Covington <u>State:</u> Alabama <u>PLSS (T-R-S):</u> 5N-17E-12 <u>Parcel No.:</u> 1 <u>Road Name:</u> Chalker Rd

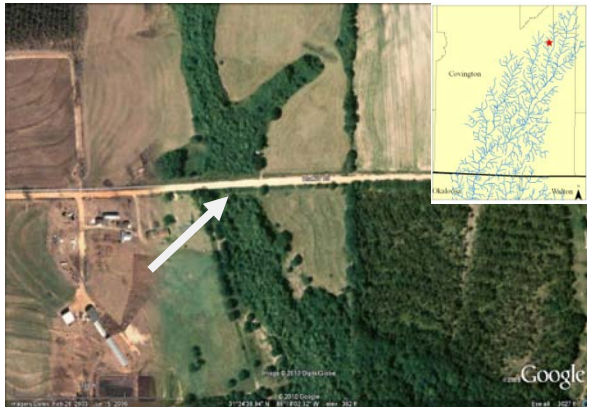
Crossing Structure: DS		US																																																																			
<table border="1"> <thead> <tr> <th>Risk Factor</th> <th>Ranking</th> <th>Score</th> </tr> </thead> <tbody> <tr><td>US Channel Morph</td><td>C</td><td>5</td></tr> <tr><td>DS Channel Morph</td><td>C</td><td>5</td></tr> <tr><td>DS Bank Alteration</td><td>MINOR/PARTIAL</td><td>3</td></tr> <tr><td>Upstream Skew Angle</td><td><5°</td><td>5</td></tr> <tr><td>Crossing fill condition</td><td>Good/Vegetated</td><td>5</td></tr> <tr><td>Inlet/Outlet Condition</td><td>No Impairment</td><td>5</td></tr> <tr><td>Road Approach Material</td><td>All Sand/Clay</td><td>3</td></tr> <tr><td>Potential Eroded Volume Mean</td><td>>40 y³</td><td>1</td></tr> <tr><td>Approach Slope Mean</td><td>2.1-4%</td><td>3</td></tr> <tr><td>Soil K Factor</td><td>0.21-0.40</td><td>3</td></tr> <tr><td>Upstream Rt Outlet</td><td>Vegetated</td><td>1</td></tr> <tr><td>Upstream Lt Outlet</td><td>Vegetated</td><td>1</td></tr> <tr><td>Upstream Rt Ditch</td><td>Bare soil</td><td>0</td></tr> <tr><td>Upstream Lt Ditch</td><td>Bare soil</td><td>0</td></tr> <tr><td>Downstream Rt Outlet</td><td>Vegetated</td><td>1</td></tr> <tr><td>Downstream Lt Outlet</td><td>Vegetated</td><td>1</td></tr> <tr><td>Downstream Rt Ditch</td><td>Bare soil</td><td>0</td></tr> <tr><td>Downstream Lt Ditch</td><td>Bare soil</td><td>0</td></tr> <tr><td>Outlet Total</td><td>Improved Outlet System</td><td>5</td></tr> <tr><td>Ditches Total</td><td>Unimproved Drainage System</td><td>1</td></tr> <tr><td>SRI Total</td><td>Medium Risk</td><td>44</td></tr> </tbody> </table>				Risk Factor	Ranking	Score	US Channel Morph	C	5	DS Channel Morph	C	5	DS Bank Alteration	MINOR/PARTIAL	3	Upstream Skew Angle	<5°	5	Crossing fill condition	Good/Vegetated	5	Inlet/Outlet Condition	No Impairment	5	Road Approach Material	All Sand/Clay	3	Potential Eroded Volume Mean	>40 y ³	1	Approach Slope Mean	2.1-4%	3	Soil K Factor	0.21-0.40	3	Upstream Rt Outlet	Vegetated	1	Upstream Lt Outlet	Vegetated	1	Upstream Rt Ditch	Bare soil	0	Upstream Lt Ditch	Bare soil	0	Downstream Rt Outlet	Vegetated	1	Downstream Lt Outlet	Vegetated	1	Downstream Rt Ditch	Bare soil	0	Downstream Lt Ditch	Bare soil	0	Outlet Total	Improved Outlet System	5	Ditches Total	Unimproved Drainage System	1	SRI Total	Medium Risk	44
