Unnamed tributary		co-1027-r-004	Sedimentation Risk Index <b>32</b>																																																																		
<u>Common:</u> 6.4mi NW of Opp <u>Drainage:</u> Yellow River <u>GPS:</u> 31.340281813, -86.340114564 <u>Land owner:</u> Dallas Henderson -DS, B&J Sasser -US		<u>County:</u> Covington <u>State:</u> Alabama <u>PLSS (T-R-S):</u> 4N-17E-3 <u>Parcel No.:</u> 8; 28 <u>Road Name:</u> Sasser Rd

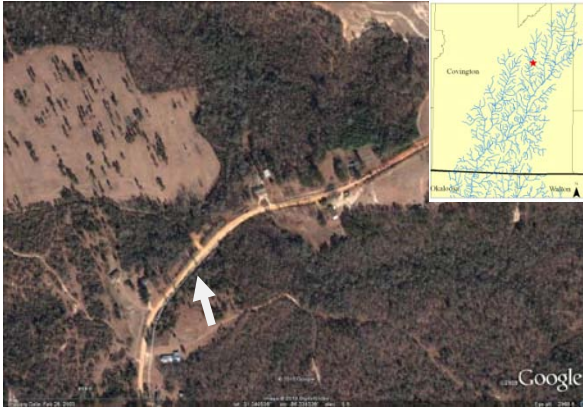
Ditches Total	Unimproved Drainage System	1																																																																			
SRI Total	High Risk	32																																																																			
<b>Additional Site Features</b> <u>Crossing Type and Quantity:</u> Culvert,2 <u>Crossing Materials:</u> Metal <u>Soil Types:</u> BoB,CdB,CdC,LuB,MBA,OrC,OrE <u>Rt Approach Prism Fill:</u> 0.75in <u>Lt Approach Prism Fill:</u> 0.75in

Notes: Recently ponded by land owner (Personal communication).
