Unnamed tributary		wa-0722-r-008	Sedimentation Risk Index 38																																																																		
<u>Common:</u> 5.3mi N of DeFuniak Springs <u>Drainage:</u> Gum Creek <u>GPS:</u> 30.795394, -86.138400 <u>Land owner:</u> Russell Ray- US, Dennis Ray-DS		<u>County:</u> Walton <u>State:</u> Florida <u>PLSS (T-R-S):</u> 4N-19-34-20000 <u>Parcel No.:</u> 1.10; 9 <u>Road Name:</u> Piney Grove Church Rd

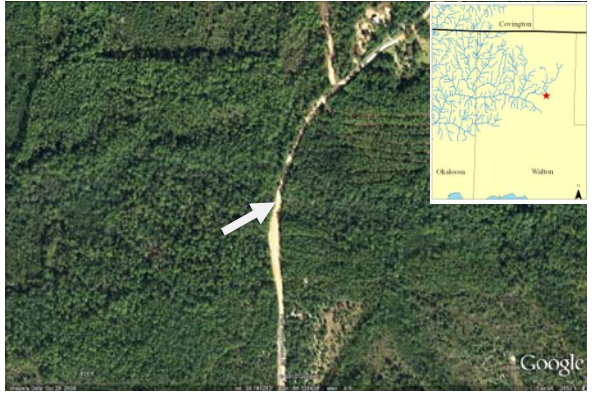
Crossing Structure: DS		US																																																																			
<table border="1"> <thead> <tr> <th>Risk Factor</th> <th>Ranking</th> <th>Score</th> </tr> </thead> <tbody> <tr><td>US Channel Morph</td><td>DA</td><td>3</td></tr> <tr><td>DS Channel Morph</td><td>DA</td><td>3</td></tr> <tr><td>DS Bank Alteration</td><td>MINOR/PARTIAL</td><td>3</td></tr> <tr><td>Upstream Skew Angle</td><td>5-30°</td><td>3</td></tr> <tr><td>Crossing fill condition</td><td>Fair/Rip Rap</td><td>3</td></tr> <tr><td>Inlet/Outlet Condition</td><td>No Impairment</td><td>5</td></tr> <tr><td>Road Approach Material</td><td>All Sand/Clay</td><td>3</td></tr> <tr><td>Potential Eroded Volume Mean</td><td>>40 y³</td><td>1</td></tr> <tr><td>Approach Slope Mean</td><td>2.1-4%</td><td>3</td></tr> <tr><td>Soil K Factor</td><td><0.20</td><td>5</td></tr> <tr><td>Upstream Rt Outlet</td><td>Vegetated</td><td>1</td></tr> <tr><td>Upstream Lt Outlet</td><td>Vegetated</td><td>1</td></tr> <tr><td>Upstream Rt Ditch</td><td>Bare soil</td><td>0</td></tr> <tr><td>Upstream Lt Ditch</td><td>Bare soil</td><td>0</td></tr> <tr><td>Downstream Rt Outlet</td><td>Vegetated</td><td>1</td></tr> <tr><td>Downstream Lt Outlet</td><td>Vegetated</td><td>1</td></tr> <tr><td>Downstream Rt Ditch</td><td>Bare soil</td><td>0</td></tr> <tr><td>Downstream Lt Ditch</td><td>Bare soil</td><td>0</td></tr> <tr><td>Outlet Total</td><td>Improved Outlet System</td><td>5</td></tr> <tr><td>Ditches Total</td><td>Unimproved Drainage System</td><td>1</td></tr> <tr><td>SRI Total</td><td>Medium Risk</td><td>38</td></tr> </tbody> </table>		Risk Factor	Ranking	Score	US Channel Morph	DA	3	DS Channel Morph	DA	3	DS Bank Alteration	MINOR/PARTIAL	3	Upstream Skew Angle	5-30°	3	Crossing fill condition	Fair/Rip Rap	3	Inlet/Outlet Condition	No Impairment	5	Road Approach Material	All Sand/Clay	3	Potential Eroded Volume Mean	>40 y ³	1	Approach Slope Mean	2.1-4%	3	Soil K Factor	<0.20	5	Upstream Rt Outlet	Vegetated	1	Upstream Lt Outlet	Vegetated	1	Upstream Rt Ditch	Bare soil	0	Upstream Lt Ditch	Bare soil	0	Downstream Rt Outlet	Vegetated	1	Downstream Lt Outlet	Vegetated	1	Downstream Rt Ditch	Bare soil	0	Downstream Lt Ditch	Bare soil	0	Outlet Total	Improved Outlet System	5	Ditches Total	Unimproved Drainage System	1	SRI Total	Medium Risk	38
