Unnamed tributary		wa-0626-r-007	Sedimentation Risk Index 44																																																																		
<u>Common:</u> 6.5mi SE of Florala <u>Drainage:</u> Turkey Creek <u>GPS:</u> 30.926158, -86.267631 <u>Land owner:</u> James & Elizabeth Hall- US, Laura Wise-Adams-DS		<u>County:</u> Walton <u>State:</u> Florida <u>PLSS:</u> 5N-20-17/20 <u>Parcel No.:</u> 5; 3.001 <u>Road Name:</u> Pittman Rd

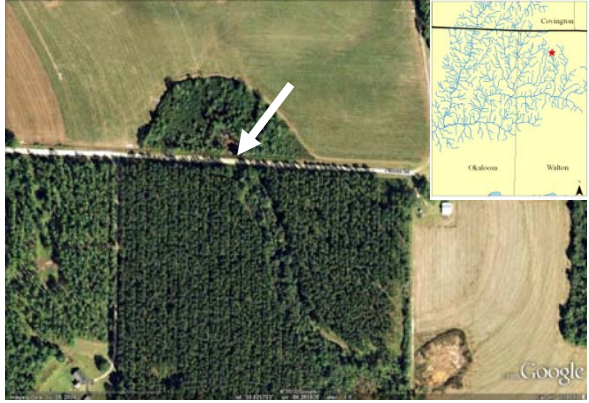
Crossing Structure: DS		US																																																																			
<table border="1"> <thead> <tr> <th>Risk Factor</th> <th>Ranking</th> <th>Score</th> </tr> </thead> <tbody> <tr><td>US Channel Morph</td><td>PONDED</td><td>1</td></tr> <tr><td>DS Channel Morph</td><td>C</td><td>5</td></tr> <tr><td>DS Bank Alteration</td><td>HIGH</td><td>1</td></tr> <tr><td>Upstream Skew Angle</td><td>5-30°</td><td>3</td></tr> <tr><td>Crossing fill condition</td><td>Good/Vegetated</td><td>5</td></tr> <tr><td>Inlet/Outlet Condition</td><td>No Impairment</td><td>5</td></tr> <tr><td>Road Approach Material</td><td>All Aggregate</td><td>5</td></tr> <tr><td>Potential Eroded Volume Mean</td><td><21 y³</td><td>5</td></tr> <tr><td>Approach Slope Mean</td><td>2.1-4%</td><td>3</td></tr> <tr><td>Soil K Factor</td><td>0.21-0.40</td><td>3</td></tr> <tr><td>Upstream Rt Outlet</td><td>Vegetated</td><td>1</td></tr> <tr><td>Upstream Lt Outlet</td><td>Vegetated</td><td>1</td></tr> <tr><td>Upstream Rt Ditch</td><td>Vegetated</td><td>1</td></tr> <tr><td>Upstream Lt Ditch</td><td>Vegetated</td><td>1</td></tr> <tr><td>Downstream Rt Outlet</td><td>Vegetated</td><td>1</td></tr> <tr><td>Downstream Lt Outlet</td><td>Vegetated</td><td>1</td></tr> <tr><td>Downstream Rt Ditch</td><td>Bare soil</td><td>0</td></tr> <tr><td>Downstream Lt Ditch</td><td>Bare soil</td><td>0</td></tr> <tr><td>Outlet Total</td><td>Improved Outlet System</td><td>5</td></tr> <tr><td>Ditches Total</td><td>Partially Improved Drainage System</td><td>3</td></tr> <tr><td>SRI Total</td><td>Medium Risk</td><td>44</td></tr> </tbody> </table>		Risk Factor	Ranking	Score	US Channel Morph	PONDED	1	DS Channel Morph	C	5	DS Bank Alteration	HIGH	1	Upstream Skew Angle	5-30°	3	Crossing fill condition	Good/Vegetated	5	Inlet/Outlet Condition	No Impairment	5	Road Approach Material	All Aggregate	5	Potential Eroded Volume Mean	<21 y ³	5	Approach Slope Mean	2.1-4%	3	Soil K Factor	0.21-0.40	3	Upstream Rt Outlet	Vegetated	1	Upstream Lt Outlet	Vegetated	1	Upstream Rt Ditch	Vegetated	1	Upstream Lt Ditch	Vegetated	1	Downstream Rt Outlet	Vegetated	1	Downstream Lt Outlet	Vegetated	1	Downstream Rt Ditch	Bare soil	0	Downstream Lt Ditch	Bare soil	0	Outlet Total	Improved Outlet System	5	Ditches Total	Partially Improved Drainage System	3	SRI Total	Medium Risk	44

Notes: Dry at time of survey. Dead minnows in DS puddle.
