Unnamed tributary		wa-0723-r-003	Sedimentation Risk Index 44																																																																		
<u>Common:</u> 7.2mi SE of Florala <u>Drainage:</u> Caney Creek <u>GPS:</u> 30.944042388, -86.230059991 <u>Land owner:</u> Elizabeth Bopp-DS, Deanna Wilson-US		<u>County:</u> Walton <u>State:</u> Florida <u>PLSS (T-R-S):</u> 5N-20-10-30000 <u>Parcel No.:</u> 7; 2.001 <u>Road Name:</u> Davis Rd

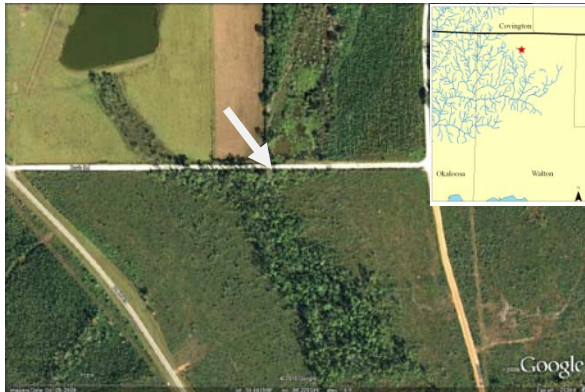
DS		US																																																																			
<table border="1"> <thead> <tr> <th>Risk Factor</th> <th>Ranking</th> <th>Score</th> </tr> </thead> <tbody> <tr><td>US Channel Morph</td><td>BEAVER DAM</td><td>3</td></tr> <tr><td>DS Channel Morph</td><td>DA</td><td>3</td></tr> <tr><td>DS Bank Alteration</td><td>MINOR/PARTIAL</td><td>3</td></tr> <tr><td>Upstream Skew Angle</td><td><5°</td><td>5</td></tr> <tr><td>Crossing fill condition</td><td>Good/Vegetated</td><td>5</td></tr> <tr><td>Inlet/Outlet Condition</td><td>Blocked</td><td>1</td></tr> <tr><td>Road Approach Material</td><td>All Aggregate</td><td>5</td></tr> <tr><td>Potential Eroded Volume Mean</td><td><21 y³</td><td>5</td></tr> <tr><td>Approach Slope Mean</td><td><2%</td><td>5</td></tr> <tr><td>Soil K Factor</td><td>0.21-0.40</td><td>3</td></tr> <tr><td>Upstream Rt Outlet</td><td>Vegetated</td><td>1</td></tr> <tr><td>Upstream Lt Outlet</td><td>Vegetated</td><td>1</td></tr> <tr><td>Upstream Rt Ditch</td><td>Bare soil</td><td>0</td></tr> <tr><td>Upstream Lt Ditch</td><td>Bare soil</td><td>0</td></tr> <tr><td>Downstream Rt Outlet</td><td>Vegetated</td><td>1</td></tr> <tr><td>Downstream Lt Outlet</td><td>Vegetated</td><td>1</td></tr> <tr><td>Downstream Rt Ditch</td><td>Bare soil</td><td>0</td></tr> <tr><td>Downstream Lt Ditch</td><td>Bare soil</td><td>0</td></tr> <tr><td>Outlet Total</td><td>Improved Outlet System</td><td>5</td></tr> <tr><td>Ditches Total</td><td>Unimproved Drainage System</td><td>1</td></tr> <tr><td>SRI Total</td><td>Medium Risk</td><td>44</td></tr> </tbody> </table>		Risk Factor	Ranking	Score	US Channel Morph	BEAVER DAM	3	DS Channel Morph	DA	3	DS Bank Alteration	MINOR/PARTIAL	3	Upstream Skew Angle	<5°	5	Crossing fill condition	Good/Vegetated	5	Inlet/Outlet Condition	Blocked	1	Road Approach Material	All Aggregate	5	Potential Eroded Volume Mean	<21 y ³	5	Approach Slope Mean	<2%	5	Soil K Factor	0.21-0.40	3	Upstream Rt Outlet	Vegetated	1	Upstream Lt Outlet	Vegetated	1	Upstream Rt Ditch	Bare soil	0	Upstream Lt Ditch	Bare soil	0	Downstream Rt Outlet	Vegetated	1	Downstream Lt Outlet	Vegetated	1	Downstream Rt Ditch	Bare soil	0	Downstream Lt Ditch	Bare soil	0	Outlet Total	Improved Outlet System	5	Ditches Total	Unimproved Drainage System	1	SRI Total	Medium Risk	44

Notes: Highly vegetated DS
