Unnamed tributary		co-0820-r-009	Sedimentation Risk Index <b>46</b>																																																																		
<u>Common:</u> 6.6mi N of Florala <u>Drainage:</u> Clear Creek <u>GPS:</u> 31.101564654, -86.332444522 <u>Land owner:</u> Rayonier Forest Resources LP		<u>County:</u> Covington <u>State:</u> Alabama <u>PLSS (T-R-S):</u> 2N-17E-34 <u>Parcel No.:</u> 3 <u>Road Name:</u> Betty's Rd

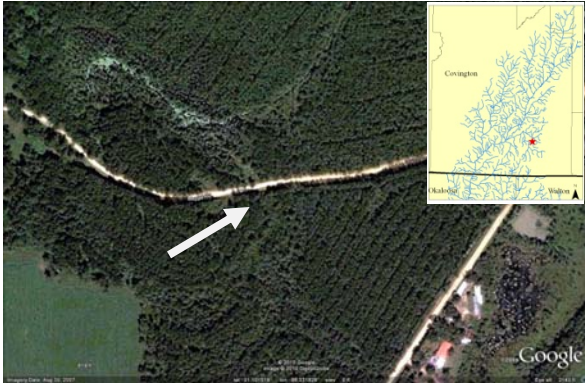
<p>US</p>																																																																			
<table border="1"> <thead> <tr> <th>Risk Factor</th> <th>Ranking</th> <th>Score</th> </tr> </thead> <tbody> <tr><td>US Channel Morph</td><td>B</td><td>5</td></tr> <tr><td>DS Channel Morph</td><td>C</td><td>5</td></tr> <tr><td>DS Bank Alteration</td><td>HIGH</td><td>1</td></tr> <tr><td>Upstream Skew Angle</td><td>&lt;5°</td><td>5</td></tr> <tr><td>Crossing fill condition</td><td>Poor/Bare soil</td><td>1</td></tr> <tr><td>Inlet/Outlet Condition</td><td>Sed Islands/Scouring</td><td>3</td></tr> <tr><td>Road Approach Material</td><td>All Sand/Clay</td><td>3</td></tr> <tr><td>Potential Eroded Volume Mean</td><td>&lt;21 y<sup>3</sup></td><td>5</td></tr> <tr><td>Approach Slope Mean</td><td>&lt;2%</td><td>5</td></tr> <tr><td>Soil K Factor</td><td>&lt;0.20</td><td>5</td></tr> <tr><td>Upstream Rt Outlet</td><td>Vegetated</td><td>1</td></tr> <tr><td>Upstream Lt Outlet</td><td>Vegetated</td><td>1</td></tr> <tr><td>Upstream Rt Ditch</td><td>Vegetated</td><td>1</td></tr> <tr><td>Upstream Lt Ditch</td><td>Vegetated</td><td>1</td></tr> <tr><td>Downstream Rt Outlet</td><td>Bare soil</td><td>0</td></tr> <tr><td>Downstream Lt Outlet</td><td>Bare soil</td><td>0</td></tr> <tr><td>Downstream Rt Ditch</td><td>Vegetated</td><td>1</td></tr> <tr><td>Downstream Lt Ditch</td><td>Vegetated</td><td>1</td></tr> <tr><td>Outlet Total</td><td>Partially Improved Outlet System</td><td>3</td></tr> <tr><td>Ditches Total</td><td>Improved Drainage System</td><td>5</td></tr> <tr><td><b>SRI Total</b></td><td><b>Low Risk</b></td><td><b>46</b></td></tr> </tbody> </table>		Risk Factor	Ranking	Score	US Channel Morph	B	5	DS Channel Morph	C	5	DS Bank Alteration	HIGH	1	Upstream Skew Angle	<5°	5	Crossing fill condition	Poor/Bare soil	1	Inlet/Outlet Condition	Sed Islands/Scouring	3	Road Approach Material	All Sand/Clay	3	Potential Eroded Volume Mean	<21 y <sup>3</sup>	5	Approach Slope Mean	<2%	5	Soil K Factor	<0.20	5	Upstream Rt Outlet	Vegetated	1	Upstream Lt Outlet	Vegetated	1	Upstream Rt Ditch	Vegetated	1	Upstream Lt Ditch	Vegetated	1	Downstream Rt Outlet	Bare soil	0	Downstream Lt Outlet	Bare soil	0	Downstream Rt Ditch	Vegetated	1	Downstream Lt Ditch	Vegetated	1	Outlet Total	Partially Improved Outlet System	3	Ditches Total	Improved Drainage System	5	<b>SRI Total</b>	<b>Low Risk</b>	<b>46</b>

Notes: Submerged culvert.
