## Diablo Model 31, G5, serial number 28685/1440, Restoration Notes

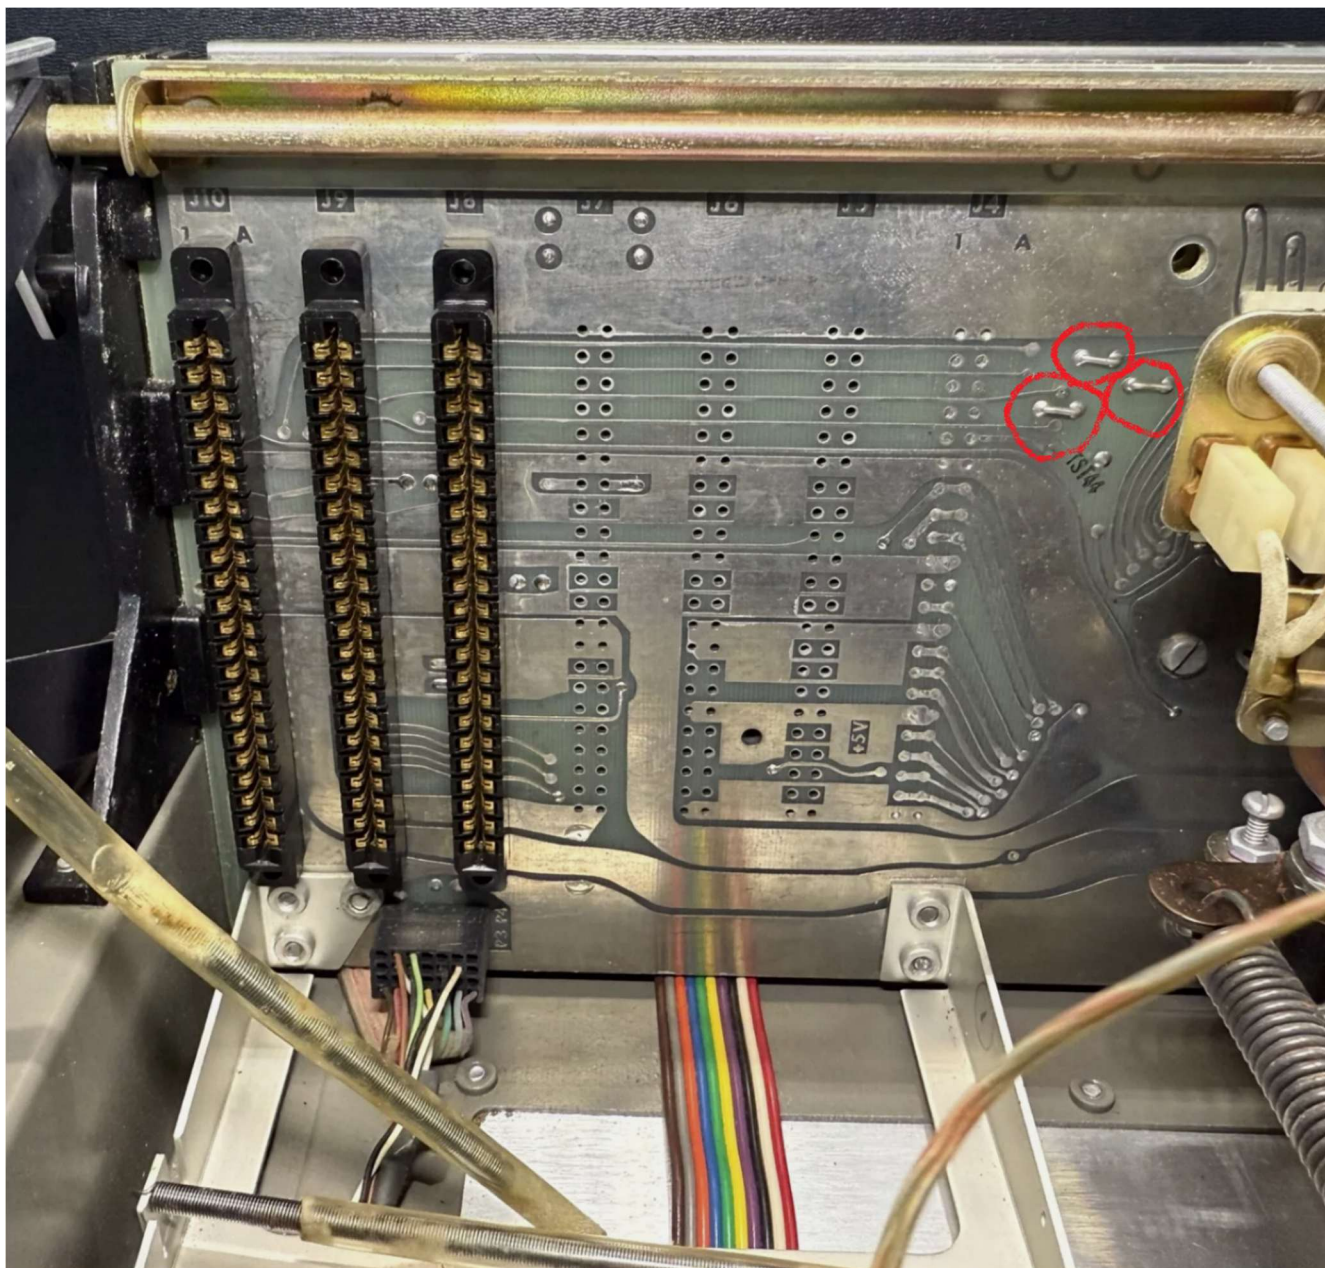
It's strange that the board in J10 is configured for high density but the backplane jumper for the “High Density Indication” signal is removed

For example, this is another drive, photo captured from an eBay listing, that has all three jumpers installed:

Added the “High Density Indication” jumper on the backplane.

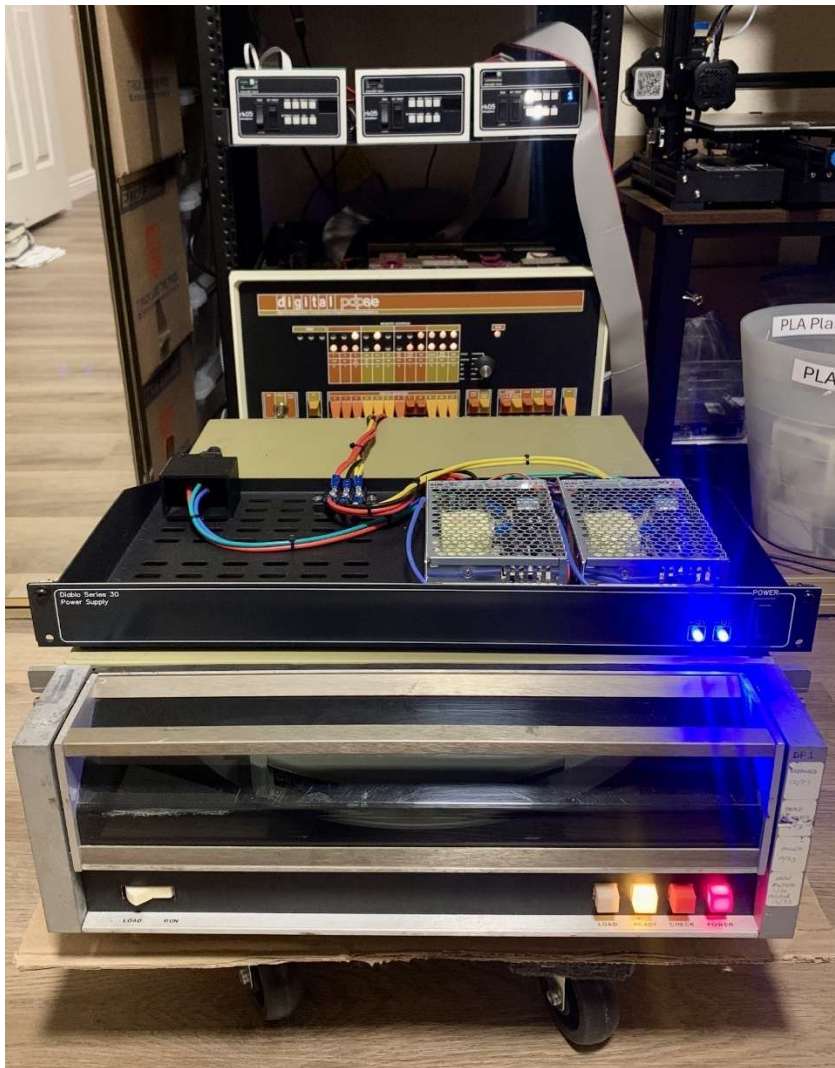
Then connected the Diablo drive to the PDP-8. Connected through the emulator on the right which is not loaded and set to drive 1. This emulator is only a pass-through for the disk signals. The Diablo drive is configured as drive 0. So, the Diablo is the only drive connected to the RK8-E controller in the PDP-8.

Was able to boot OS8 from the Diablo drive!

Still need to properly repair the board in J10. A pair of DM8601 one-shot ICs are on order. Need to replace the one at location F37 on the J10 board and remove the temporary jumpers.

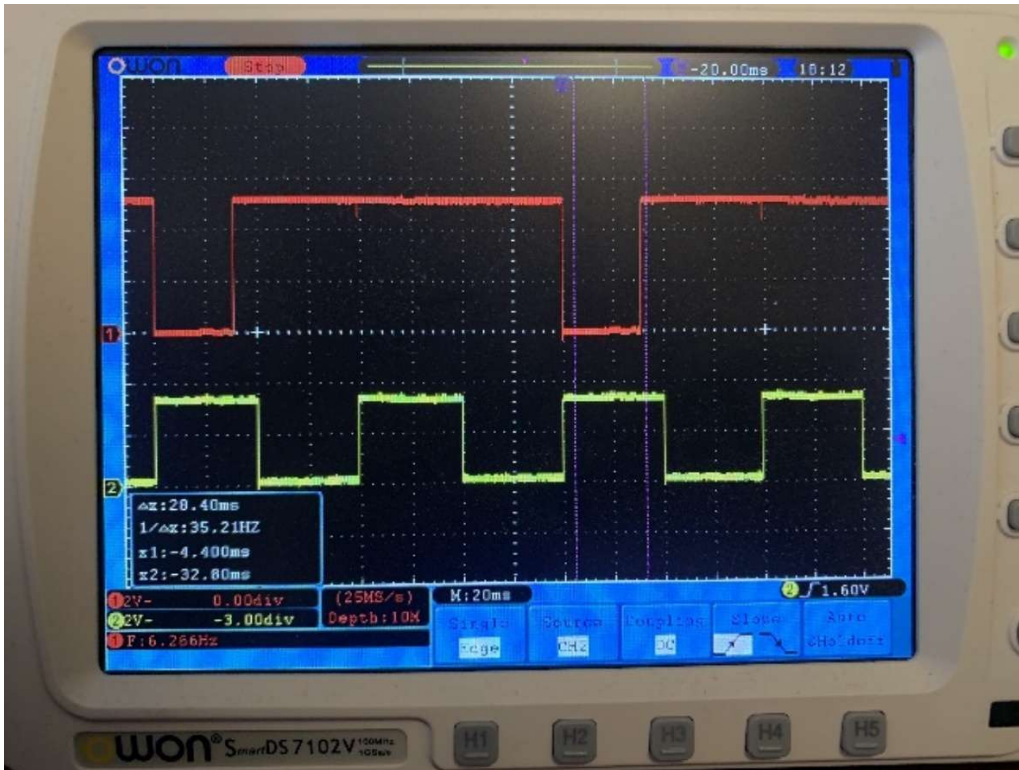
Observe the test points on module J2 in the digital circuit related to head movement. Entered a CHS list containing: 0 0 0, 20 0 0. CH1 (red) is TPx, CH2 (yellow) is BUS\_RWS\_RDY\_L (pin F on the MRAC42):

- TP1 – always high, low sets the “SEEK INCOMPLETE FF”
- TP2 – always high, “RESTORE FF1-Q-bar”
- TP3 – same as RWS Ready, “-R/S/R/W”
- TP4 – “-REV & 1<sup>st</sup> SPEED”

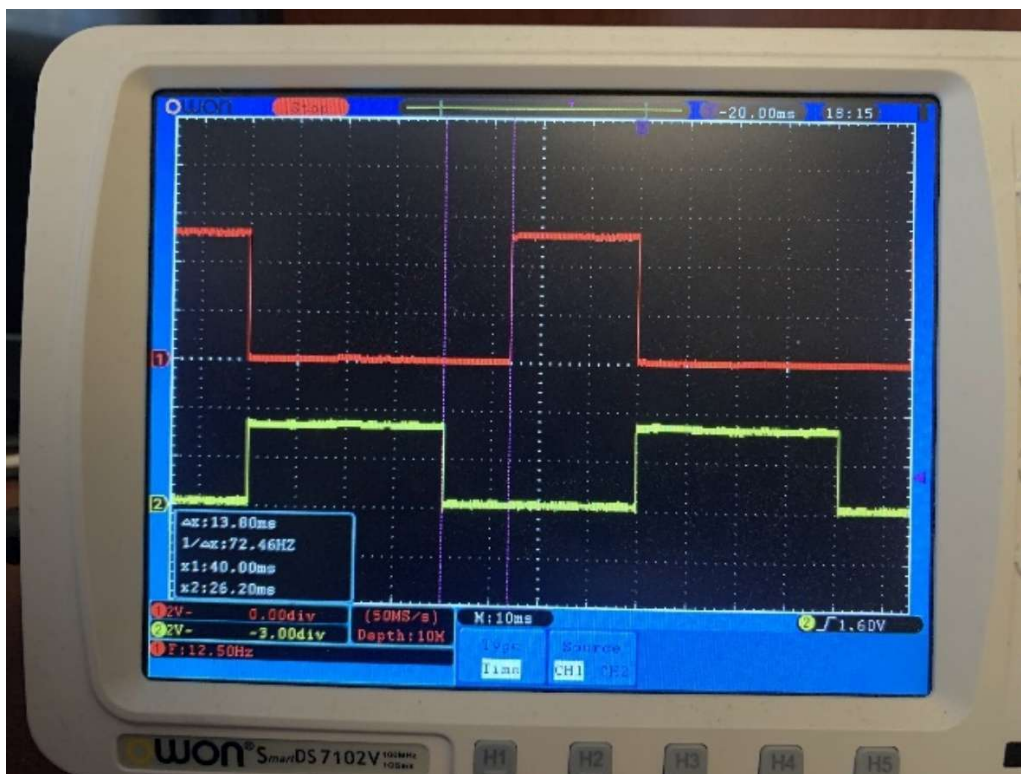
- TP5 – always high, “INITIAL RESET”

- TP6 – active-low “Motion Indicator Level”

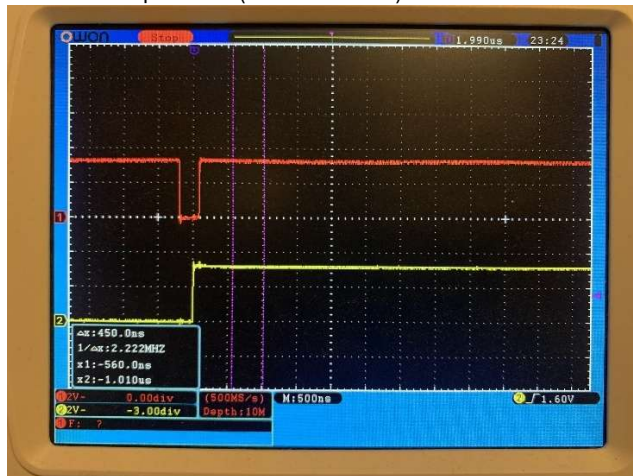
**Photo #1,**  
CH1 – BUS\_STROBE\_L, CH2 – BUS\_RWS\_RDY\_L  
Shows when BUS\_STROBE\_L goes active and inactive. Same time base as photo #2 (500ns/division)

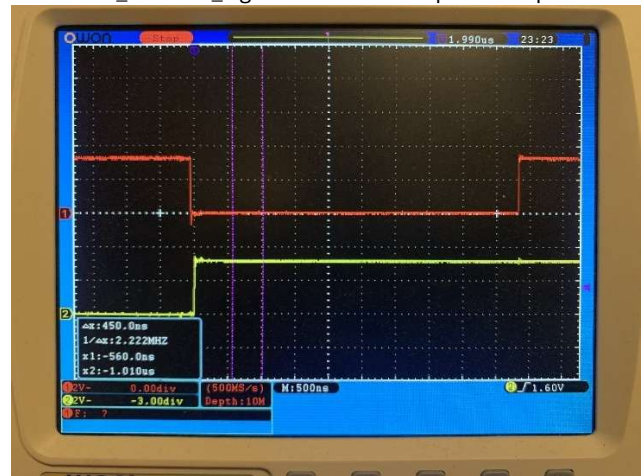
**Photo #2,**  
CH1 – BUS\_ADDR\_ACCEPTED\_L, CH2 – BUS\_RWS\_RDY\_L  
Shows BUS\_ADDR\_ACCEPTED\_L is asserted at the same time when BUS\_STROBE\_L goes inactive. Compare with photo #1

I’m wondering whether the Diablo drive responding slowly to the BUS\_STROBE\_L might be the cause of the “maindec-08-dhrkc-h-pb” test failures.

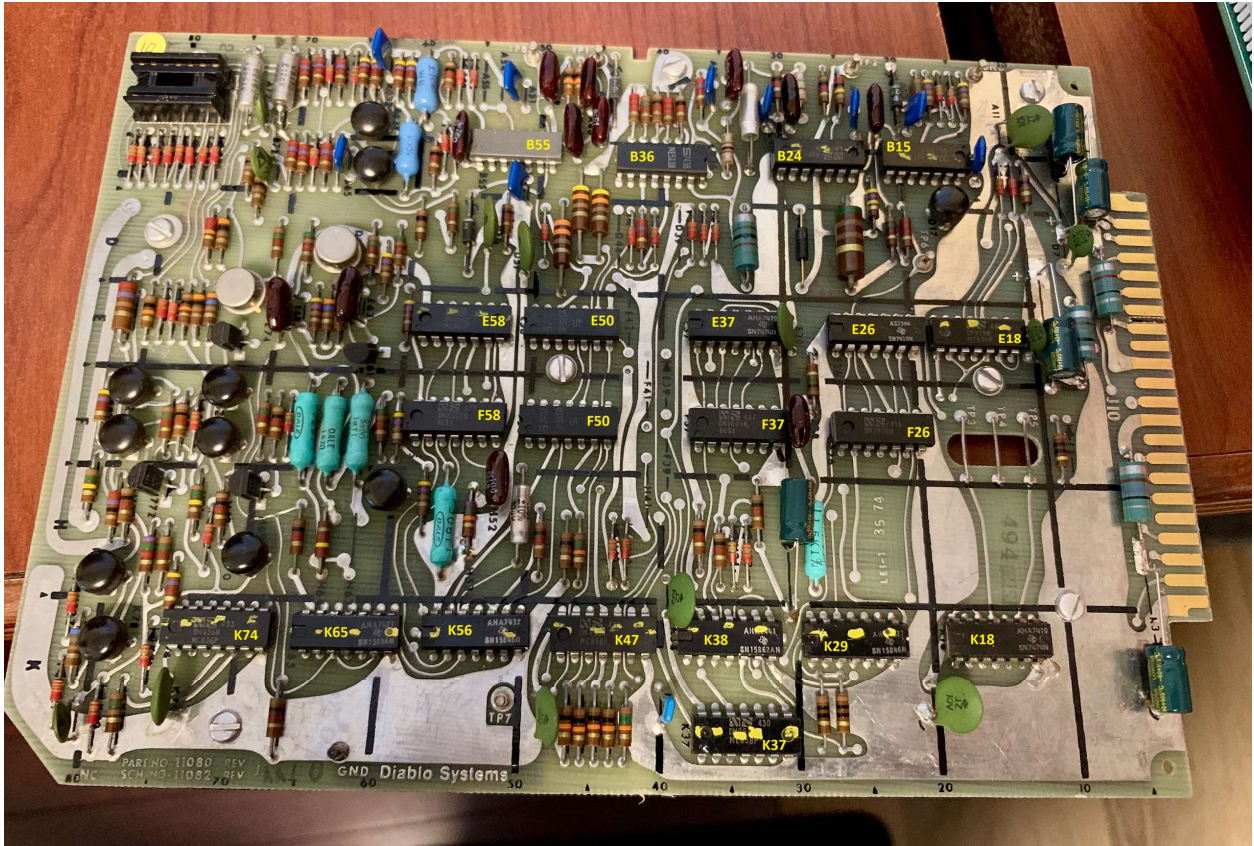
- I thought about designing an extender board to be able to more easily probe circuits on the six plug-in cards. The extender would need to offset in one direction to have mechanical clearance from the frame of the disk drive. Fortunately, most of the probing was on J10, which is on the end of the backplane, on the left side of the drive. It was possible to remove the metal shield from the J10 board to be able to probe circuitry from the back.
