Visit Report

Date of visit: 18 Jul. 2023
 Date of report: 21 Jul. 2023

Plaston / CFMOTO-R2R

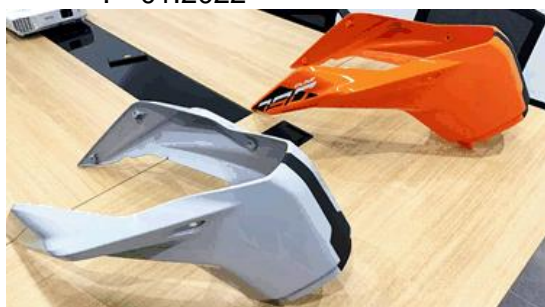
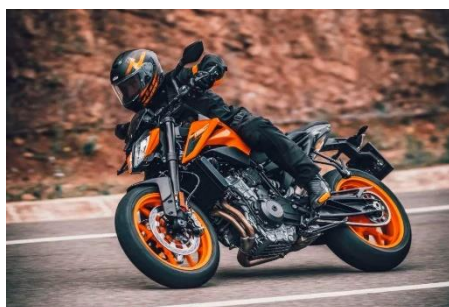
Participants : Plaston : Beck (PE)
 EMS : XUEA
 OEM : CFMOTO-R2R
 Sales responsible : GUOE
 Distributor : N/A
 Location : Zhejiang Jiaxing
 Application : Motorcycle Gasoline Tank Cover
 Segment Code : 740
 Project number : Old
 Material : Grilamid TR 90 UV + 4% Yellow MB from Plaston
 USP : Stress crack resistance (*Resist to gasoline*); High gloss surface / paint free;
 UV resistance (*Long time exposure to sun light*); Toughness (*Impact under different situation*)
 Potential : 10 t/a
 SOP : 01.2022
