EGLE-RRD-UpperPeninsulaEDM

**Subject: Site Assessment Report – Revision 1
5th St. Calumet Fire Site – RS
Calumet, Houghton County, Michigan
EPA Contract No.: 68-HE-0519-D0005 (START V, Region 5)
Task Order-Task Order Line Item No.: F0032-0001CF101
Document Tracking No.: 0767A**

**SITE ASSESSMENT REPORT
5th ST. CALUMET FIRE SITE – RS
CALUMET, HOUGHTON COUNTY, MICHIGAN
Revision 0**

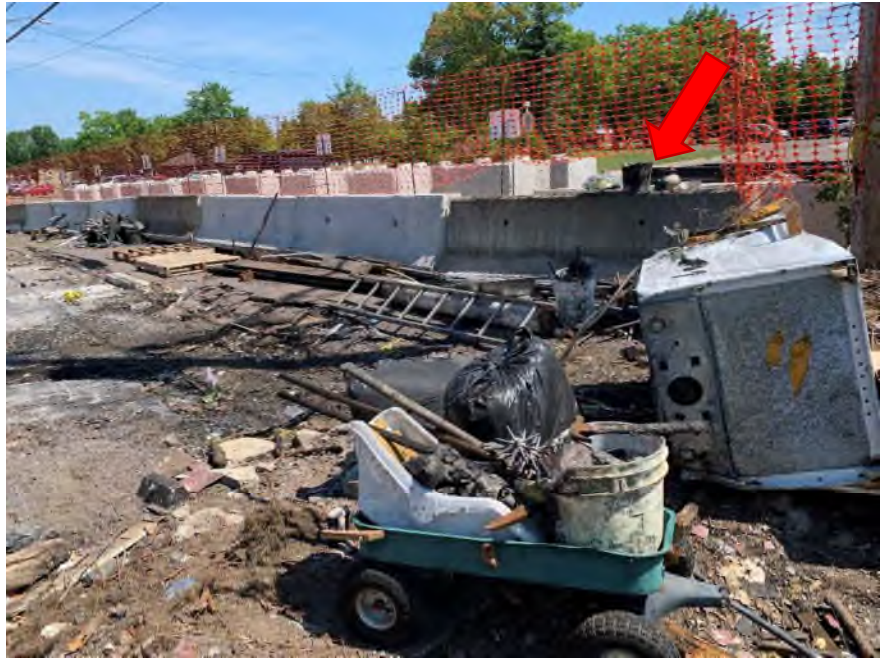
View of sorted piles of debris, which appear to have been created by trespassers along the eastern side of the 5th St. Calumet Fire Site - RS. Piles appear to be sorted into scrap metal, tools, glassware, and rock piles found in the refrigerator in the right of the photograph. Note items staged within and along the site barriers (red arrow).
