Building and Timber Pest Inspection Report

Inspection Date: Thu, 20 Jul 2023

Property Address: 67 Ferris St, Annandale NSW 2038,
Australia

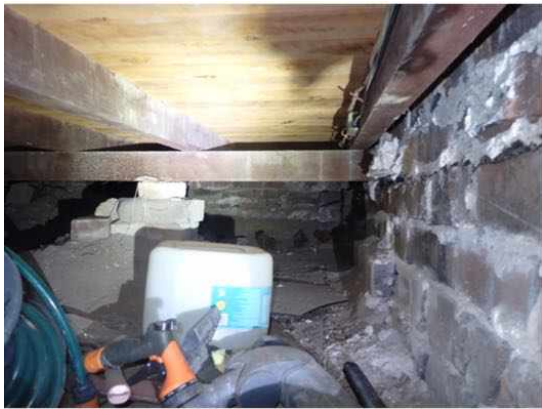
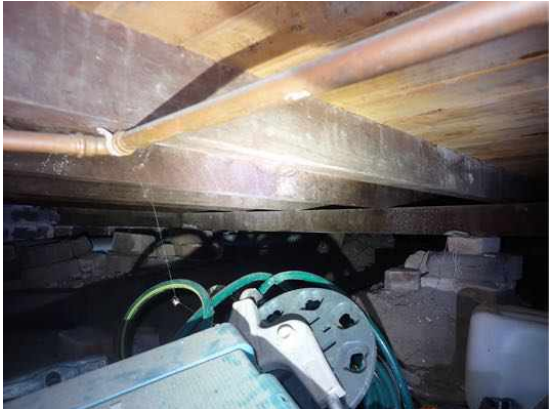
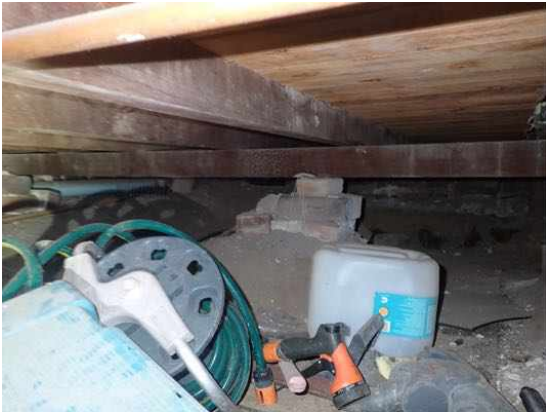
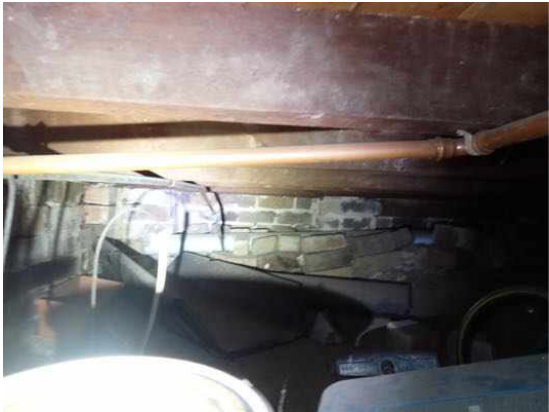
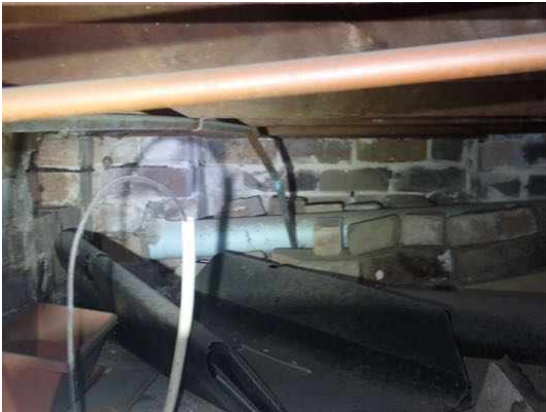
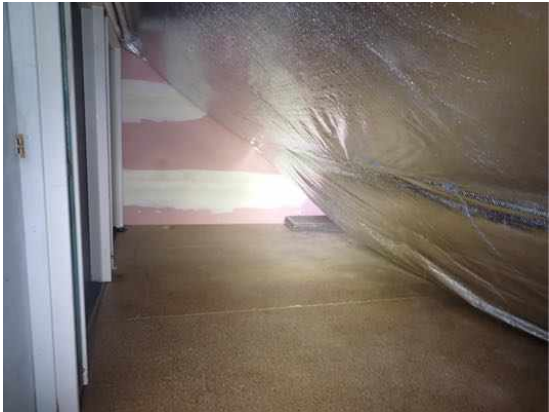
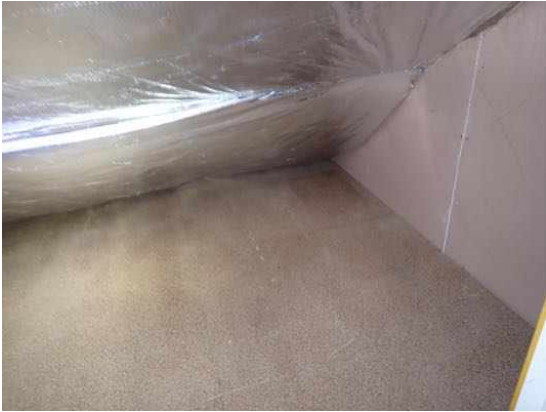
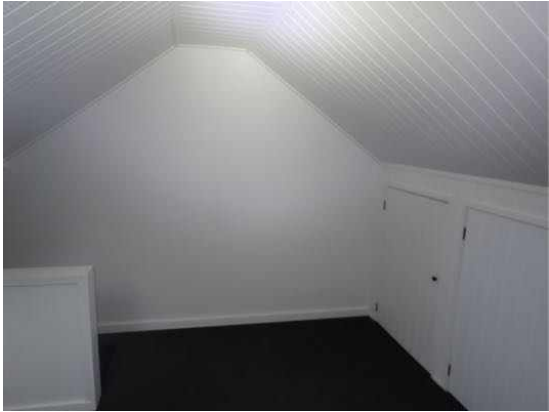
Finding 6.02

Building:	
Location:	All Areas
Finding:	Additional Photos - Information Only
Information:	Additional photographs of the roof void & subfloor (when accessible) are provided for general reference.
