**INVESTIGATION REPORT ON SERIUOS INCIDENT TO M/s GLOBAL  
VECTRA HELICORP LTD. AS350B3E HELICOPTER VT-RRH AT  
PANCHTARNI ON 10.07.2023**

**INVESTIGATION REPORT ON SERIOUS INCIDENT TO M/s M/s GLOBAL VECTRA  
HELICORP LTD. AS350B3E HELICOPTER VT-RRH AT PANCHTARNI ON  
10.07.2023**

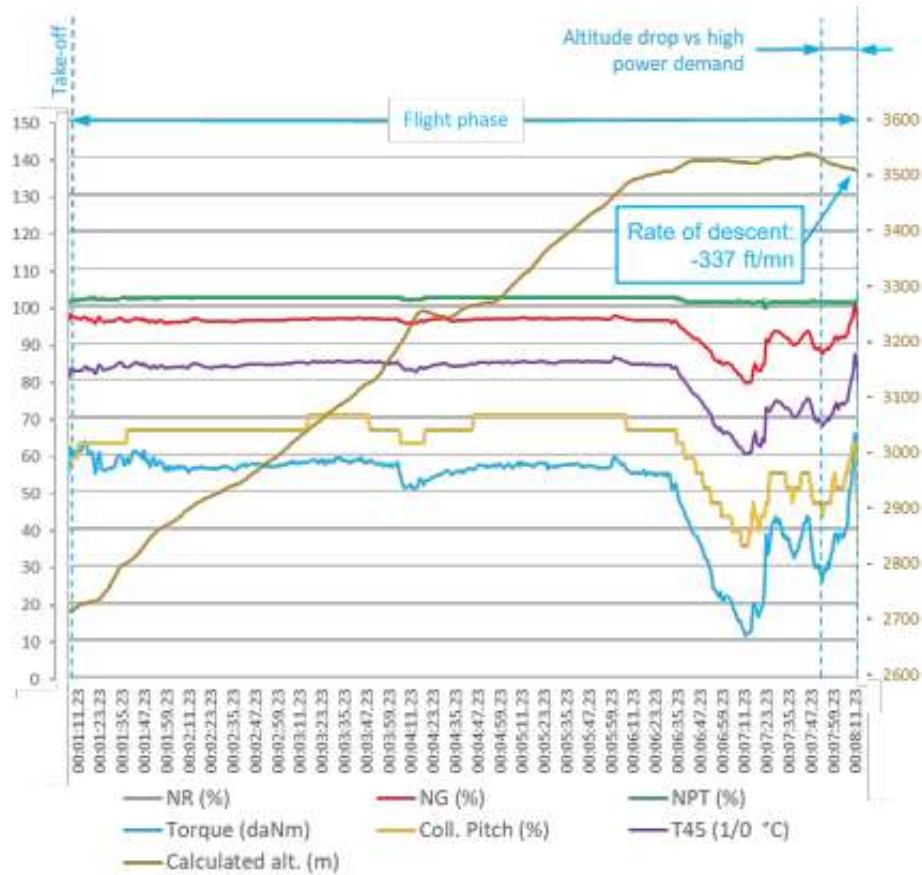
Helicopter is not installed with DFDR, however the Engine data was downloaded and analyzed by the engine manufacturer and following are the salient observations:

- There seems to be no fault recorded nor over limit recorded during the last flight.
- The behavior of TRQ, N1, T45 seems to be consistent during the flight.
- Oil and fuel filter pressure seems to be consistent with the N1 variations all over the flight.
- The flight phase lasted 7mn 15sec, during which all the engine parameters reacted in synchronicity with the power demands. No discrepancy messages and no Contexts were recorded and the NR speed was maintained at nominal value.
- The aircraft's altitude dropped in the last 30 seconds of the flight with an estimated rate of descent between -200ft/mn and -337 ft/mn, with the latter just one second before touch-down. In the last 4 seconds, the engine's power increased 160 kW to reach 416kW.
