REPORT ON INCIDENT TO TELANGANA STATE
AVIATION ACADEMY CESSNA-172R AIRCRAFT VT-CAM AT
BEGUMPET AIRPORT ON 06.04.2021.

SYNOPSIS:

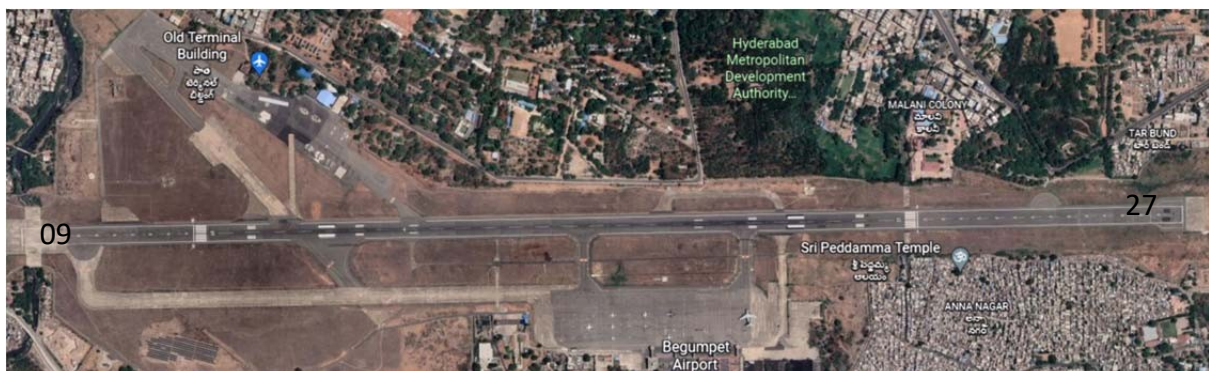
Fig.6 Runway09&27atBegumpetAirport, Hyderabad

The aircraft approached from RWY 09. Based on the propeller strike markings on the runway, it is indicating that the first point of contact of the propeller blades from the threshold of RWY 09 was 721 feet. The damage on the runway from the propeller blade strike with one hit followed by a second propeller hit marking a distance of 4 feet. After 12 feet from the second strike of the propeller, there were continuous propeller hit markings on the runway for about 196 feet. The damage on the runway surface from the propeller blades strikes were observed on the RHS of the Runway Centerline. The aircraft had moved 312 feet further where only tyre markings were observed on the RHS of the Runway Centerline, indicating suspected engine power loss.

The aircraft moved forward for approximately 787 feet and finally stopped at 77.7 feet to the right of the runway centerline. The tyre mark was found. (See Figure 7 wreckage plot).

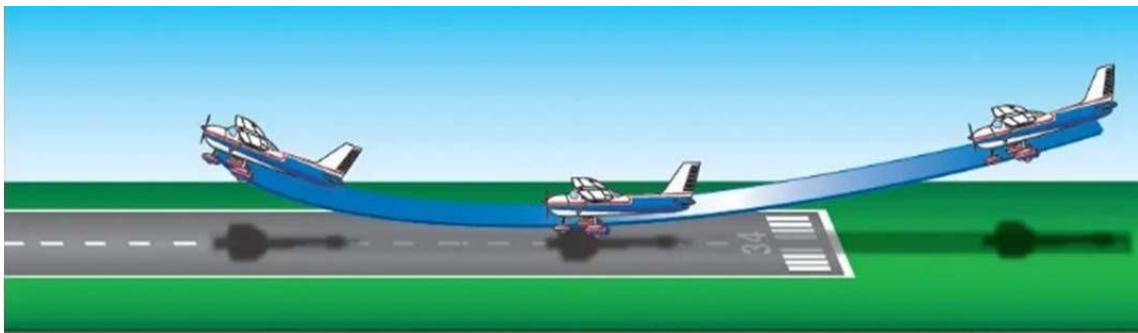
Fig.8 Ballooning during round out

This not only stops the descent, but actually starts the airplane climbing. This climbing during the round out is known as ballooning.

When ballooning is excessive, it is best to execute a go around immediately, do not attempt to salvage the landing. Power must be applied before the airplane enters a stalled condition.

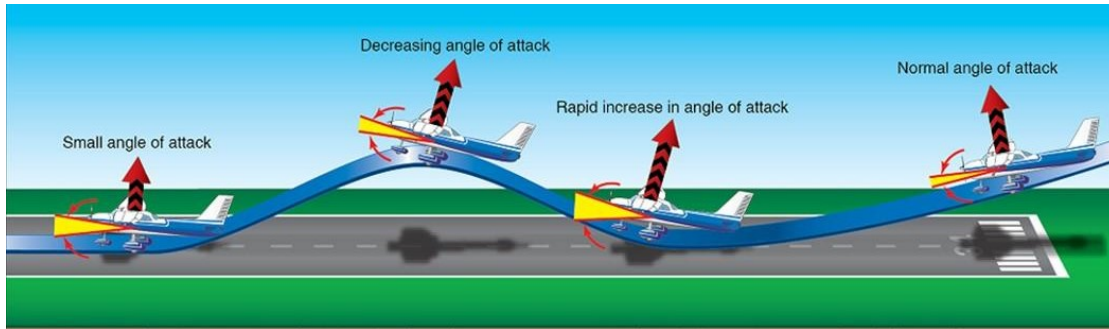
Fig.9 Bouncing during touchdown

The bounced landing is the result of trying to land with too much airspeed, then leveling too low, followed by jerking the control stick or yoke back. The airplane contacts the runway and bounces back into the air, at which time the in experienced pilot will relax the control pressure allowing the airplane to contact the runway again. The pilot then applies backpressure, causing the airplane to bounce back in the air. Without the proper recovery technique, the bouncer landing will usually conclude with a hard landing when the excess airspeed is finally dissipated, and sometimes followed by loss of directional control.

nose landing gear and damage to the propeller. The aircraft then veered to the right and came to a stop on the runway in a nose-down position, 77.98 feet to the right of the RWY 09 centerline. From examining the aircraft damage and ground marks, it was determined that the aircraft had landed on nose landing gear, resulting in the collapse of the nose landing gear.
