**FINAL INVESTIGATION REPORT ON
HARD LANDING INCIDENT DUE VIBRATIONS TO M/s HELIGO
CHARTERS PRIVATE LIMITED BELL 412 HELICOPTER VT-HLG
ON 13/03/2019 AT VIJAYAWADA AIRPORT**

**GOVERNMENT OF INDIA
O/o, DIRECTOR AIR SAFETY, WESTERN REGION,
NEW INTEGRATED OPERATIONAL OFFICE COMPLEX,
SAHAR ROAD, VILE PARLE (EAST), MUMBAI-400099**

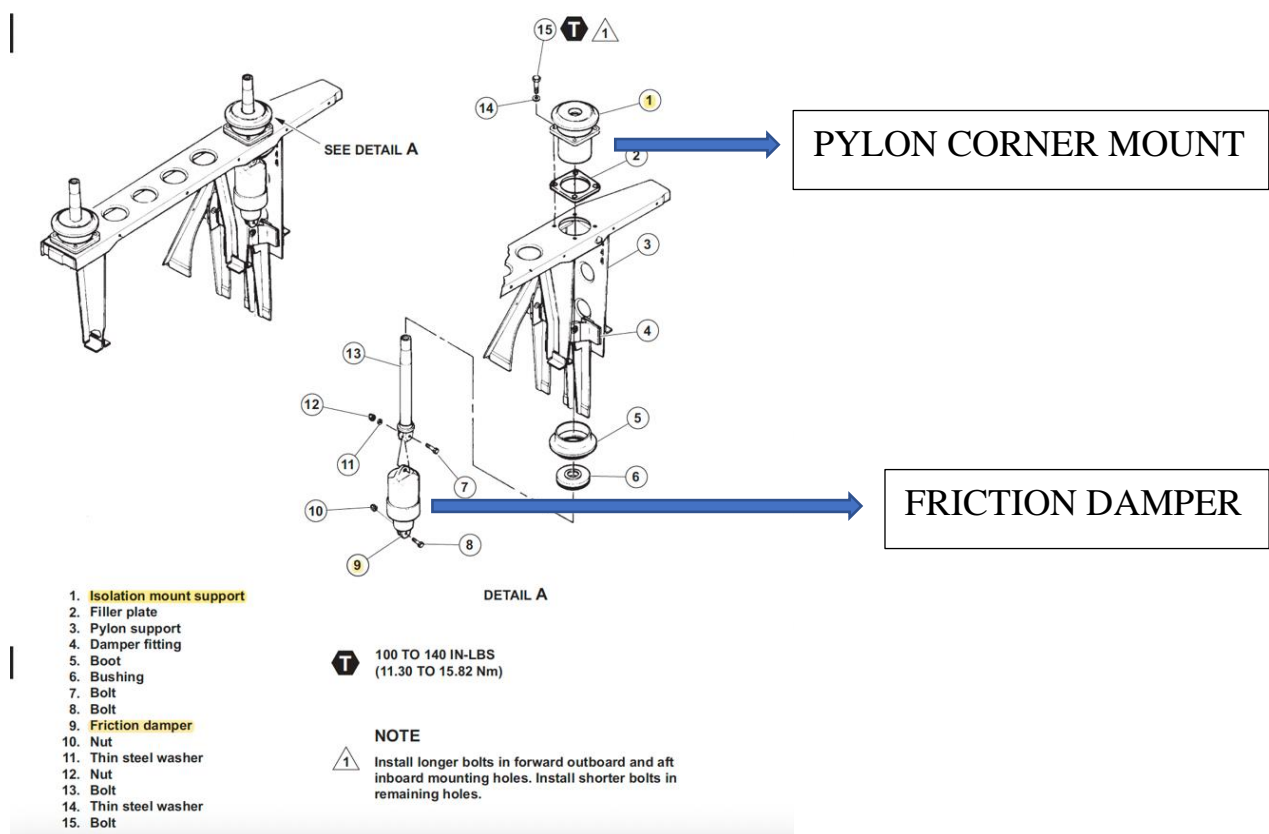
Figure 8: Pylon Corner Mount and Friction Damper

After the incident had occurred, based on the manufacturer's inputs, the operator carried out a hard landing inspection and an engine overspeed inspection. During the hard landing inspections, an inspection of the Pylon Corner Mounts and the Friction Dampers were carried out by the operator along with the representative of the manufacturer. A total of 4 Pylon Corner mounts (2 forward and 2 aft) Part no 204-031-927-107, and 2 Aft Friction Dampers, Part no 204-031-920-3, were sent to the manufacturer for lab testing and analysis.

The above-mentioned components were overhauled components which were installed on the helicopter on 16.01.2017 during the compliance of 5000hrs/ 5years Inspection at 2806:34 airframe hours after which there was no scheduled or unscheduled inspection carried out on them. At the time of the removal both the Pylon Corner mount assembly and the friction dampers, had 1007 hours of component time.

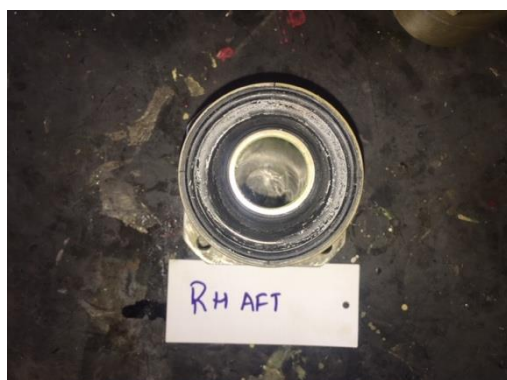
Figure 11: RH Aft Mount

As per the report of the laboratory, a visual inspection of the four pylon corner mounts showed no apparent defects or damage to the structure. All the mounts had small amounts of white residue on the elastomer. Spectroscopy of the same showed that the residue was paraffin wax, which is consistent with the dampers having undergone large oscillatory motions. Stiffness measurements indicate age hardening, but there are no signs of elastomer degradation.

The corner mounts were also subjected to static and dynamic stiffness testing. The stiffness measurements for each of the corner mounts were in good agreement with one another and well above the minimum stiffness requirements for a new damper, indicating that there was no degradation of the elastomer, and the condition of the corner mounts was as expected for a fielded component.

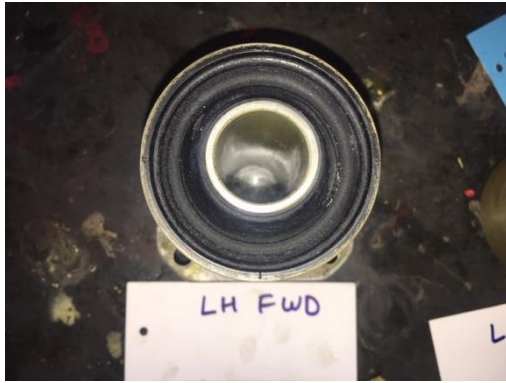
Figure 13: LH Forward Mount

In both LH and RH forward mounts, the bolts in the left/fwd corner and right/aft corner were found swapped. Such incorrect installation can result in insufficient clamping in the locations where a longer bolt was used. It is reported by the manufacturer, that this has been observed in at least one other field incident involving excessive vertical vibrations.
