**FINAL INVESTIGATION REPORT ON INCIDENT TO M/s GUJARAT
FLYING CLUB, CESSNA FA 152 AIRCRAFT, VT-EMM, ON 19.03.2020 AT
VADODARA**

GOVT OF INDIA
O/O DIRECTOR AIR SAFETY
WESTERN REGION
NEW INTEGRATED OPERATIONAL COMPLEX
SAHAR ROAD
VILLE PARLE (EAST)
MUMBAI-400099

a) Aircraft	Type & Model : Cessna FA 152 Aircraft
	Nationality: Indian
	Registration: VT-EMM
b) Owner	: M/s The Aero Club of India
c) Operator	: M/s The Gujarat Flying Club
d) Pilot in command	: SPL holder
e) Extent to injuries	: Nil
f) First Officer	: N/A
g) Extent to injuries	: N/A
h) Passengers onboard	: Nil
i) Extent to injuries	: N/A
j) Place of incident	: Vadodara, Gujarat (VABO)
k) Co-ordinates of Incident site	: N 22.340563, E 73.230490
l) Date and time of Event	: 19.03.2020, Approx. 11:33 IST
m) Last Point of Departure	: VABO
n) Point of Intended Landing	: VABO
o) Type of operation	: Training flight (Solo)
p) Phase of operation	: Landing
q) Type of Incident	: Abnormal Runway Contact

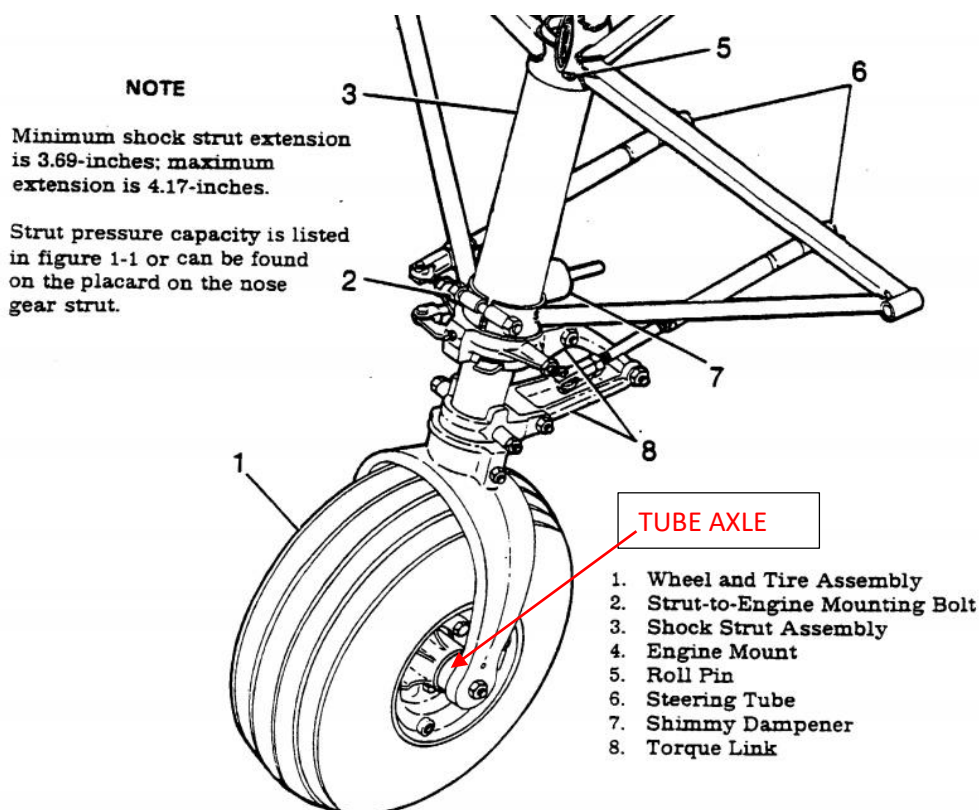
The failed / damaged parts of the nose wheel assembly were examined in Aircraft Engineering Directorate, DGCA Hqrs. Upon examination, The Inner Diameter of bearing inner race and Outer Diameter of tube axle at the corresponding bearing locations have been dimensionally examined and it is found that the parts under excessive clearance /play (undersized) in their assembly from the prescribed limits observed. Hence, tube axle (As Shown in Fig.05) is worn out and undersized at the bearing diameter locations. There was an indication of undersized tube axle, circumferential rubbing marking and pitting were noticed on the tube axle.

The worn-out tube axle outer diameter at the bearing locations would have eased the bearing units to rotate over the tube axle. This could have also caused the entire wheel assembly along with bearing unit (which is restrained by ring retainer within the wheel assembly) to move on lateral direction. The lateral movement of the wheel would have probably caused offsetting of wheel loading on the tube axle, movement of bearing units

Over a period, the stated events would have loosened the fastening of NLG tube axle unit with NLG Fork and perhaps caused the disintegration of wheel unit from NLG due overload and exposing the fork to come in direct contact with landing surface. The chip off/ flaking away of rolling elements within the rollers also suggestive of overload due to offset wheel loading. Other failures like, steering tube, steering tube linkage failure, shimmy damper lug failure and wheel rim damage are consequential failures.

Wheel assembly detachment failure could have probably due impact contributed by undersize/ worn out tube axle and subsequent the NLG collapsed.

The nose landing gear assembly is to be inspected during 100 Hrs/12 months & 50 hrs inspection which includes the inspection of NLG for condition and security of attachment, however there is no specific inspection to measure the dimensions of axle tube and the bearing of the nose wheel.

Fig.05 Cessna FA 152 Aircraft Nose landing Gear Assembly

During the investigation of the failed nose wheel at DGCA HQ, indication of poor maintenance in the nose wheel area was observed. The tube axle was found to be undersized beyond manufacturer specified limits. The loose tube axle inside the bearing led to the breaking of the nose gear on impact.

Based on findings one of Safety recommendation was to carry out onetime inspection to measure the dimensions of axle tube and of the bearing of the nose wheel of the entire fleet of the flying club.
