FINAL INVESTIGATION REPORT ON SERIOUS INCIDENT TO M/S MP FLYING CLUB CESSNA-172S AIRCRAFT VT-MPF ON 10.03.2023 AT INDORE

**FINAL INVESTIGATION REPORT ON SERIOUS INCIDENT TO M/S MP FLYING CLUB
CESSNA-172S AIRCRAFT VT-MPF ON 10.03.2023 AT INDORE**

1	Aircraft	Type	Cessna
		Model	172S
		Nationality	Indian
		Registration	VT-MPF
2	Owner and Operator	M/s Madhya Pradesh Flying Club Ltd	
	Pilot-in command	Student Pilot licence (SPL) holder	
3	Extent of Injuries	Nil	
4	Date & Time of Incident	10.03.2023 & 11:40hrs UTC approx.	
5	Place of Incident	Indore Airport	
6	Co-Ordinates of Incident Site	Latitude 22°43'24"N Longitude 75°48'20"E	
7	Last Point of Departure	VAID (Indore Airport)	
8	Intended place of landing	VAID (Indore Airport)	
9	No. of Passengers on Board	Nil	
10	Type of Operation	Training flight (Solo)	
11	Phase of Operation	Landing	
12	Type of Incident	Runway Excursion

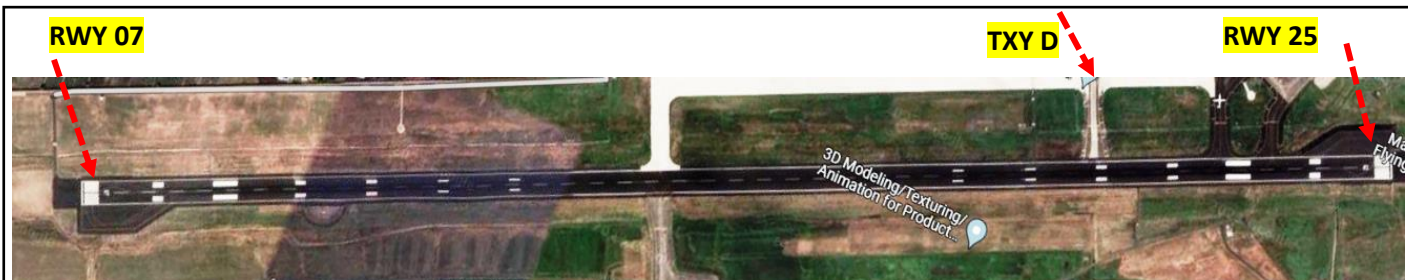
(Photograph# 6-Indore Airport Runway)

The Indore Airport is an International Airport (ICAO Code: VAID), which is named as Devi Ahilyabai Holkar Airport. It is a public aerodrome operated by Airports Authority of India. It has one runway with designated Runway ends: 07 and 25. Refer Photograph 6. The runway physical characteristics are mentioned in Table: 5 below. Last Runway Surface Friction Testing was carried out on 21.02.2023, friction values were found above Minimum acceptable friction level and Maintenance planning level.
