**FINAL INVESTIGATION REPORT ON
INCIDENT TO
M/s TRU JET LTD. ATR 72-212A (500
Series) INDIAN REGISTERED
AIRCRAFT
VT-TMK ON 18-11-2021 AT KANDLA**

**INVESTIGATION REPORT ON INCIDENT TO M/s TRUE JET LTD. AIRCRAFT
VT-TMK ON 18.11.2021**

| 12. Type of incident | | : | Runway excursion and Tail strike |

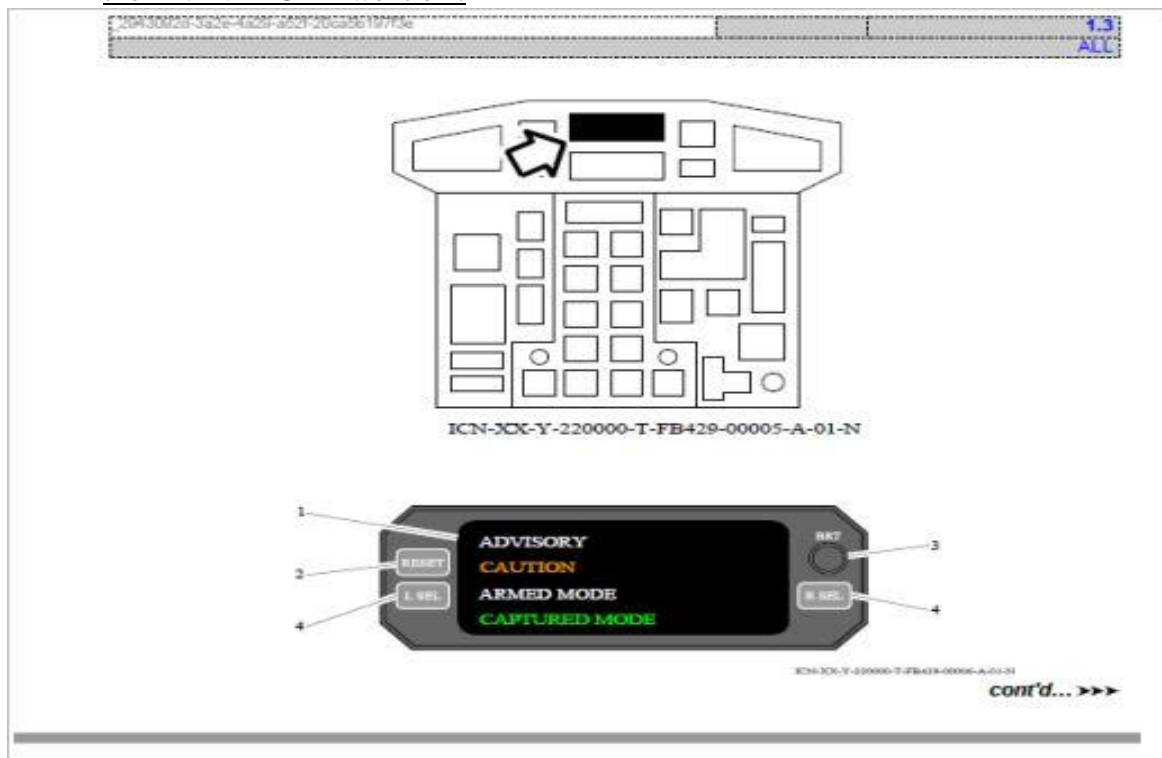
1.18.3 ADU

- (f) The ADU, Advisory Display Unit is a display showing advisory (white) and caution messages related to any change to AP functions, such as lateral modes. The recorded FDR parameter Advisory Display Unit is ACTIVE when a message is displayed. This description is issued from the FCOM of the company (Rev 29-June 21). During the event, the parameter Advisory Display Unit Caution Active became active when the LNAV MODE went off.
