**FINAL INVESTIGATION REPORT ON RUNWAY EXCURSION INCIDENT TO
M/s. NATIONAL FLYING TRAINING INSTITUTE PVT LTD
DIAMOND DA 40 AIRCRAFT, VT-NFK
ON 17.06.2017 AT GONDIA AIRPORT, NAGPUR, MAHARASHTRA**

**GOVERNMENT OF INDIA
OFFICE OF DIRECTOR OF AIR SAFETY (WESTERN REGION)
INTEGRATED OPERATIONAL OFFICE COMPLEX,
SAHAR ROAD, VILEPARLE (E), MUMBAI – 400099**

FINAL INVESTIGATION REPORT ON RUNWAY EXCURSION INCIDENT TO
M/s. NATIONAL FLYING TRAINING INSTITUTE PVT LTD (NFTI)
DIAMOND DA 40 AIRCRAFT VT-NFK AT GONDIA ON 17.06.2017

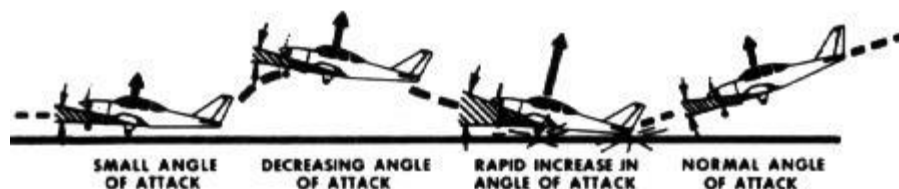
Fig.18. Bounced landing phenomenon

Bouncing During Touchdown: When the airplane contacts the ground with a sharp impact as the result of an improper attitude or an excessive rate of sink, it tends to "bounce" back into the air. Though the airplane's tires and shock struts provide some springing action, the

airplane does not bounce as does a rubber ball. Instead, it rebounds into the air because the wing's angle of attack was abruptly increased, producing a sudden addition of lift.

The abrupt change in angle of attack is the result of inertia instantly forcing the airplane's tail downward when the main wheels contact the ground sharply. The severity of the "bounce" depends on the airspeed at the moment of contact and the degree to which the angle of attack or pitch attitude was increased. Since a bounce occurs when the airplane makes contact with the ground before the proper touchdown attitude is attained, it is almost invariably accompanied by the application of excessive back elevator pressure. This is usually the result of the pilot realizing too late that the airplane is not in the proper attitude and attempting to establish it just as the second touchdown occurs.

Recovery from bounce: The corrective action for a bounce is the same as for ballooning and similarly depends on its severity. When it is very slight and there is no extreme change in the airplane's pitch attitude, a follow-up landing may be executed by applying sufficient power to cushion the subsequent touchdown, and smoothly adjusting the pitch to the proper touchdown attitude. When a bounce is severe, the safest procedure is to EXECUTE A GO-AROUND IMMEDIATELY. Full power should be applied while simultaneously maintaining directional control and lowering the nose to a safe climb attitude. The go-around procedure should be continued even though the airplane may descend and another bounce may be encountered. It would be better to avoid an attempt for landing from a bad bounce since airspeed diminishes very rapidly in the nose high attitude and a stall may occur before a subsequent touchdown could be made.
