Investigation Report On Incident to M/s Alliance Air Aviation Ltd.

(Alliance Air) Aircraft VT-RKJ on 09.02.2022

11. Phase of operation : Take-off roll
12. Type of Incident : System/Component Failure - Non-Power plant (SCF-NP)

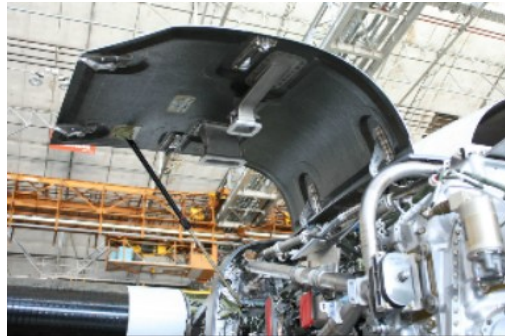
Two cowls, opening upwards, are hinged on either side of the upper beam (refer figure below). They are made of carbon/Nomex fireproof sandwich and are covered on their outer face by bronze mesh. They include DC starter generator and AC generator ventilation air outlets and inlets, oil level inspection and fire extinguisher nozzle introduction access door. Each cowl is held closed by four locks. The travel of each cowl is limited by a telescopic rod.
