**FINAL INVESTIGATION REPORT ON  
AIR TURN BACK INCIDENT DUE TO  
LOSS OF PRESSURIZATION TO  
M/s AIR INDIA LTD BOEING 787-800 AIRCRAFT  
VT-ANU ON 06/03/2019 AT DELHI**

**GOVERNMENT OF INDIA  
O/o DIRECTOR AIR SAFETY, WESTERN REGION,  
NEW INTEGRATED OPERATIONAL OFFICE COMPLEX,  
SAHAR ROAD, VILE PARLE (EAST), MUMBAI-400099**

On 06<sup>th</sup> March 2019, M/s Air India Ltd Boeing 787-800 aircraft VT-ANU was involved in air turn back incident due to loss of pressurization during climbing while operating flight AI-121 (VIDP-EDDF).

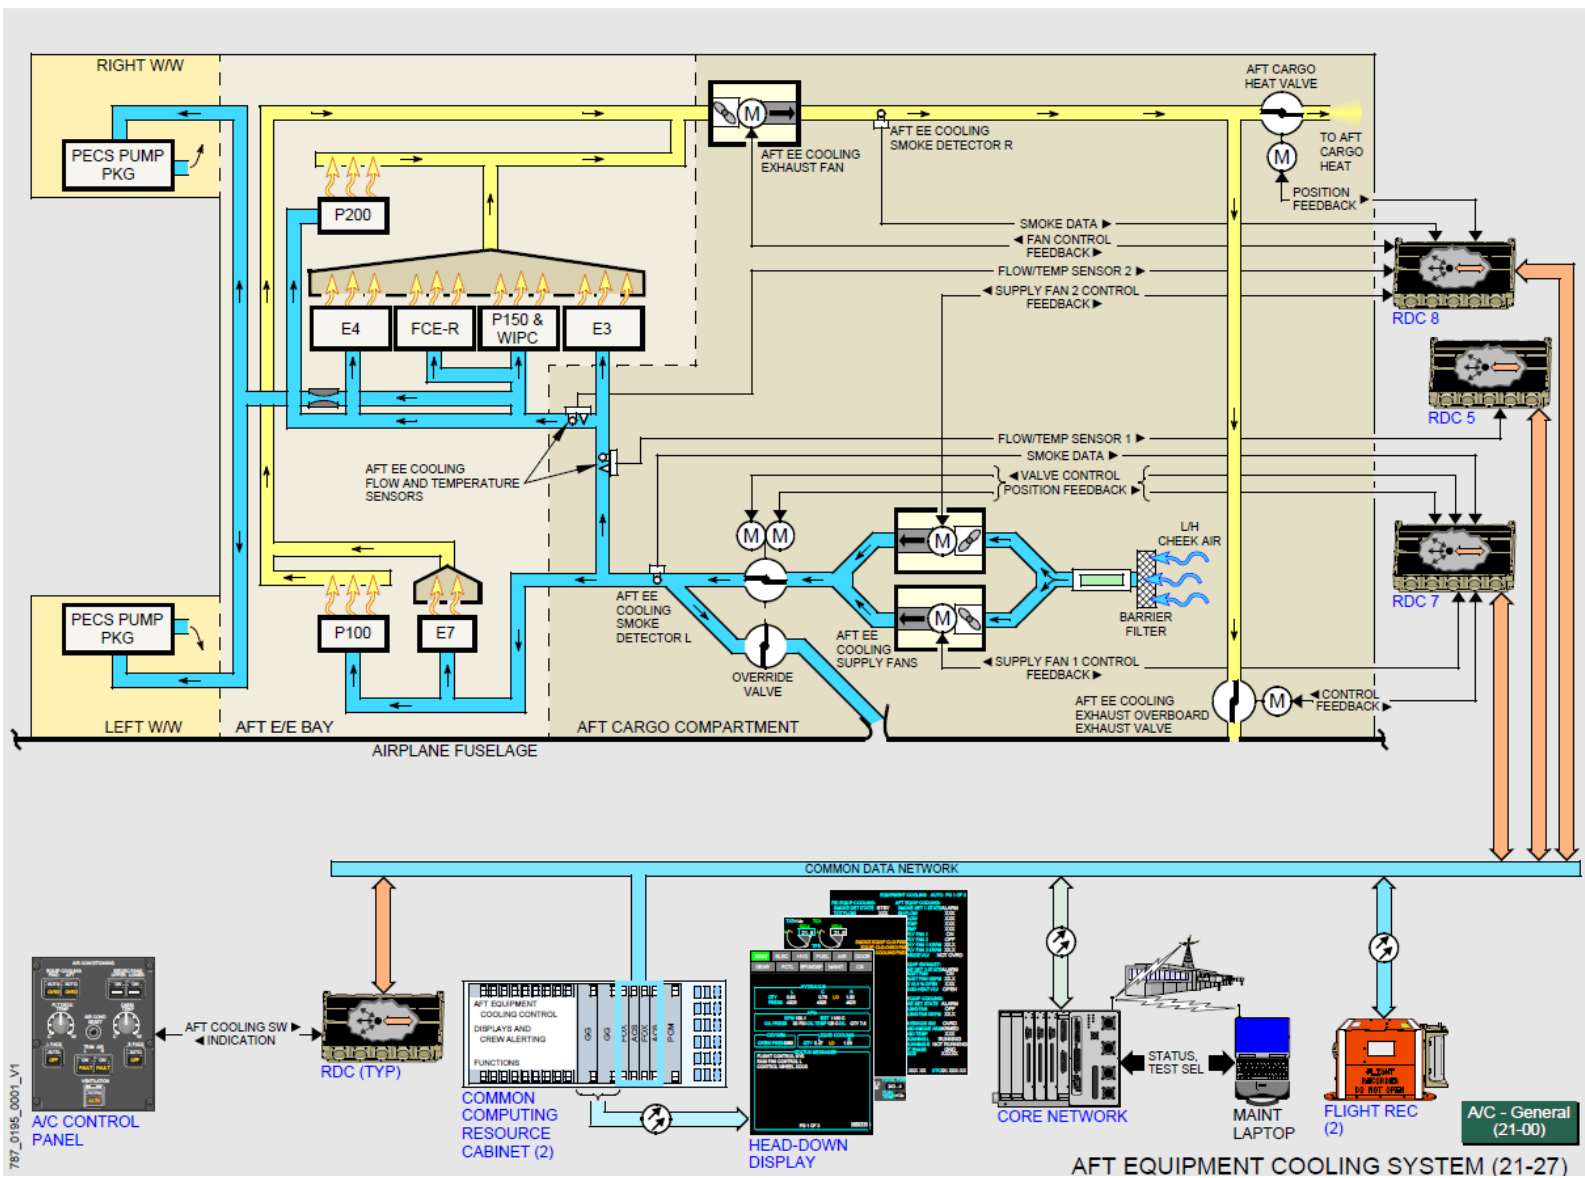
Figure # 3 Aft Equipment Cooling System

EQUIP OVBD VLV AFT message indicates that the aft equipment cooling overboard valve is failed in the open position. Pressurizing the airplane with this valve open leads to a large pressure differential between the cabin and equipment cooling duct. This causes duct failure and subsequent loss of cabin pressure through the equipment cooling overboard valve.

History of snags & AHM reports prior to incident flight substantiate that the valve was generating intermittent faults and finally failed on 06/03/2019. As per the report of the M/s Collins Aerospace, the Aft EE Cooling Exhaust Overboard (Skin Flush) valve was confirmed defective, i.e. outside of test limits for Door Closure flushness tests. Hence the reason for the EQUIP OVBD VLV AFT advisory/ status messages generated throughout the flight and in previous sectors is attributed to the defective Aft EE Cooling Exhaust Overboard (Skin Flush) valve. The defect did not repeat after replacement of the valve substantiates the same.

Wiring check and Remote Data Concentrator 07 revealed no abnormality during fault isolation carried out as per FIM of correlated maintenance message 21-22420. This fact along with the M/s Collins Aerospace report confirms that the maintenance message '21-22420- Aft EE Cooling Exhaust Overboard (Skin Flush) Valve position feedback has failed' was generated due to defective Aft EE Cooling Exhaust Overboard (Skin Flush) Valve.
