High Rate In-situ Damage of Electronics Packages

Drop Tower shock tests of highly-instrumented electronics package

Alain Béliveau, Jonathan Hong
Applied Research Associates Inc.

Jacob Dodson, Michael Davies
Air Force Research Laboratory

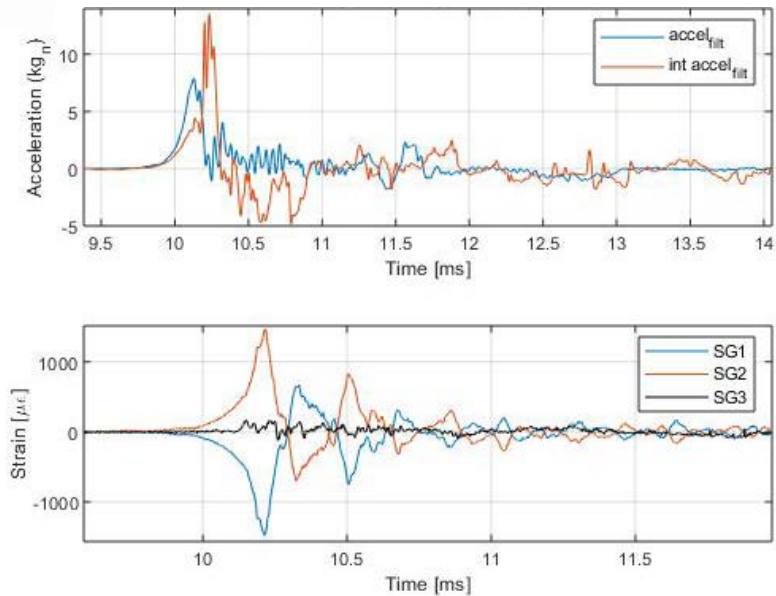
In this test series, 1 unit (unpotted electronic assembly) was shock tested on a MTS drop tower at 5 shock levels (T04-T08). After the 5th test, the RC circuit was damaged no longer gave the appropriate charging signal.
