Samsung HA SVC Guide Booklet

- 2023.05 -

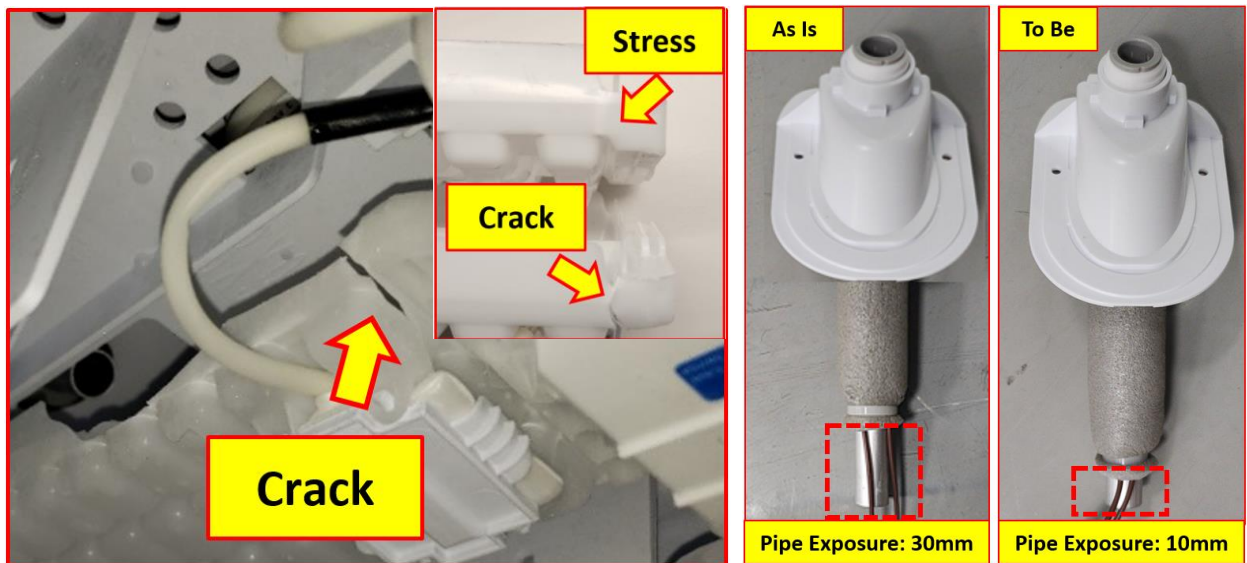
- No nugget ice production due to broken nugget ice tray
- I/M water pipe freezes due to insufficient insulation
 - Ice build-up at tip of water pipe hits tray when rotating

- I/M Water Pipe insulation increase
- Replace I/M Water Pipe

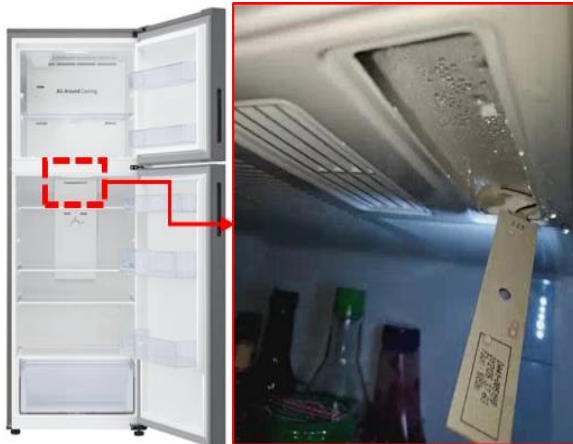
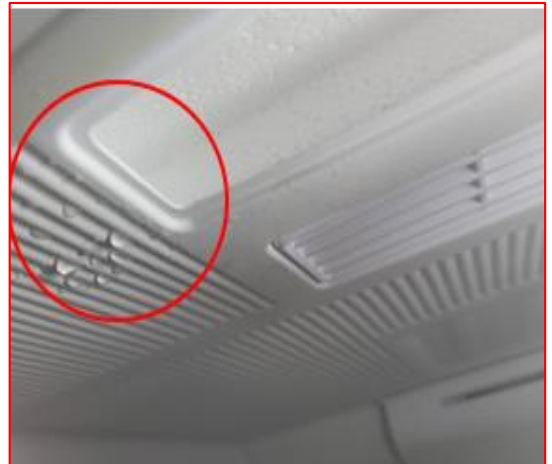
Water leaking from FF ceiling by the lamp which is caused by super cooling of the freezer when unit ice maker is set to on, but unit does not have ice maker present or is connected to water.

Under this condition the temperature of the freezer can achieve -24 C (-11.2 F)

This condition will cause condensation on the lower (fresh food) compartment

- Turn off Ice Maker function

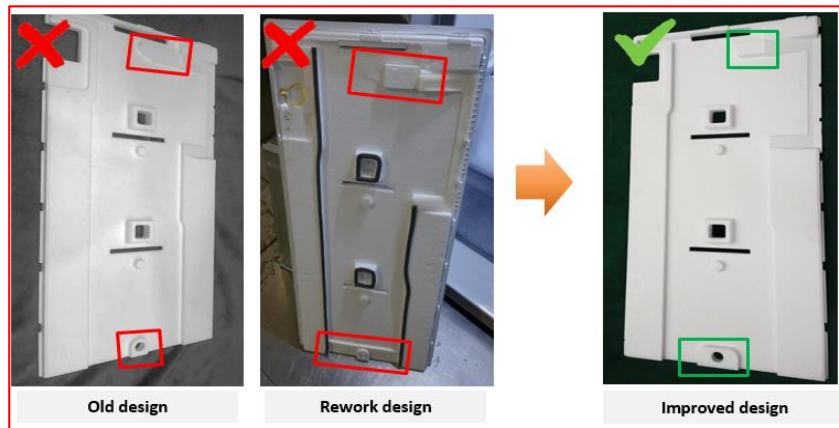
- ❑ **Symptom:**
 - Overcooling in Flex Zone
- ❑ **Solution :**
 - Service Guide release ('21 Sep)
 - Replace Evap. Cover
 - Change temperature setting & S/W Update

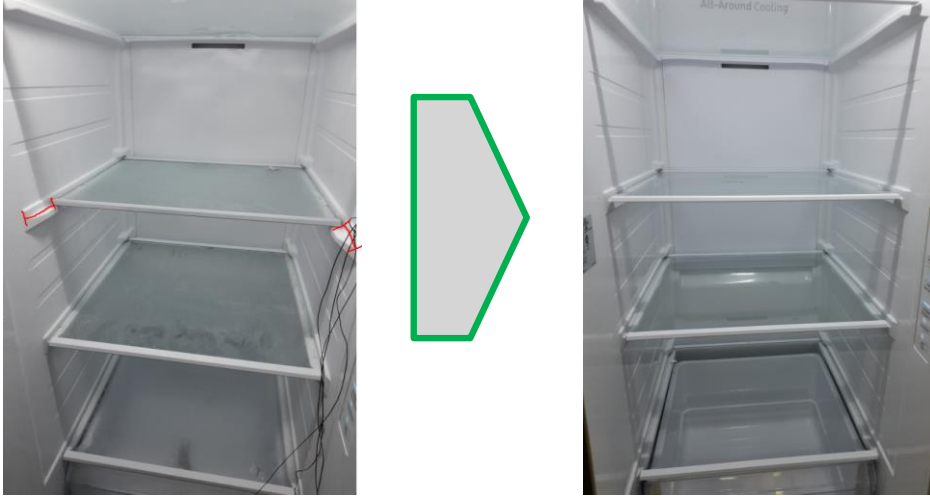
- Make sure that all shelves of the right size are installed for this model. **1) *****
If there is a wrong sized shelves, it could be affecting temperatures.
- If there are shelves that do not correspond with model, please change the part.

1) *** : There is a difference in size between RS27 * model and RS22 * model shelves by about 60 mm.

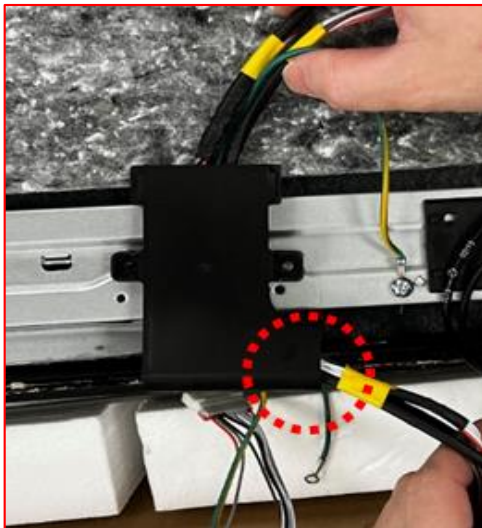
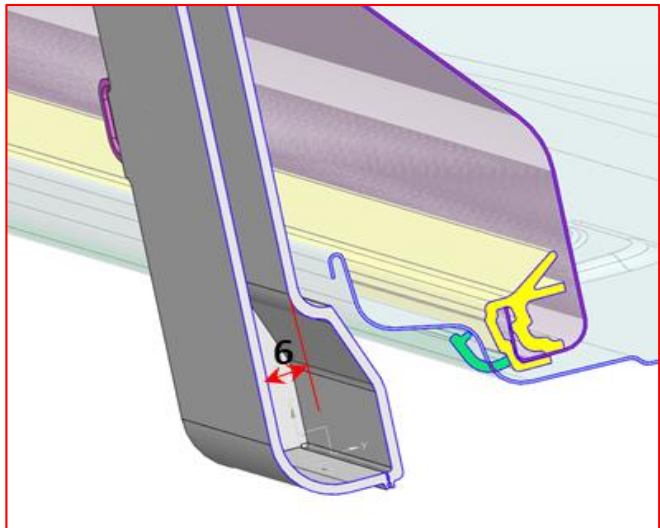
- ❑ **Symptom:**
 - Not cleaning & 4C/7C/PC Error due to cut sub wire harness
- ❑ **Solution :**
 - Service Guide release ('22 Sep)
 - Replace wire cover & sub wire harness

- Unit is not filling with water (4C error)
- Unit display PC & 7C error
- Ran Smart Install and received PC or 4C, or 7C
- **Three types(PC, 4C, 7C) of errors occur intermittently or alternately**
 . With the neutral wire connected to the water valve (4C), distributing motor (PC), and geared motor (7C), three errors can occur simultaneously or alternately.
- **The same error occurs even when the error-related parts are replaced.**

- Replace the wire harness (sub) that assembled in the inner door. (Below red arrow)
- Refer to the table below for Part No.

※ **Don't replace the Assy Door, Just replace the only wire harness sub**

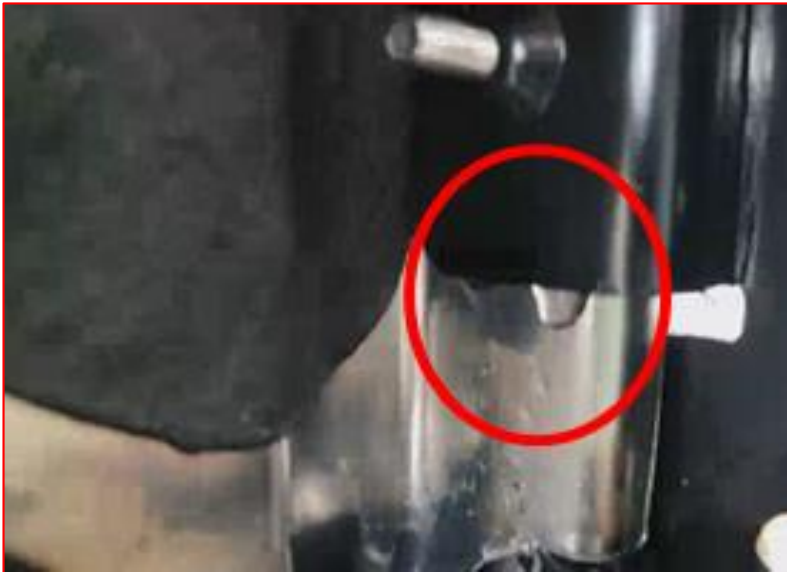
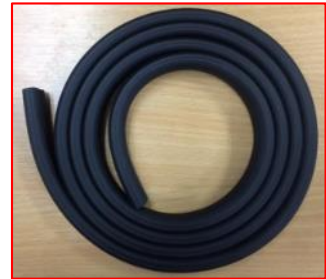
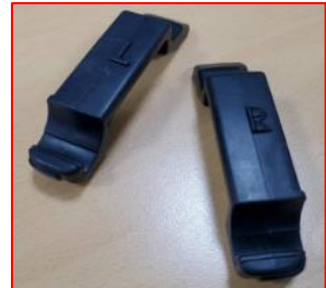
- ❑ **Symptom:**
 - Water leaks from bottom of the door or bottom corners of tub
- ❑ **Solution :**
 - SVC Guide released with water leak SVC part kit (Feb '21)
 - Revised SVC Guide for water leak checkpoints released (Mar '23)

Most commonly mistake related to this issue is not applying information from service tip, techs replace door seal but do not replace corner seal on the first visit. Also, techs do not check for channel separation while replacing the seal and do not check if unit is level.

- Water leaks from the lower part of the door lower and drips on the floor
- Water leaks from the left and right corners of the bottom-tub

- Order and install the water leak service kit (DD82-01988A)
- To prevent a water leak defect, refer to the following pages and replace the parts as necessary.

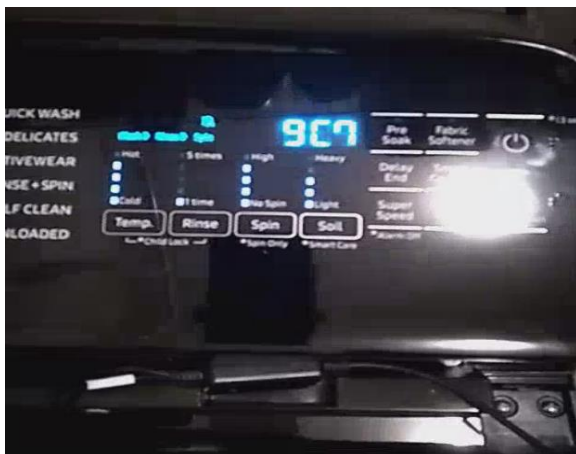
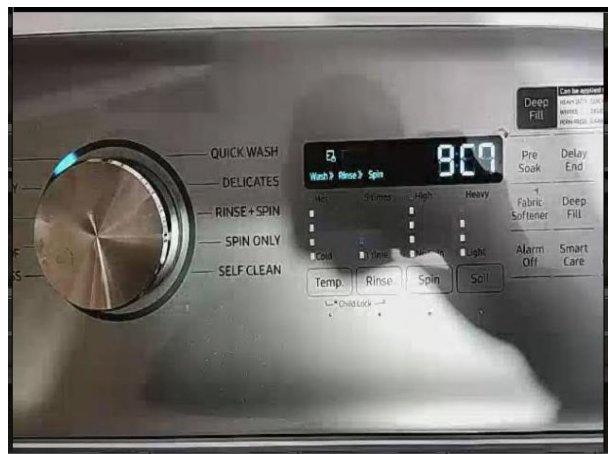
- ❑ **Symptom:**
 - 9C6, 9C7, 9C8 errors display on control panel.
- ❑ **Solution :**
 - If it shows 9C6, 9C7, 9C8, the Main PBA needs to be replaced
 - After replacement, update the serial number in new Main PBA using HASS

Error	Description
9C6	Error that detects high temperature to prevent PBA failure
9C7	Error that detects hardware defects to prevent PBA failure
9C8	Error that detects software defects to prevent PBA failure

- When washer detects abnormal conditions, error codes like above will be displayed for a protection.

- 1) Check error code
- 2) If it shows 9C6, 9C7, 9C8, the Main PBA needs to be replace
- 3) After replacement, update the serial number in new Main PBA using HASS

- Service PBA Part will not have the serial number of the product and serial number **MUST** be written via HASS
- After main PBA replacement, serial number needs to be registered in HASS

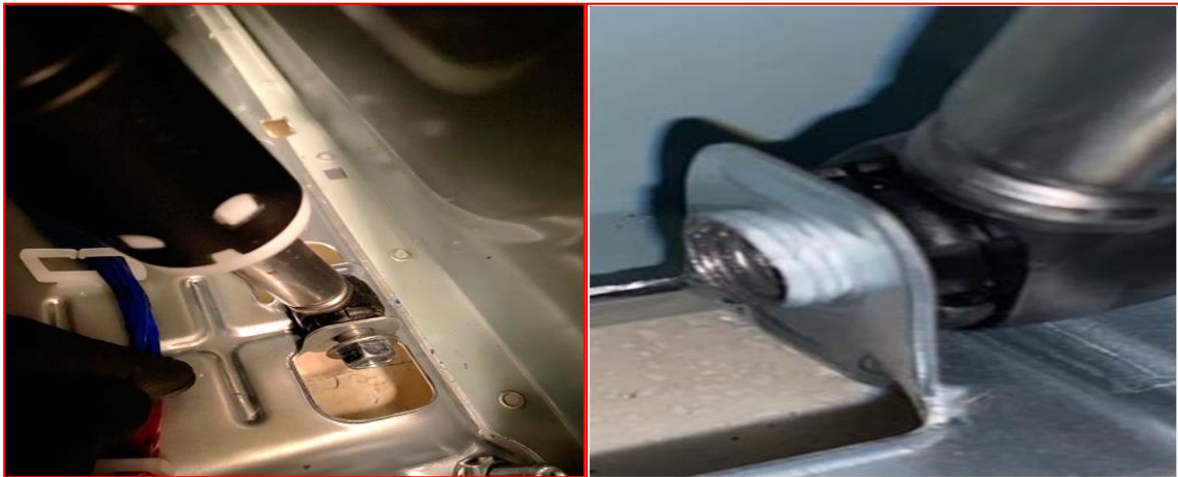
-Vibration and knocking noises caused by stripped threads on the bottom mounting tab that Damper bolt threads through.

Vibration and knocking noises due to loose mechanical connection between the bottom frame tab and damper caused by stripped threads on the bottom mounting tab

- Identify which damper is the source of the noise.
- Remove the old damper bolt and insert the new longer bolt from kit, attach and tighten the included nut.
