Long-term monitoring of a damaged historic structure using a wireless sensor network

Esequiel Mesquita^{a,*}, António Arêde^a, Nuno Pinto^a, Paulo Antunes^b, Humberto Varum^a^a CONSTRUCT-LESE, Faculty of Engineering of University of Porto, Department of Civil Engineering, 4200-465 Porto, Portugal^b I3N & Department of Physic of the Aveiro University and Instituto de Telecomunicações, Campus de Santiago, 3810-193 Aveiro, Portugal

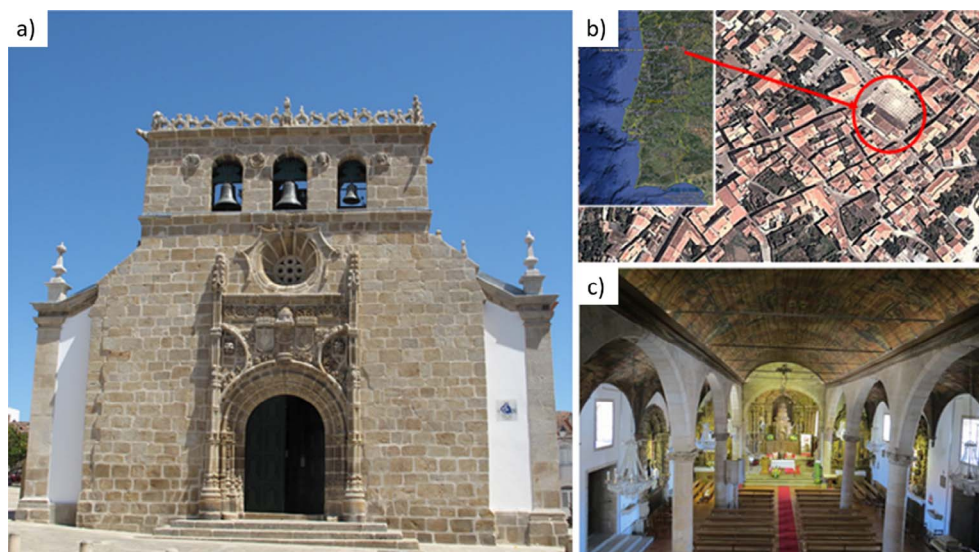
The main façade is characterized by an exposed granitic stone masonry (Fig. 1a) where the arch on the main door is decorated with *Manuelino* marks and there are three bells on the top. At the interior side of the church, two plans of columns and arch represent the division between the main nave with the left and right naves. Fig. 1c shows the interior view of the Church.

Fig. 1. Foz Côa Church: (a) main façade, (b) geographic location, and (c) interior view of the Foz Côa Church.

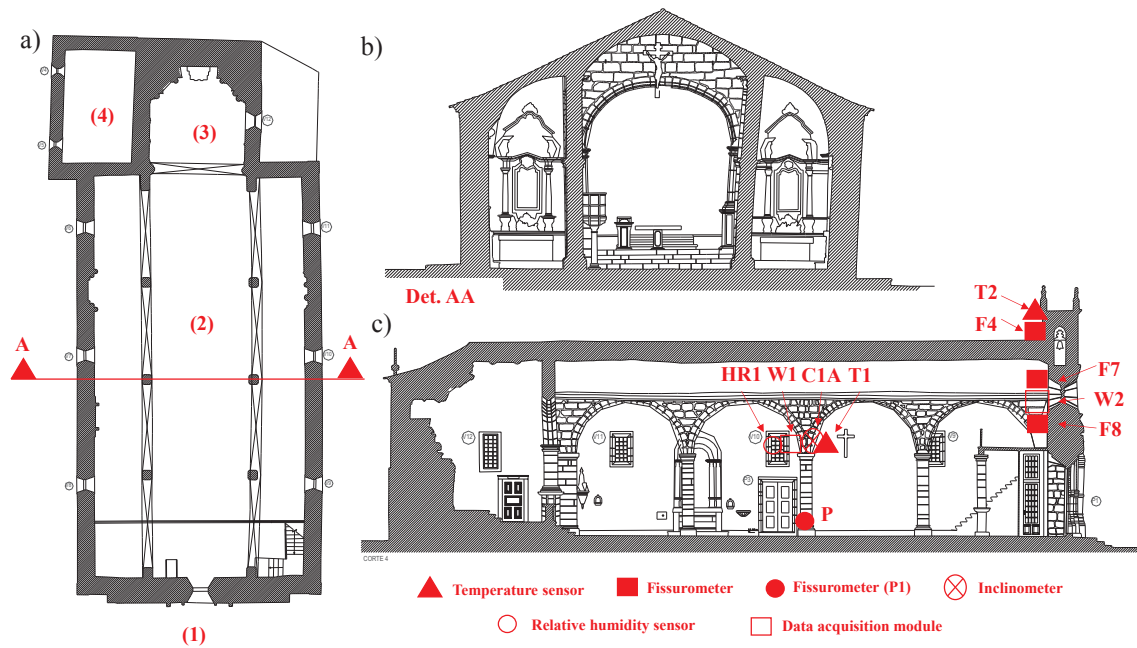
lateral right, as well on the main façade. The column 2 (Fig. 2) was assigned as the region with higher deformations, and hence densely instrumented. Column 2 is the main instrumented column presented in Fig. 5.

For the long term-monitoring of the Foz Côa Church, eight sensors were used in total, mainly focused on displacements monitoring of the column 2 and main façade, as shown in Fig. 5. From those, two temperature sensors, one of them designated as T2C, was placed on the top of the main façade while the other one, so-called T1C, was positioned on the top of the column 2, close to a relative humidity sensor. An inclination sensor, C1A, was also installed on the top of the same column, while a linear potentiometer displacement sensor, designated as P1, was placed on the bottom of the same column. Other two linear potentiometer displacement sensors (crack-opening sensor), namely F7 and F8, were placed along the internal wall, on the main façade, while another one, assigned as F4, was installed near the T2C temperature sensor, at the top of the façade.

Fig. 5. Geometric view of the Foz Côa Church (a) where 1 - is the main façade, 2 - is the Central Nave, 3 - is the Altar-Mor and 4 - is an office; the transversal view of the detail AA is presented in (b) and the sensors positioning are shown by (c).

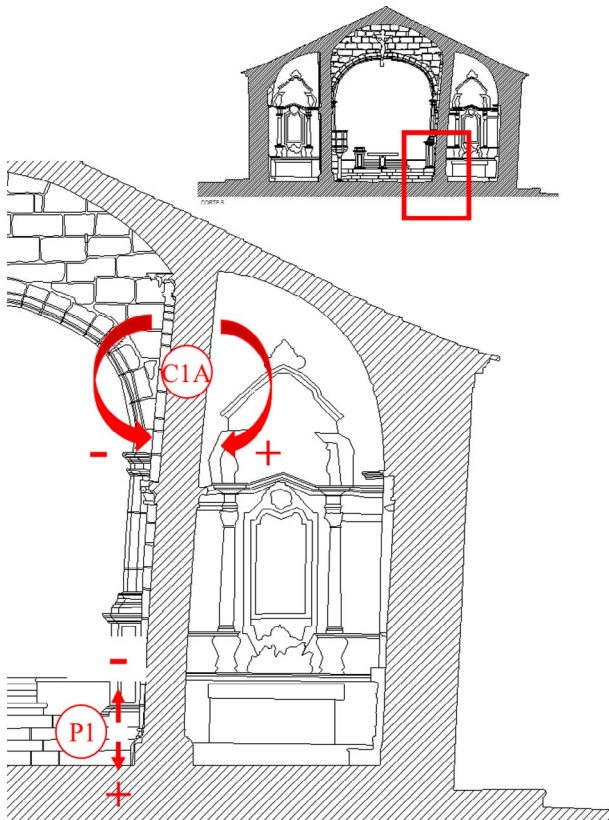
Fig. 7. Schematic view of the movements and orientations monitored through sensors C1A and P1.

Fig. 7 shows in detail the displacement parameters monitored on column 2, one of the most damaged elements inside of the Foz Côa Church. The C1A sensor was positioned to collect displacements concerning inclination along column 2, where the positive values indicate displacement of the column 2 to the interior side of the right lateral nave, while the negative values evidence the column 2 inclination in the direction of the Central nave. Additionally, the P1 sensor was positioned to measure the relative displacements on the bottom of the column 2, where the positive values recorded indicate movements in the down direction while the negative values indicate movements in the opposite direction. In other words, the recorded positive values of displacements in the basis of the column 2 can be understood as compression movements, while the negative values can be interpreted as tension.

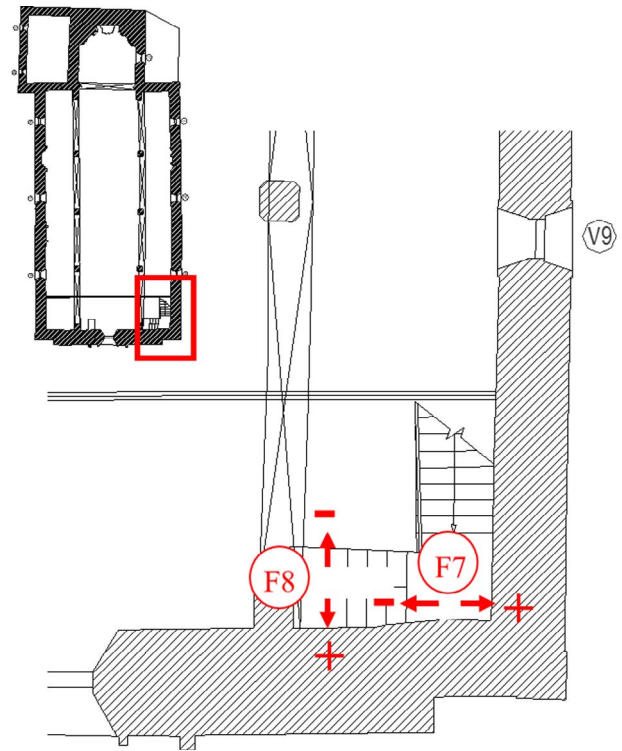
Concerning the sensors F7 and F8 positioned aligned with the façade stone walls (from interior side of the church), as shown by Fig. 8, they measure relative displacements at transversal and longitudinal direction of the façade, respectively. The positive and negative directions indicate movements out-of-plane, where positive displacements can be understood as movements to exterior of the church and the negative displacements indicate that the movements are occurring to the interior of the church. The F4 sensor was placed on the top of the main façade, inside the bell-tower, to measure the relative displacements along the transversal direction of the church, as shown in Fig. 9, where the positive values correspond to the movements towards the left while the negative values correspond to the movements towards the right.

Fig. 8. Schematic view of the movements and orientations monitored through sensors F7 and F8.

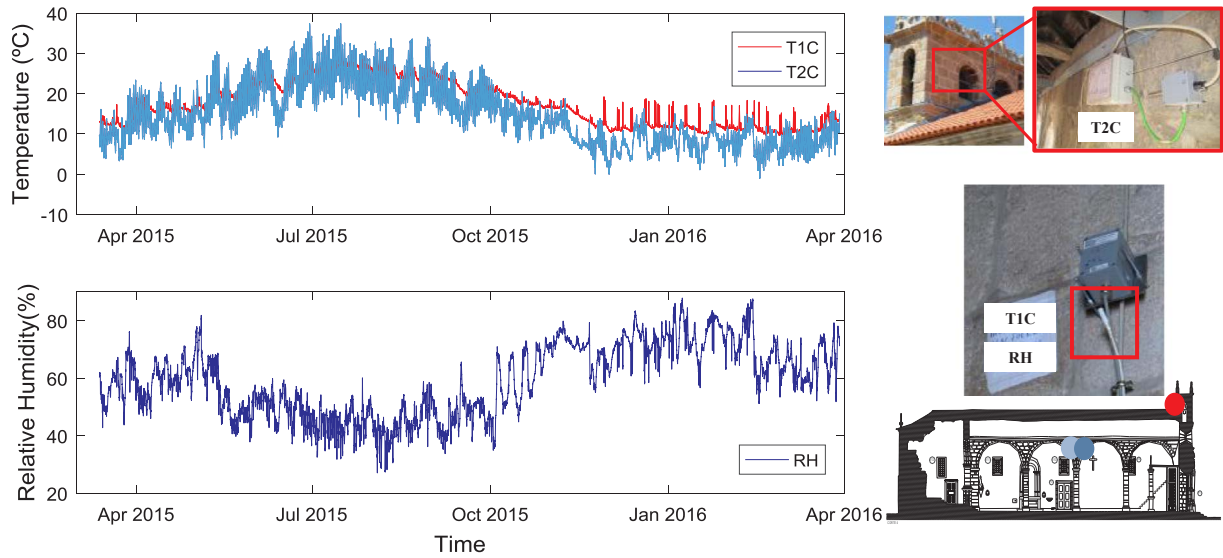
The time evolution of the internal and external temperatures and the relative humidity recorded by the monitoring system are shown through the data in Fig. 10, whereby the maximum and minimum values of measured temperature were over around 39 °C and 0 °C, respectively, while the maximum and minimum values of relative humidity were of 88% and 25%, respectively. It should be noted that the temperature measurements recorded by the T1C sensor, placed inside

Fig. 10. Time evolution of the internal and external temperatures and relative humidity monitored at Foz Côa Church.

the church, present significantly less variation (ranging from 9 °C to 29 °C) than the values of temperature collected by sensor T2C, that vary from −1 °C to 37 °C, as can be observed in Fig. 10.

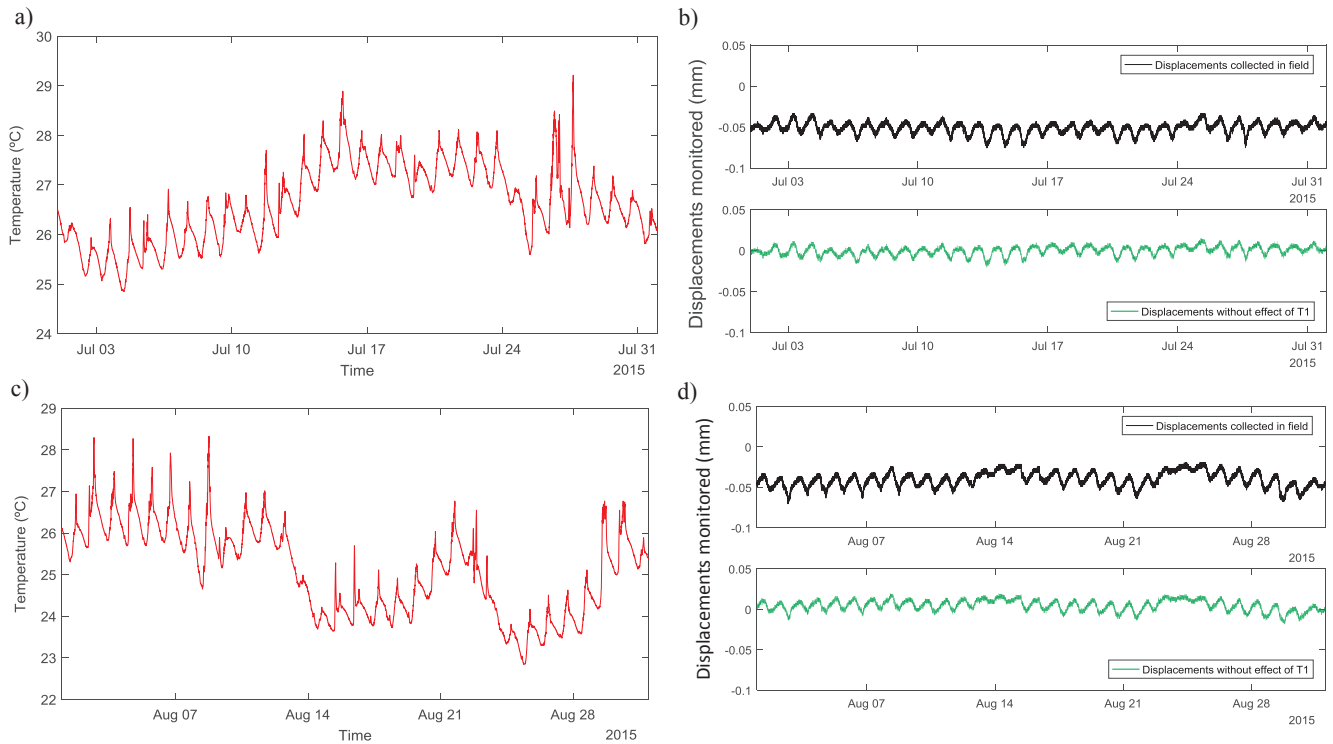
Especially during the summer period, the relative displacements recorded through P1 achieved higher values. This way, the temperatures and the relative displacements recorded in July and August of 2015 are presented in Fig. 13, allowing to observe the day-by-day thermic cycles, and its correspondent effects on the relative displacements evolution. After removing the temperature effect, the relative displacements tend to stabilize around zero, supporting our finding of absence representative structural movements.

Fig. 13. Time evolution of the temperature and displacements measured on the bottom of column 2: (a) temperature measured at the sensor T1C location from July 1st to 31th, 2015 and correspondent (b) displacement measured on sensor P1 with and without the temperature effect; (c) temperature measured at sensor T1C location from August 1st to 31th, 2015 and correspondent (d) displacement measured on sensor P1 with and without the temperature.
