Safety Briefing

Contractor Safety Assurance Team

April 7th 2022

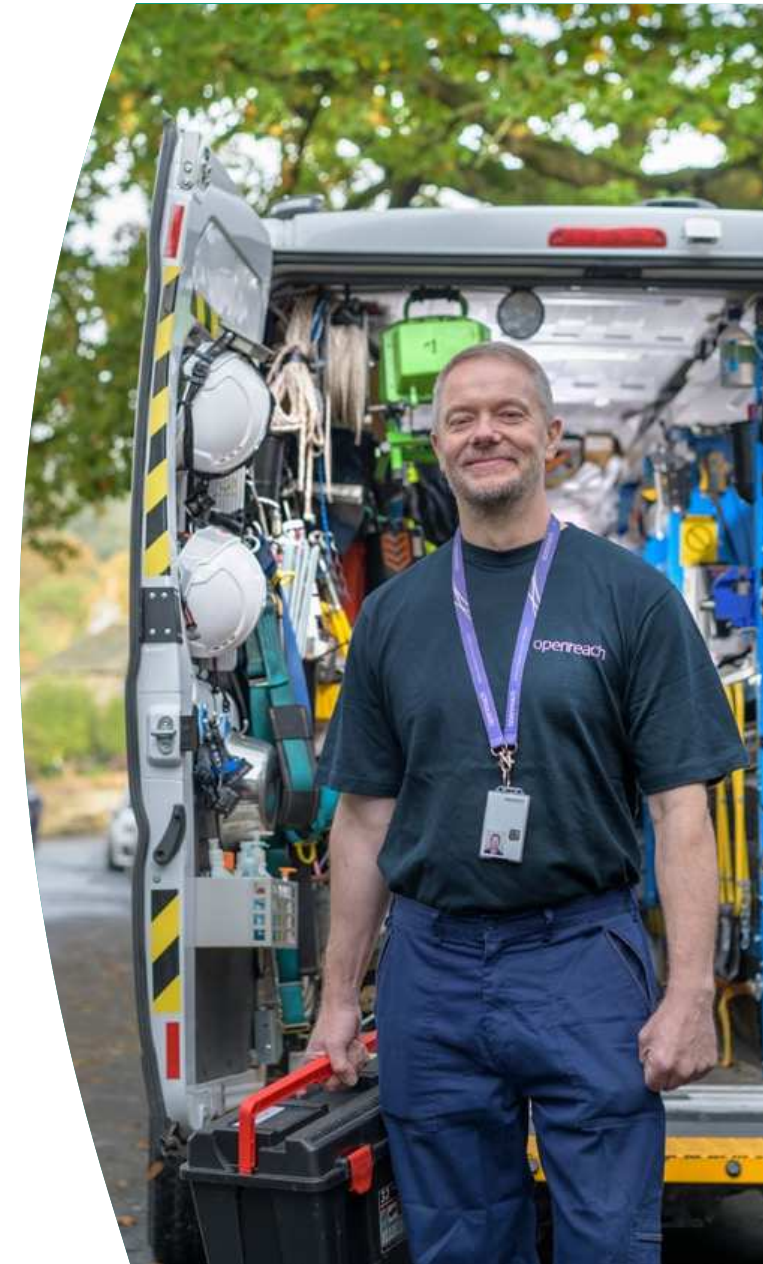
Incident 1

Unsafe Site Set Up and Poor Vehicle Storage

An operative was witnessed working in a joint box without appropriate signing, lighting and guarding (SLG), no Gas Detection Unit (GDU), unsuitable Personal Protective Equipment (PPE) and without the appropriate lifting key or rolling bar. The van internal storage was unsafe.

- The GDU should also be used when first opening a joint box and should be in use and as close as possible to the open joint box.
- All PPE including boots should be worn.
- Enough SLG to cover the whole working area should be in place.
- Missing SLG, PPE or GDU should be reported to the line manager immediately.
- The rear space of commercial vehicles should never be overloaded and tools and items should be stored correctly. If the vehicle is missing appropriate racking, the operative should inform their line manager.
