PCAL assembly – Module-I

Box assembly

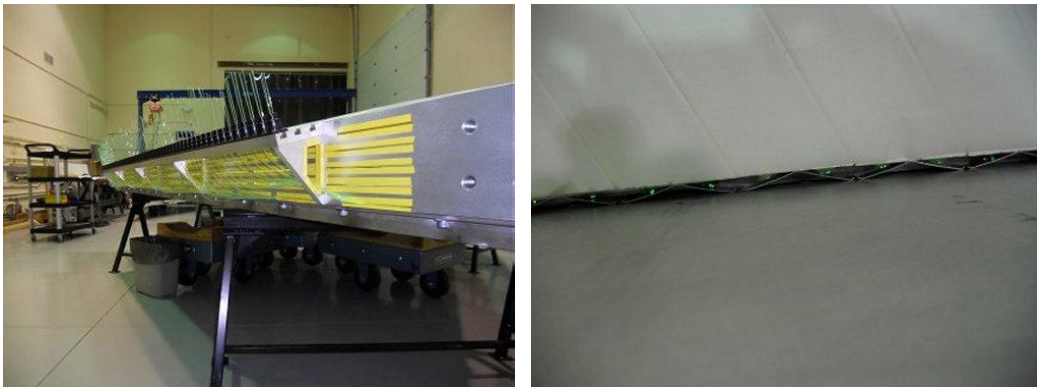
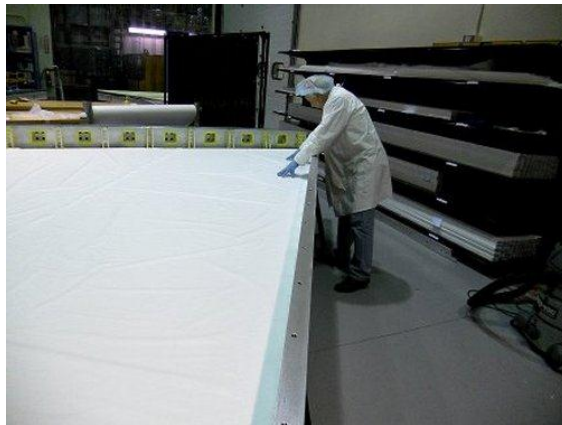
- May 8, the ends of the fibers were glued to the scintillator. Two component epoxy, DP-190, was used. A new gluing technique was developed, Teflon wrapped aluminum shim supports were used underneath the fibers where they come out of the scintillator strip (at the opposite end to the readout side), to glue the fibers near the top of the hole to the scintillator strip. In this way the hole is not fully closed, allowing the flow of nitrogen. The method is quick, for each fiber just a drop of glue

is needed.

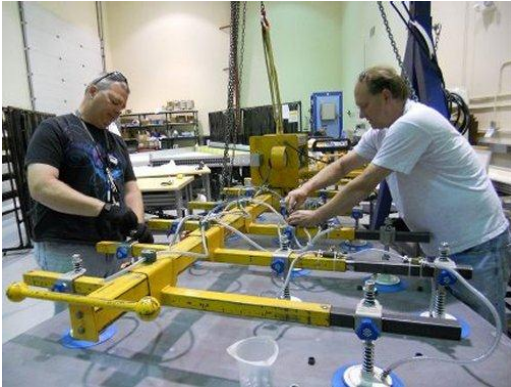
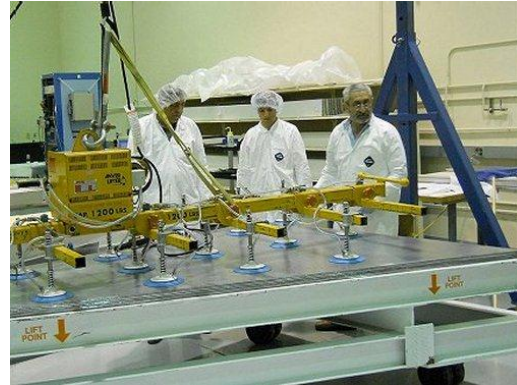
In the meantime, Danny, Dave and Calvin worked on the lead lifting fixture. The springs on the suction caps were replaced and a spacer (a tube) was added to each suction cap in order to move the frame higher. Otherwise it interfered with the box's sidewalls.

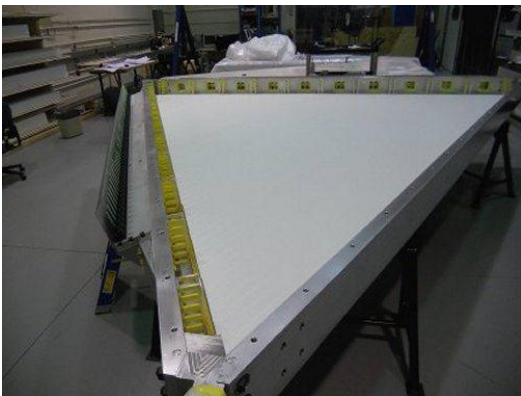
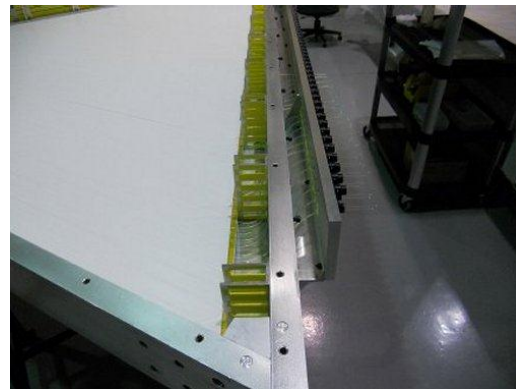
- May 13, start stacking the second layer of scintillator. By the end of the day all the scintillators were laid and a few fibers were inserted.

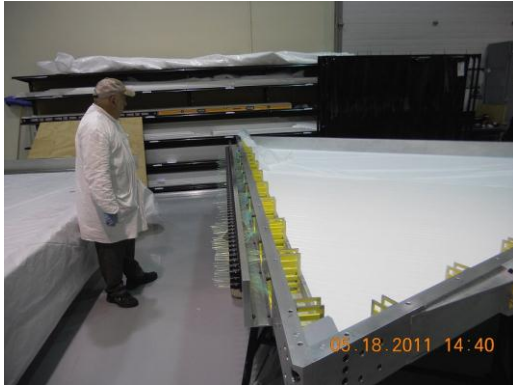
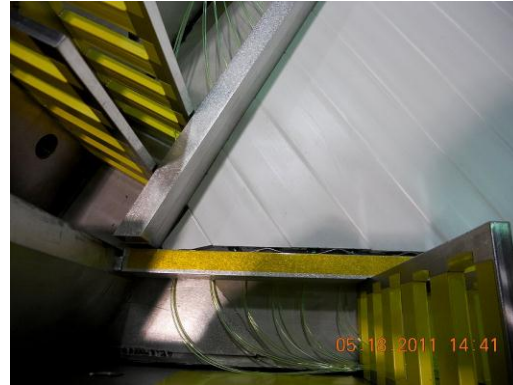
- May 18, the assembly of scintillators and fibers of the second layer was finished at 2pm. For spot gluing the ends of fibers, newly purchased rectangular Teflon bars, 0.25''x0.5''x 4' long, were used, this made things even simpler.
