NASA Reference Publication 1390

Spacecraft System Failures and Anomalies Attributed to the Natural Space Environment

K.L. Bedingfield, R.D. Leach, and M.B. Alexander, Editor

August 1996

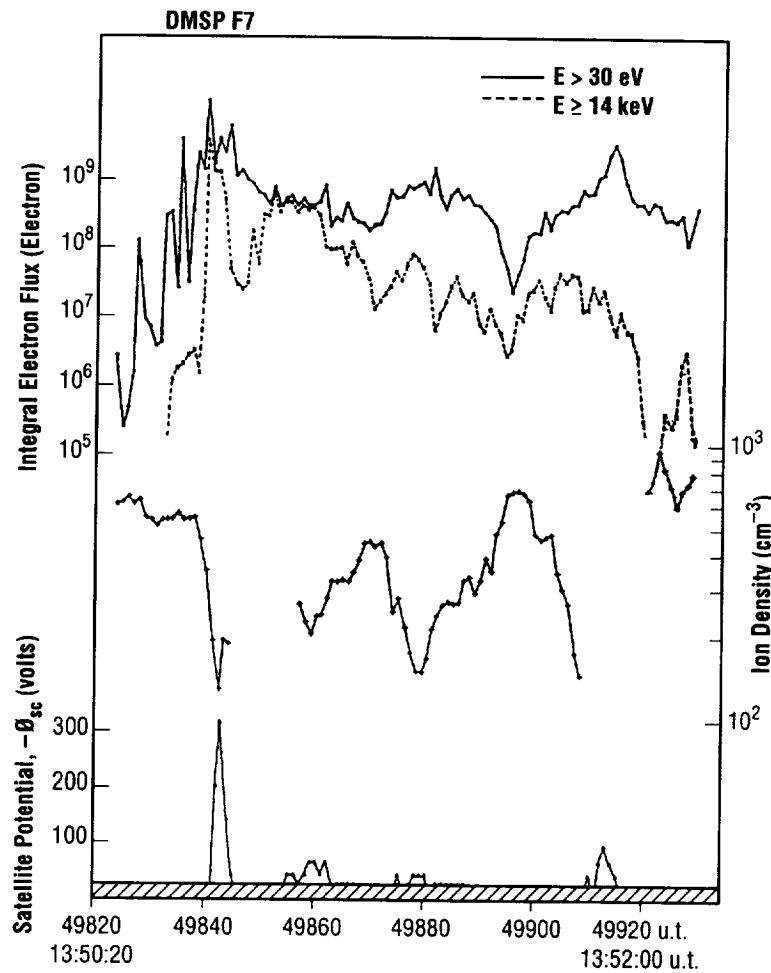
Figure 8. An example of the type of charging events encountered by the DMSP satellite F7 on November 26, 1983. DMSP 7 is a defense meteorological satellite flying LEO/polar.
