4/7/24 Dyno

Critical Issues:

- Ignition coils would not fire
 - PDU had bad soldering on the output of the ignition current sensor IC
- No power to entire car
 - PDU 12V+ ring terminal crimp failed and pulled out
- Fuel pressure regulator started dumping fuel out of the vac/boost reference hole/fitting location
 - Assumed the internal seal failed
- Starter would not crank, and dash had no power
 - PDU output connector wasn't fully seated lol
- Fuel pump stopped working
 - PDU 0602 0 ohm jumper on the fuel pump circuit burnt up

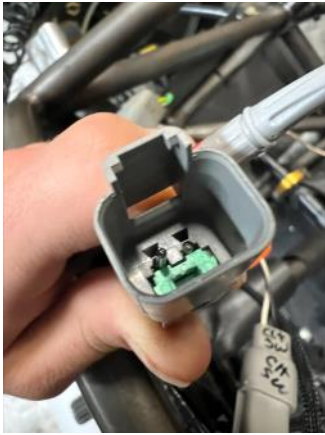
After this, the dash lost power and the starter button would not cause the car to crank. Upon investigating this, it was discovered that one of the crimps inside the 2pin DT connector is missing/broke it's retainment ring and is able to be pulled out easily. Also, it happened to be noticed that the E-Stop 2pin DT does not have its locking insert/clip, and those wires could be accidentally pulled out in the future. Neither of those were the core issue, as the PDU just hadn't been fully plugged in from above. Once plugged in, dash received power and car would crank.

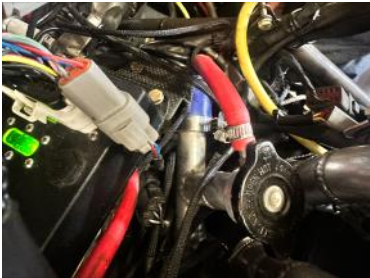
As seen below blue hose is minimally attached on the flange.

This was fixed, hose clamps were undone and tube was moved up and re-tightened
