Implementation – Post-Trip Report

Community:	Ait Bayoud, Bizdad
Country:	Morocco
Chapter:	Columbia University
Submittal Date:	
Dates Traveled:	December 30, 2016 - January 14, 2017
Scope of Implementation (100 words):	The following items were accomplished during this trip: <ol style="list-style-type: none">1. Pumped the well continuously for 5 hours to develop it and take water samples2. Tested portions of the pipeline for leaks3. Collected data on geological formations and water quality

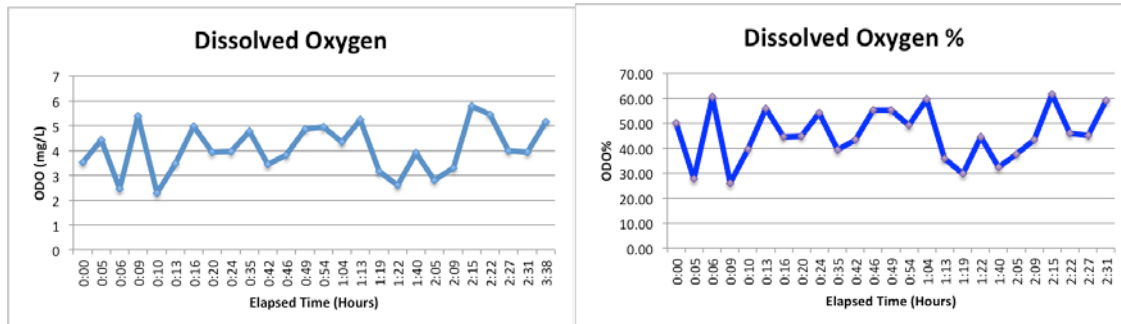
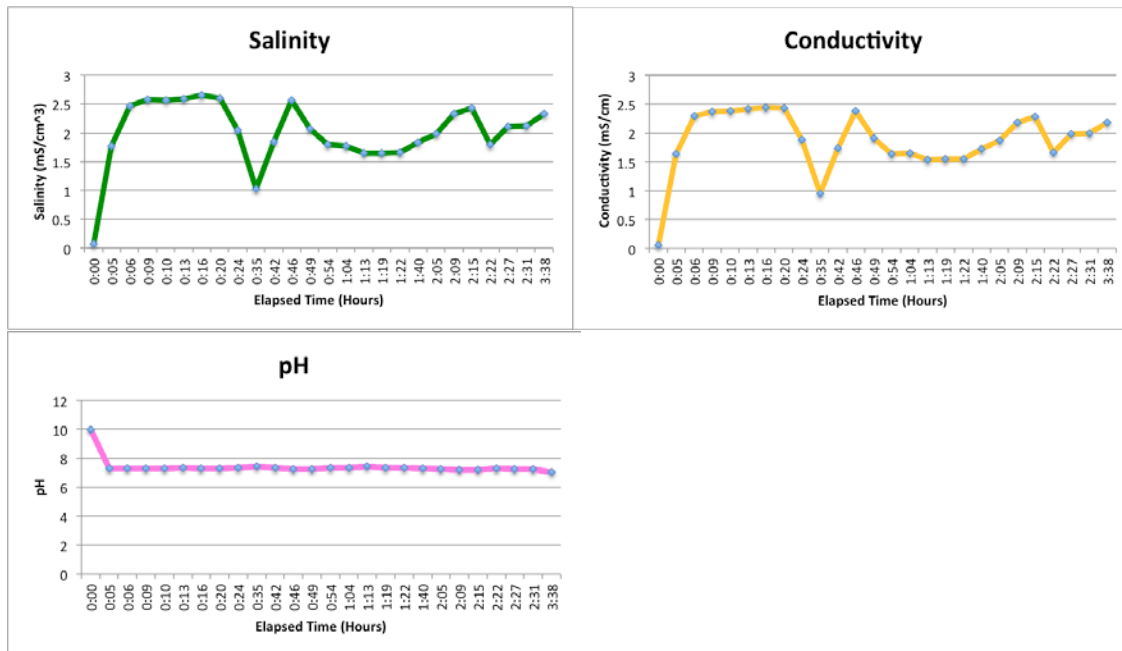
Sonde Data

Measurements were conducted at irregular intervals; trends are not proportional to overall test time.

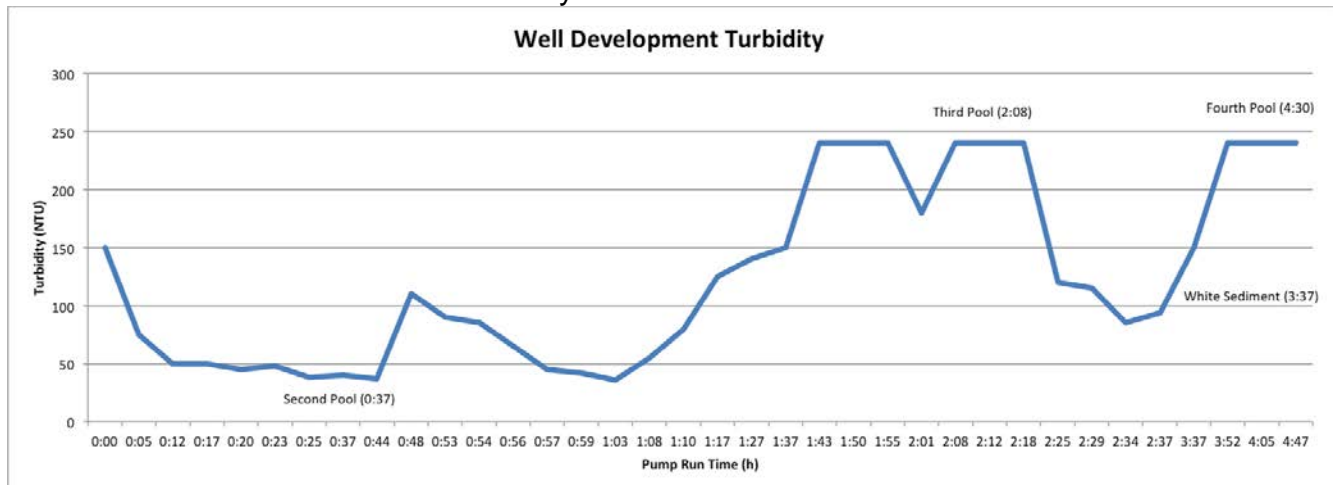
Turbidity Tube

Measurements were taken intermittently.

Note: Values above 240 NTU could not be measured.

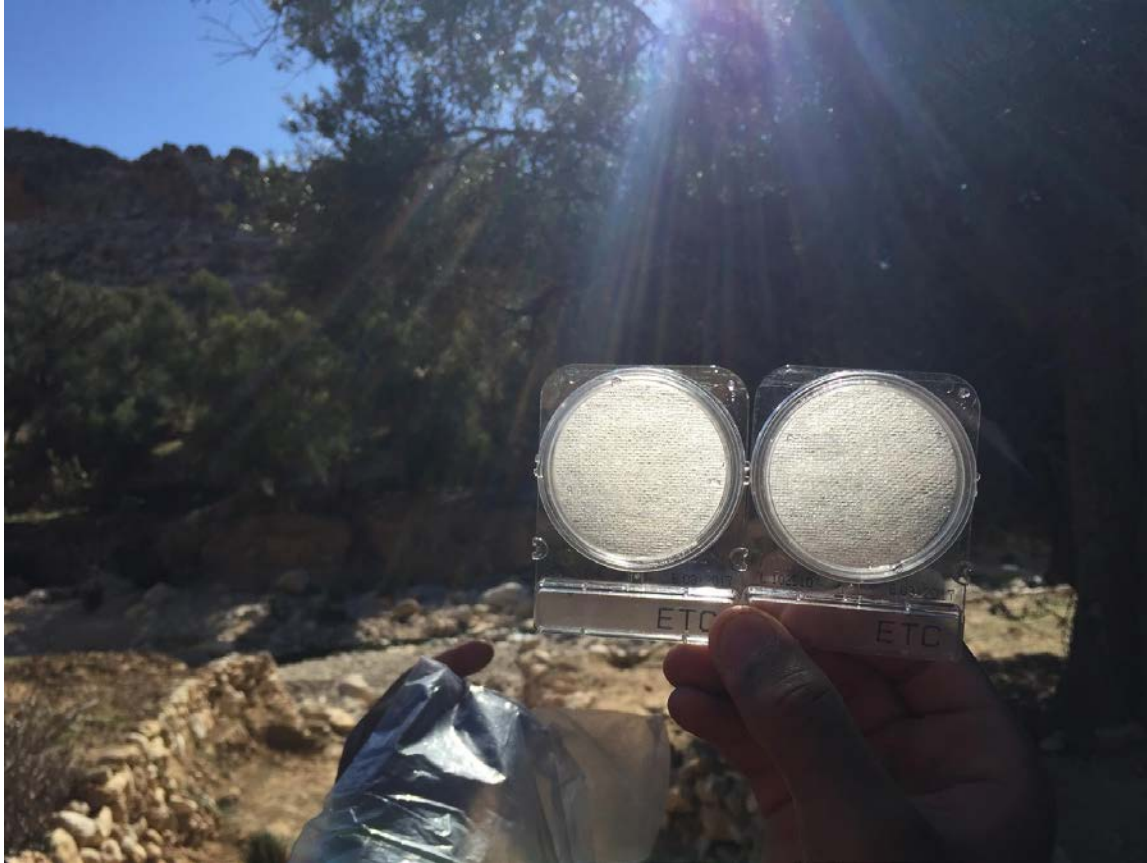
phosphate kit was expired and produced no color change after 5 minutes. The nitrate test showed no signs of color change after 3 minutes and was slightly pink (<0.2 ppm reading) after an additional 2 minutes. Water from the same sample was placed on the bacteria kits and kept in a Ziploc gallon bag wrapped in a grocery bag and incubated in a Peace Corps volunteer's jacket for 24 hours. When the kits were checked on 01/12/17, no signs of bacteria were found upon inspection in full sunlight.

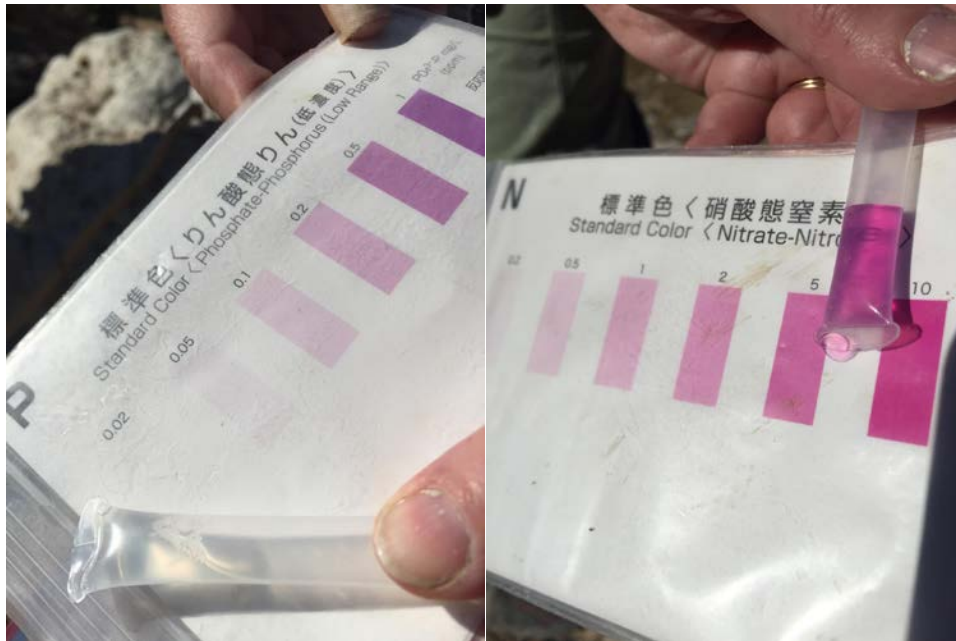
The phosphate test showed no color change during the test. The presence of donkeys in the area of water where the sample was collected confirms that the expired phosphate kit is unreliable. The nitrate test showed about 5 ppm.

1. *Phosphate test of spring water.*
2. *Nitrate test of spring water.*

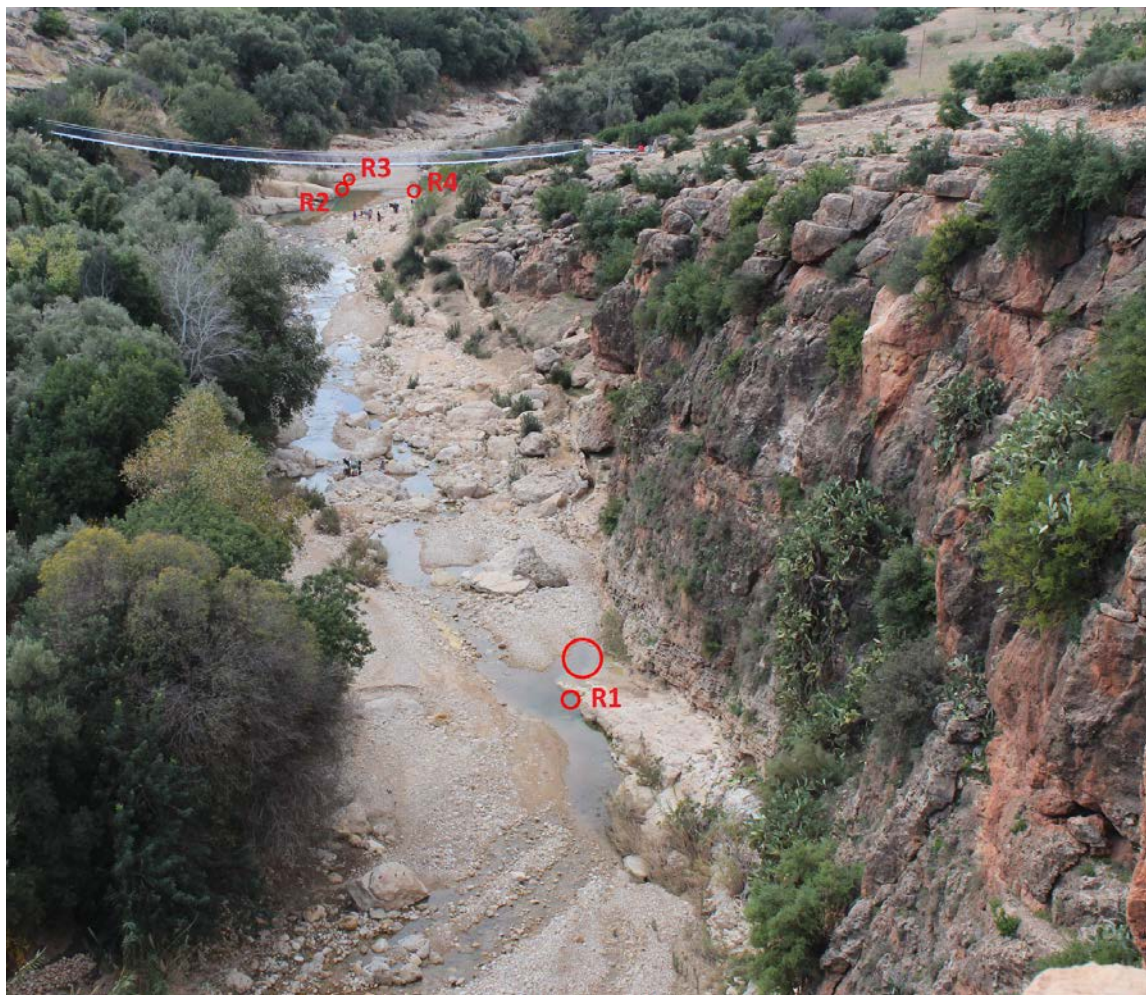
Location R1: 4 riffles upstream from bridge

Turbidity	2.4 NTU
Salinity	1.027 mS/cm ³
Conductivity	0.679 mS/cm
pH	8.28
Dissolved Oxygen %	96.0 ODO%
Dissolved Oxygen	11.66 ODO mg/L

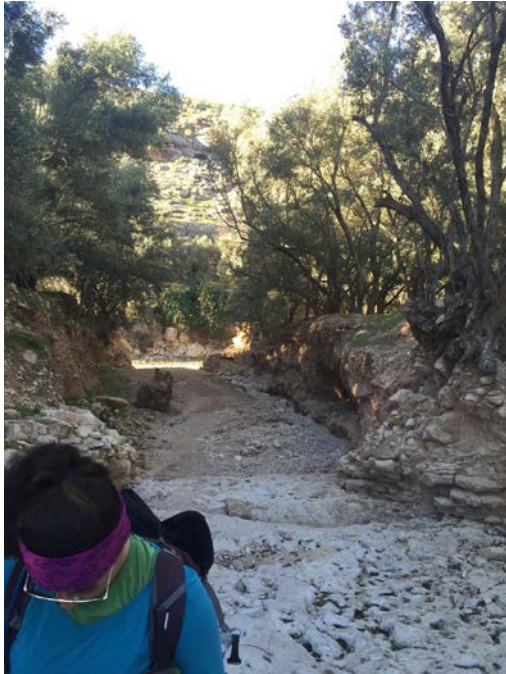
Location G3:

Path down to the river.
