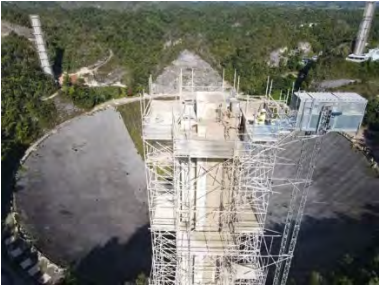
10/15/2021	An overview of the work being performed on the towers during October 2021. Tower 4 with hoist is in the foreground, Tower 8 is to the left, and Tower 12 is to the right.	Thornton Tomasetti
34

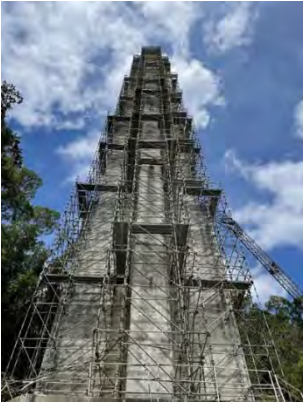
06/28/2021	Installation of Tower 8 scaffolding was completed in May 2021 and work on the tower began.	Thornton Tomasetti
37
