RACK INSPECTION REPORT FOR:

INFRATEC UK LTD

MIDDLESBROUGH

29TH APRIL 2025

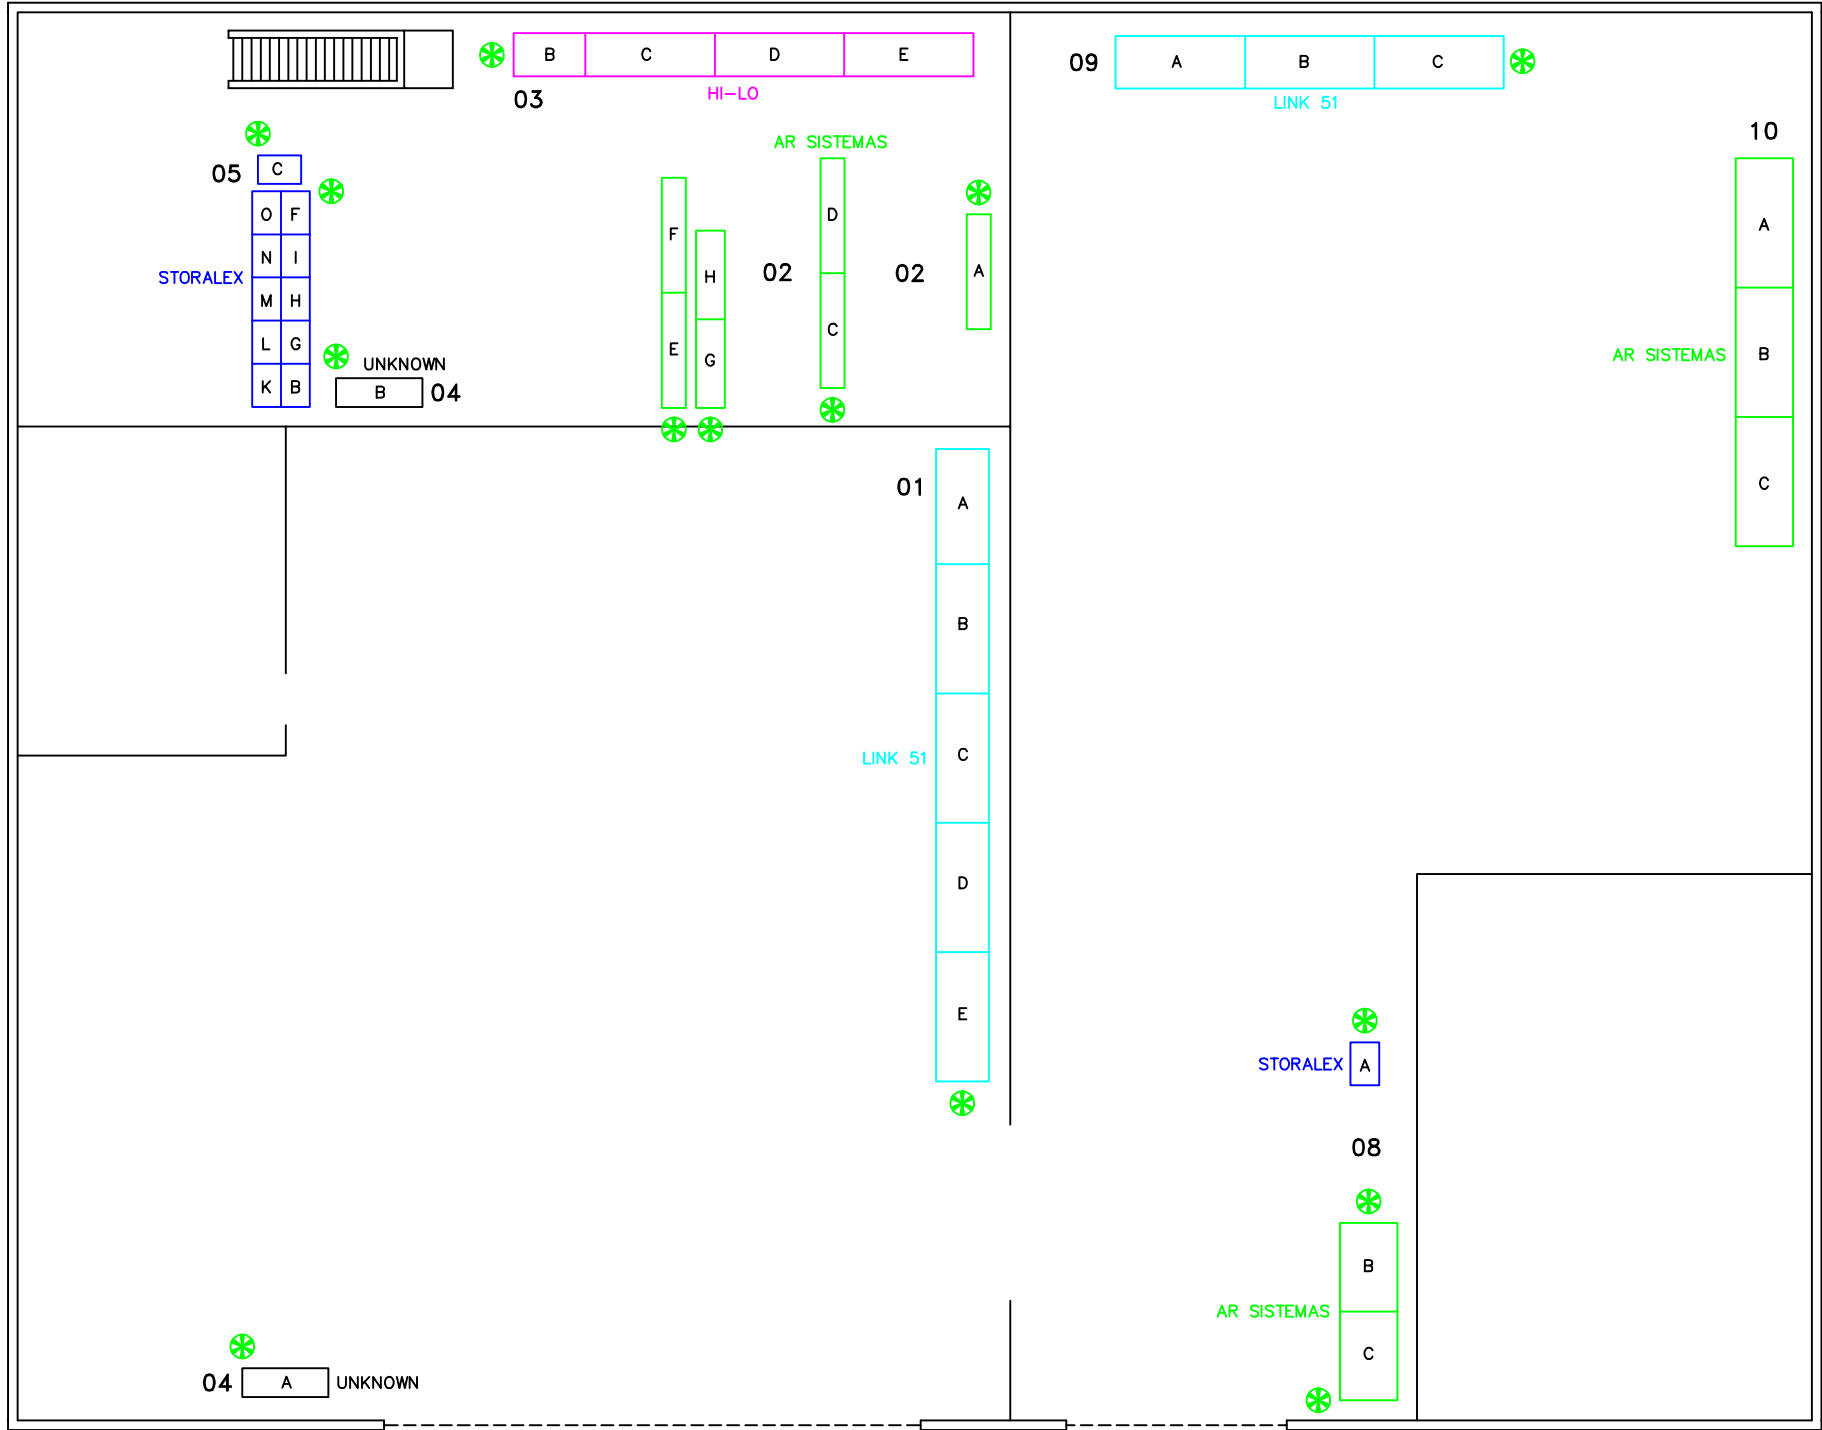
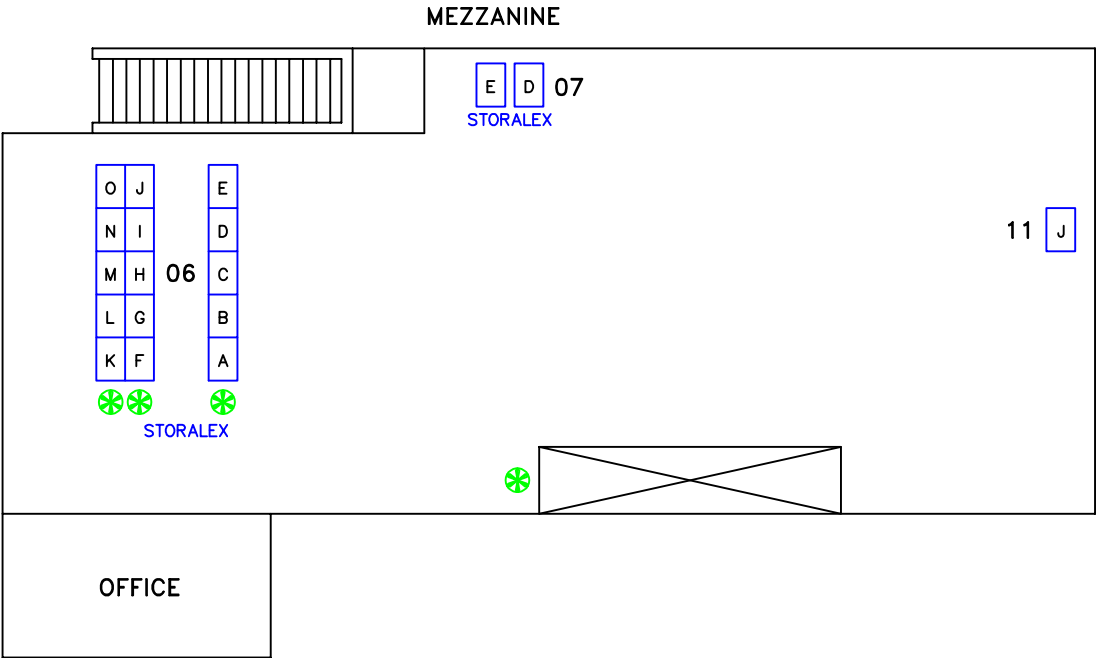
.-Main-04	(ALL/	N/A	Welded	Floor Fixing	Both	Missing	Monitor	8	-
-----------	-------	-----	--------	--------------	------	---------	---------	---	---

Handloaded. No MHE.
