On-Site Ambulance Crash Investigation

Case Number DS15009

Vehicle: 2009 Ford E-350 Type II Ambulance

Crash Date: July 2015

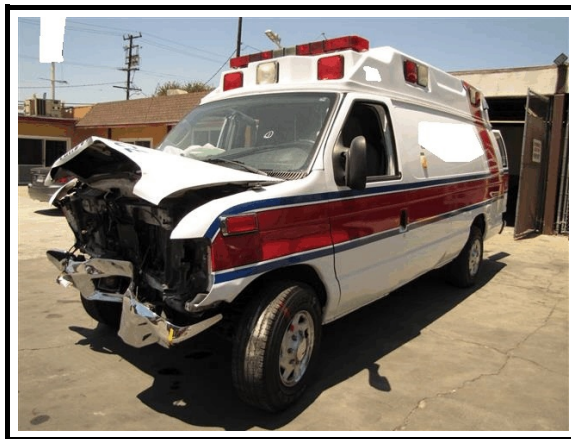
Figure 1. 2009 Ford E-350 Type II ambulance

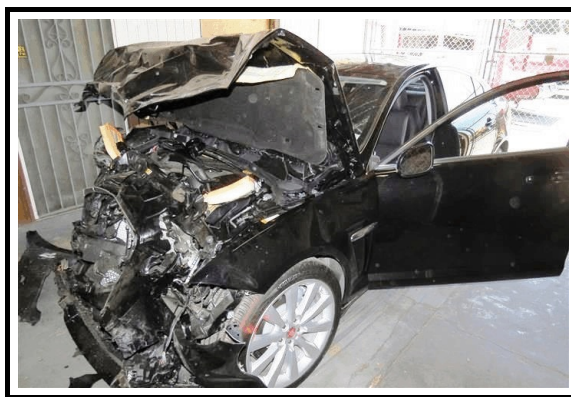
Figure 2. 2014 Jaguar XF 3.0

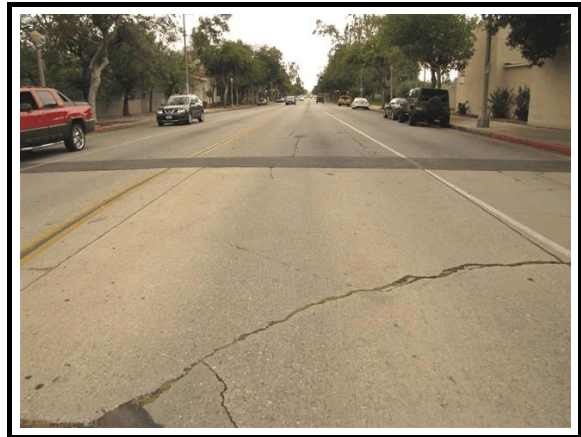
The crash occurred on an undivided four-lane north/south roadway in the state of California (**Figure 3**). The roadway consisted of two lanes for each direction delineated by white painted dashed stripes and separated by a double yellow painted stripe. The roadway measured 18.3 m (60.0 ft) in total width. The two curb lanes each measured 5.8 m (19.0 ft) in width and the second lanes from the right each measured 3.4 m (11.0 ft) in width. Curb parking was allowed beginning just north of the area of impact and extending south. The roadway was straight, and in the southbound direction had a negative slope of 2.5 percent with a super-elevation of positive 1.2 percent. It was paved with asphalt in fair condition and was bordered by raised curbs and sidewalks. The roadside was lined with mature trees.

Figure 3. Crash site, looking south

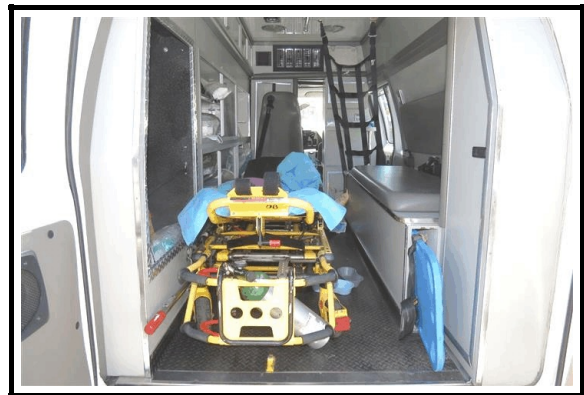
Figure 5. Patient compartment, 2009 Ford E-350 Type II ambulance

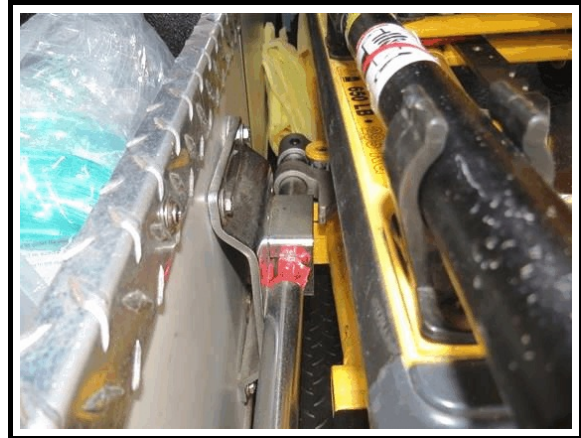
At the time of the SCI inspection, the ambulance cot was secured in place by the fastening system. The investigator released the mechanism for inspection and it was determined to be functional and undamaged. The cot was equipped with a manual restraint system consisting of two lap type belts with locking latch plates (**Figure 10**), the lower of which was used to restrain the legs and the upper which was used to restrain the chest. The webbing, latch plates and buckles were examined by the investigator and found to be functioning properly. The chest belt revealed occupant loading evidence in the form of scuff marks to the webbing (**Figure 11**). The leg

Figure 9. Stryker model 6371 cot fastening system

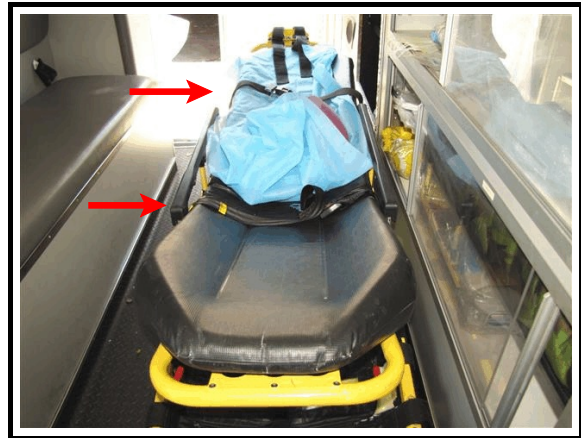
The specifications sheet for the MX-PRO R3 indicate standard features include a four-point shoulder restraint which would typically be installed at the head of the frame, in addition to the two lap belts. During the inspection, no shoulder restraints were found installed either on the cot or within the patient compartment of the vehicle. The ambulance driver stated in the police report that this cot was not configured with shoulder straps. He stated further that it is common practice to secure the belts whenever transporting patients but that he did not remember specifically buckling the straps when preparing the patient for transport on the day of the crash.

Figure 10. Manual leg and chest belt restraints, Stryker EMS Model 6082 MX-PRO R3 Ambulance Cot, looking rearward

restraint was unremarkable. The police noted in their report that, after reviewing their on-scene photos, they determined the leg belt was definitely buckled following the crash. They could not determine with certainty whether the upper belt was buckled although it did not appear to be so. During the subsequent police vehicle inspection, the officer noted the upper chest belt was unbuckled.

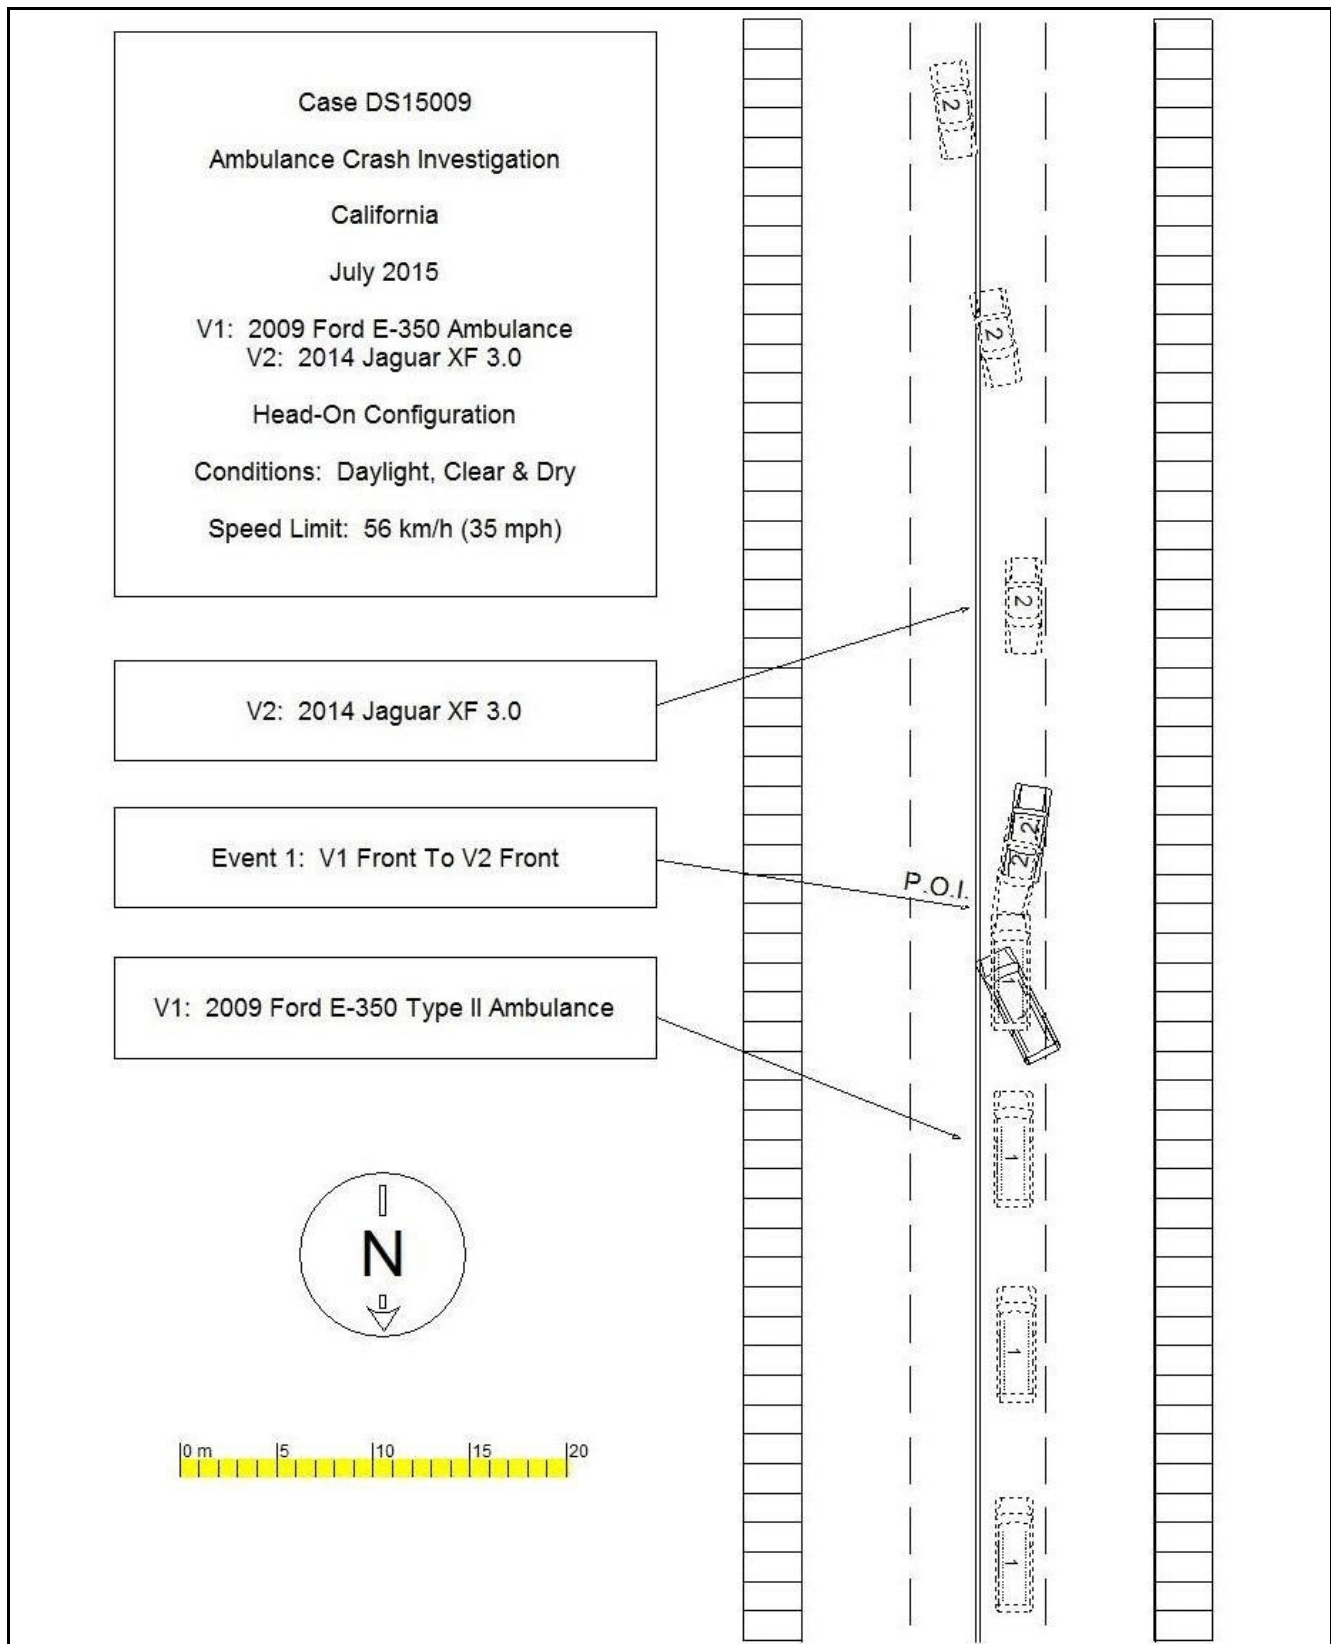
CRASH DIAGRAM

The crash consisted of one event in which the front plane of the Ford impacted the front plane of the Jaguar (Event 1). Contact damage to both vehicles was distributed across their front planes. The POI was located in the second southbound lane from the right, mid-block and 7.4 m (24.2 ft) east of the west curb line. Following the impact, both vehicles rebounded rearward. The Ford traveled rearward approximately 2.3 m (7.5 ft) and rotated slightly counterclockwise, and came to rest facing southeast in the same lane as the impact. The Jaguar traveled rearward approximately 1.7 m (5.6 ft) and rotated slightly clockwise, and came to rest facing northeast in the same lane as the impact (**Figure 4**). During the crash, the patient in the Ford was displaced from his cot belt restraints and his head impacted a cabinet surface located at the forward aspect of the patient compartment. He came to rest on the compartment floor. The cot remained attached to the ambulance at the floor and left panel fastening points. Additional details regarding the patient cot and restraints usage are discussed in the Patient Cot section of this report.

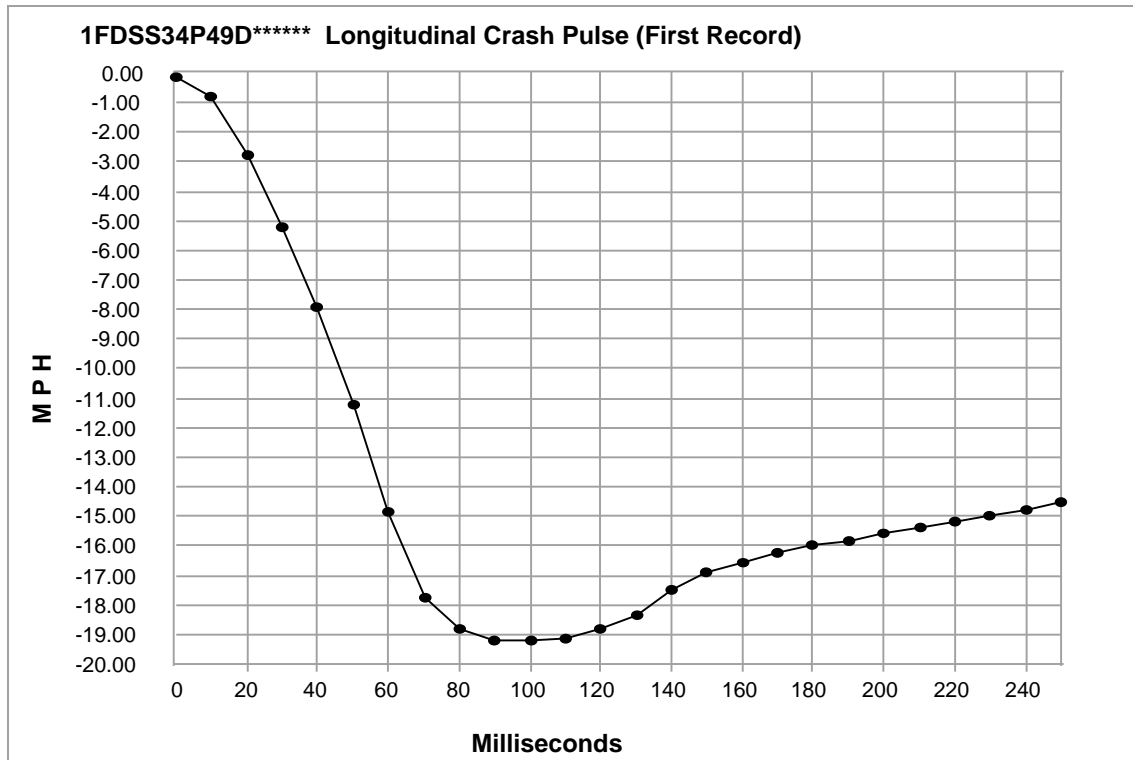
Longitudinal Crash Pulse (First Record)

The impact with the Jaguar was captured by the Ford's EDR as a deployment event. At impact, both frontal air bags deployed and both safety belt pretensioners actuated in the Ford. The Time to Algorithm Enable for the air bag deployments was 27.5 milliseconds (ms). For the Ford in this event, the WinSMASH program Damage only algorithm calculated a Total Delta-V of 25.0 km/h (16.0 mph) with Longitudinal and Lateral components of -25.0 km/h (-16.0 mph) and -4.0 km/h (-2.0 mph), respectively, and a Barrier Equivalent Speed (BES) of 32.0 km/h (20.0 mph). The Ford's
