**CASE NO.: CR14057**

**ON-SITE AMBULANCE CRASH INVESTIGATION**

**VEHICLE: 2011 FORD E350 TYPE III AMBULANCE**  
**AMBULANCE BODY: WHEELED COACH CITIMEDIC PLUS VII**

**CRASH DATE: AUGUST 2014**

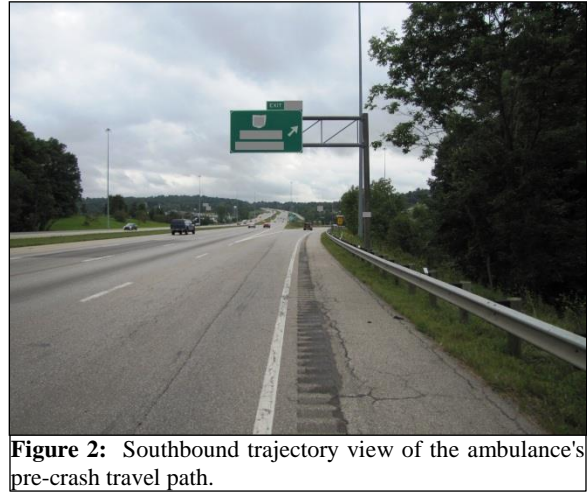
**Figure 2:** Southbound trajectory view of the ambulance's pre-crash travel path.

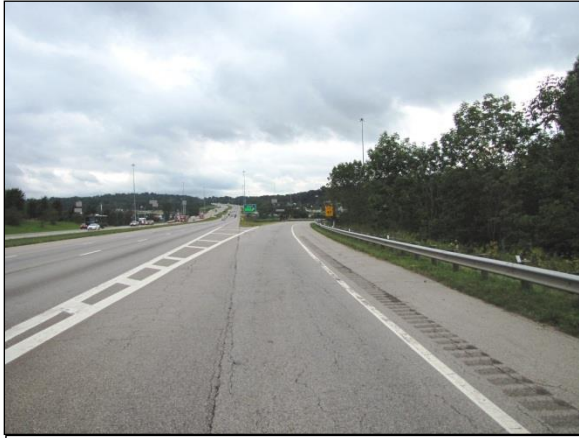
**Figure 3:** South facing view of the ambulance's errant trajectory onto the exit interchange ramp.

Due to the engagement of the cruise control, the ambulance maintained its travel speed as the exit ramp increasingly curved away from the limited-access roadway. The ambulance passed through the gore and departed the roadway into the swale between the exit ramp and the multi-lane roadway. **Figure 3** depicts the trajectory of the ambulance from a pre-crash approach view. There was no evidence at the scene of any avoidance steering or braking action by the driver, an observation which was confirmed through a review of the Ford's pre-crash buffer data within the imaged EDR report. As the

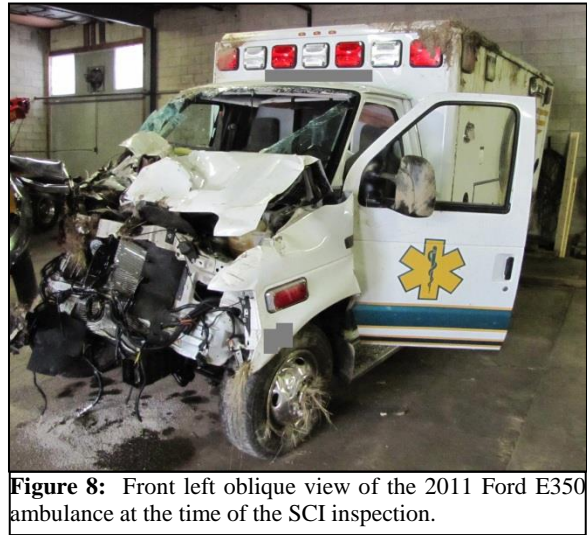
**Figure 8:** Front left oblique view of the 2011 Ford E350 ambulance at the time of the SCI inspection.

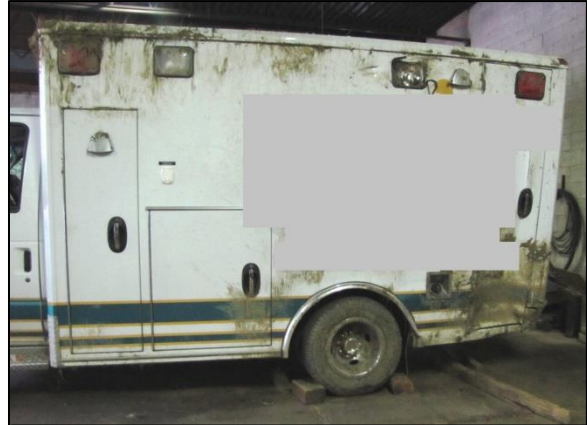
**Figure 9:** Left side view of the Wheeled Coach Type III patient compartment.

The patient compartment was constructed primarily of 5x5 cm (2.0x2.0 in) square aluminum tubing welded in ladder-frame patterns, with aluminum sheeting covering exterior surfaces. Interior cabinets were constructed of 2 cm (0.75 in) plywood bonded using glue and wooden pegs, with laminate surface finish and Lexan sliding doors. Aluminum corner bead was used for edge trim. Fiberglass and foam insulation provided thermal barrier and sound protection from the outside environment.

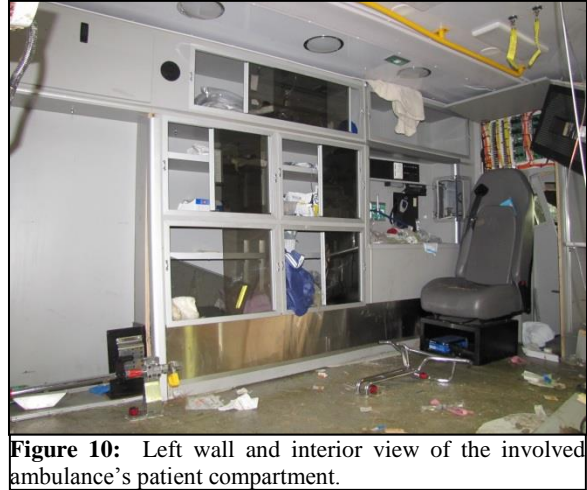
A rear-facing captain's chair was located immediately right of the countertop, overlooking the head area of the cot (**Figure 10**). The pass-through to the cab was in front of the captain's chair, and a large cabinetry area was located on the right aspect of the front wall. The right wall included the three-passenger bench seat with small overhead storage cabinetry. The cot was positioned rear-facing within the central area of the patient compartment.

**Figure 10:** Left wall and interior view of the involved ambulance's patient compartment.

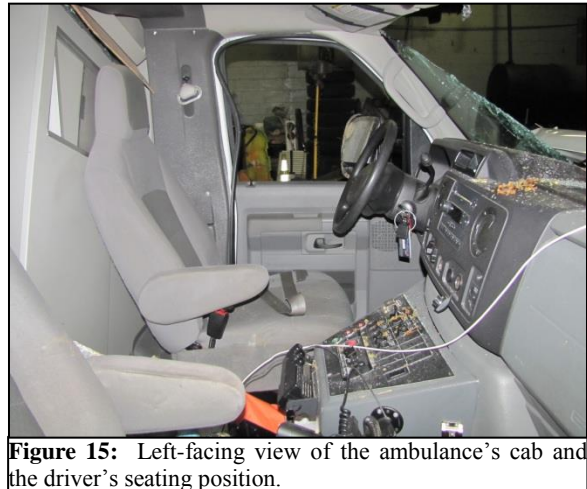
The cab of the ambulance was inspected for occupant contact, intrusion, and crash related damage. There was no observed evidence of interior occupant contact points, the absence of which was attributed to the driver's use of the available manual safety belt system. It was noted that the AS1 laminated windshield glazing had been removed by emergency response personnel to obtain entry to the ambulance's cab and provide a means of egress for the driver. **Figure 15** depicts the driver's seat position within the ambulance's cab at the time of the SCI vehicle inspection.

**Figure 15:** Left-facing view of the ambulance's cab and the driver's seating position.

It is probable that the windshield glazing was fractured by crash forces prior to its post-crash removal. Remaining glazing of the Ford's cab remained intact and both front doors were closed and operational.

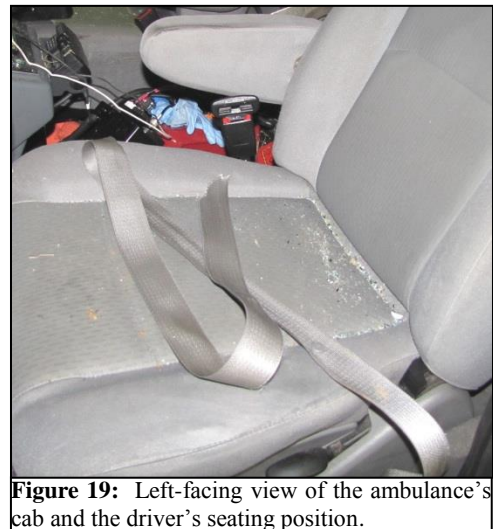
The driver's safety belt webbing had been cut by emergency response personnel in order to assist the driver from the overturned vehicle following the crash. The cut was located 170 cm (67.0 in) from the lower anchor (**Figure 19**). All remaining webbing above the cut location had retracted and was concealed by the retractor within the polymer B-pillar fascia. No crash-related occupant loading or contact damage could be identified on the cut portion of the safety belt webbing. At the time of the SCI inspection, the driver's sliding latch plate remained engaged within the buckle. There were minor loading abrasions identified within the belt path on the latch plate.

**Figure 19:** Left-facing view of the ambulance's cab and the driver's seating position.

Based on the inspection of the driver's safety belt system, and in conjunction with a review of the data imaged from the Ford's EDR, it was apparent that the driver's safety belt system was in use by the driver for manual restraint at the time of the crash. The absence of interior points of contact and driver injury was consistent with her use of the manual restraint. There was no loading evidence present on the front right safety belt system; however, the front right seat was unoccupied at the time of the crash.

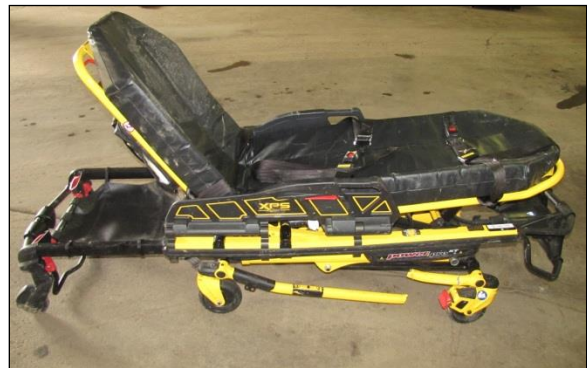
The patient cot (**Figure 21**) was a 6500 Power-PRO XT Power Ambulance Cot that was manufactured by Stryker, serial number (S/N): 13074xxxx. Based on this serial number, it was manufactured in July of 2013. The cot was constructed of a tubular aluminum frame with circumferential weld joints and steel hardware fasteners. The X-frame supporting the mattress platform featured power raise/lower capabilities with infinite height positions between a minimum of 36 cm (14.0 in) and a maximum of 105 cm (41.5 in).

**Figure 21:** Stryker 6500 Power-PRO XT cot at the time of the SCI inspection.

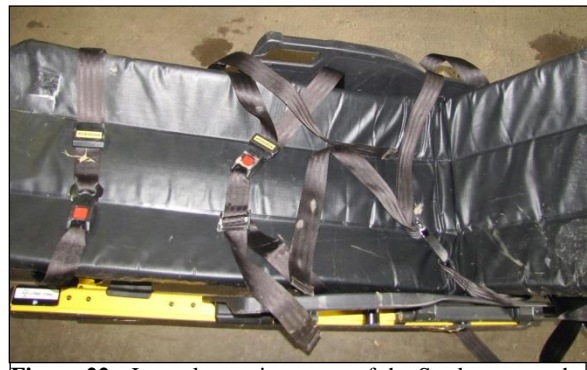
The Stryker cot was equipped with a multi-point harness system for manual restraint of its occupant (patient). This system consisted of a lateral leg strap, a lateral lap/thigh strap, and two shoulder straps that buckled into a lateral chest strap. All webbing straps were fixed length and included locking latch plates or sewn buckles. At the time of the SCI inspection, the lateral restraint straps of the cot all remained buckled (**Figure 22**). Both shoulder harness straps were tucked behind the head portion of the mattress. In its buckled position, the leg strap was adjusted to a length that provided 55 cm (21.7 in) of available occupant space. The lap/thigh and chest straps provided 81 cm (31.9 in) and 88 cm (34.6 in), respectively. The comparison value of the buckled lateral straps with all slack removed was 43 cm (16.9 in).

**Figure 22:** Lateral restraint straps of the Stryker cot at the time of the SCI inspection.

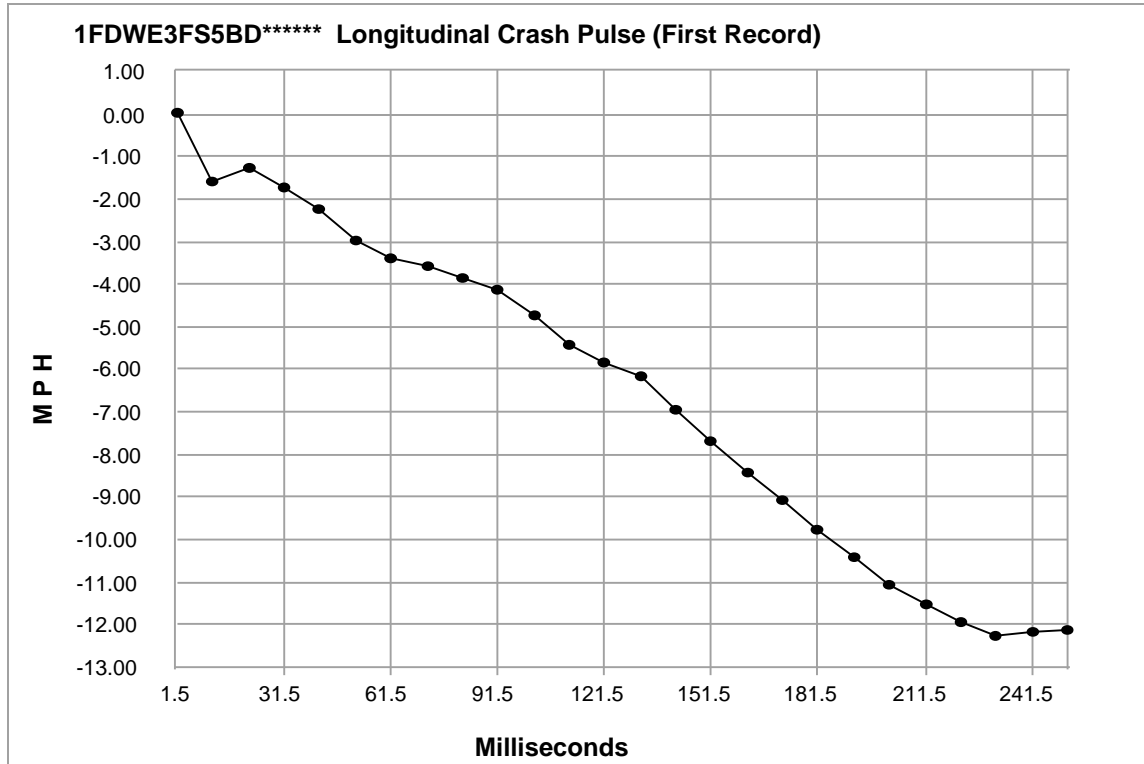
**Longitudinal Crash Pulse (First Record)**

Time (msec)	Delta-V, longitudinal (MPH)	Delta-V, longitudinal (km/h)
1.5	0.02	0.04
11.5	-1.59	-2.55
21.5	-1.27	-2.05
31.5	-1.74	-2.80
41.5	-2.24	-3.60
51.5	-2.96	-4.77
61.5	-3.41	-5.48
71.5	-3.57	-5.74
81.5	-3.86	-6.22
91.5	-4.14	-6.67
101.5	-4.75	-7.64
111.5	-5.44	-8.75
121.5	-5.85	-9.42
131.5	-6.18	-9.95
141.5	-6.95	-11.18
151.5	-7.68	-12.36
161.5	-8.41	-13.54
171.5	-9.05	-14.57
181.5	-9.76	-15.71
191.5	-10.41	-16.75
201.5	-11.06	-17.79
211.5	-11.52	-18.55
221.5	-11.96	-19.25
231.5	-12.24	-19.70
241.5	-12.17	-19.59
251.5	-12.13	-19.52

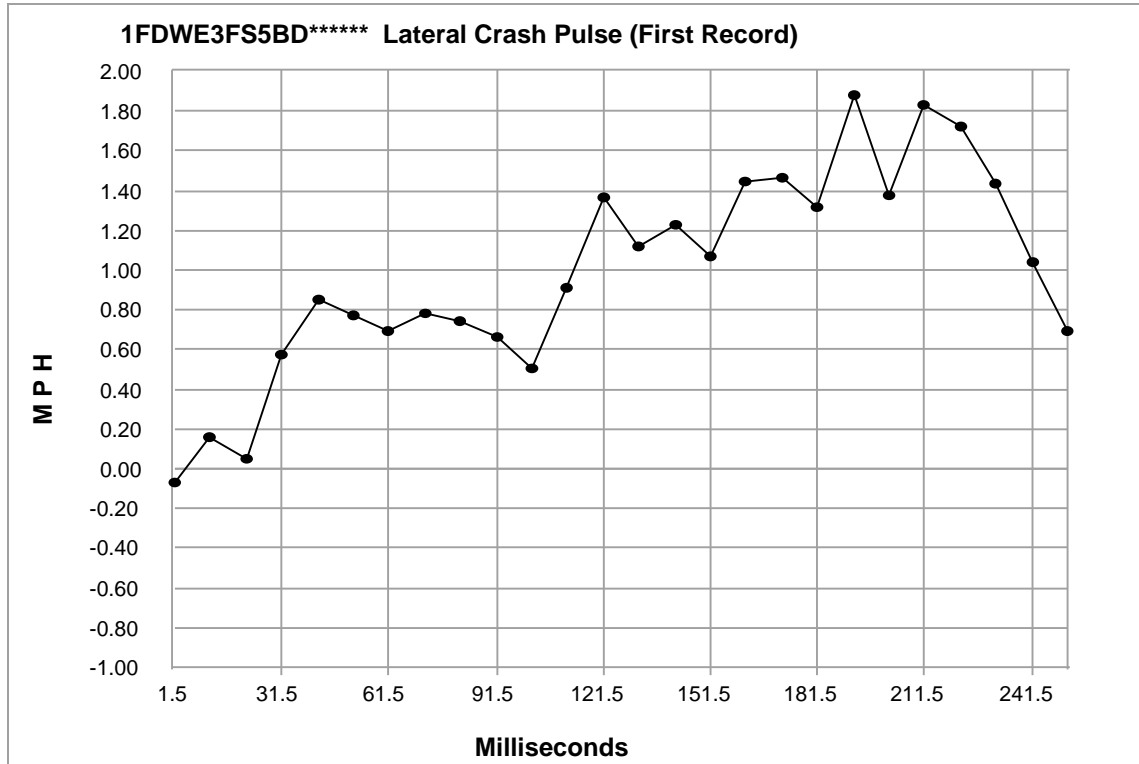
**Lateral Crash Pulse (First Record)**

Time (msec)	Delta-V, lateral (MPH)	Delta-V, lateral (km/h)
1.5	-0.07	-0.11
11.5	0.15	0.25
21.5	0.05	0.09
31.5	0.58	0.93
41.5	0.85	1.37
51.5	0.77	1.24
61.5	0.69	1.11
71.5	0.79	1.27
81.5	0.74	1.19
91.5	0.66	1.07
101.5	0.51	0.81
111.5	0.91	1.46
121.5	1.36	2.19
131.5	1.12	1.80
141.5	1.23	1.98
151.5	1.07	1.72
161.5	1.45	2.33
171.5	1.47	2.37
181.5	1.32	2.12
191.5	1.88	3.02
201.5	1.37	2.21
211.5	1.83	2.95
221.5	1.73	2.78
231.5	1.44	2.32
241.5	1.04	1.67
251.5	0.69	1.11

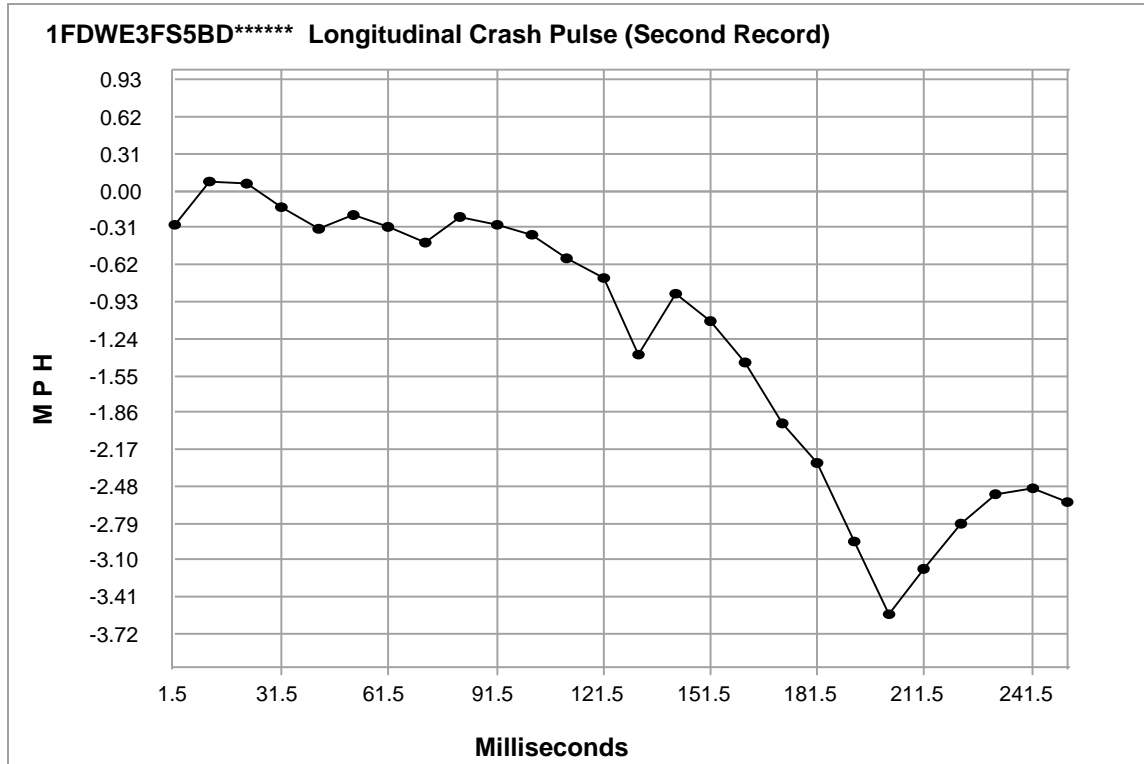
**Longitudinal Crash Pulse (Second Record)**

Time (msec)	Delta-V, longitudinal (MPH)	Delta-V, longitudinal (km/h)
1.5	-0.29	-0.46
11.5	0.08	0.12
21.5	0.07	0.11
31.5	-0.14	-0.23
41.5	-0.32	-0.52
51.5	-0.21	-0.33
61.5	-0.31	-0.50
71.5	-0.43	-0.69
81.5	-0.22	-0.35
91.5	-0.29	-0.47
101.5	-0.36	-0.58
111.5	-0.57	-0.91
121.5	-0.72	-1.17
131.5	-1.37	-2.21
141.5	-0.87	-1.40
151.5	-1.09	-1.76
161.5	-1.44	-2.32
171.5	-1.95	-3.14
181.5	-2.28	-3.67
191.5	-2.94	-4.73
201.5	-3.56	-5.73
211.5	-3.17	-5.10
221.5	-2.80	-4.50
231.5	-2.55	-4.11
241.5	-2.49	-4.01
251.5	-2.61	-4.21

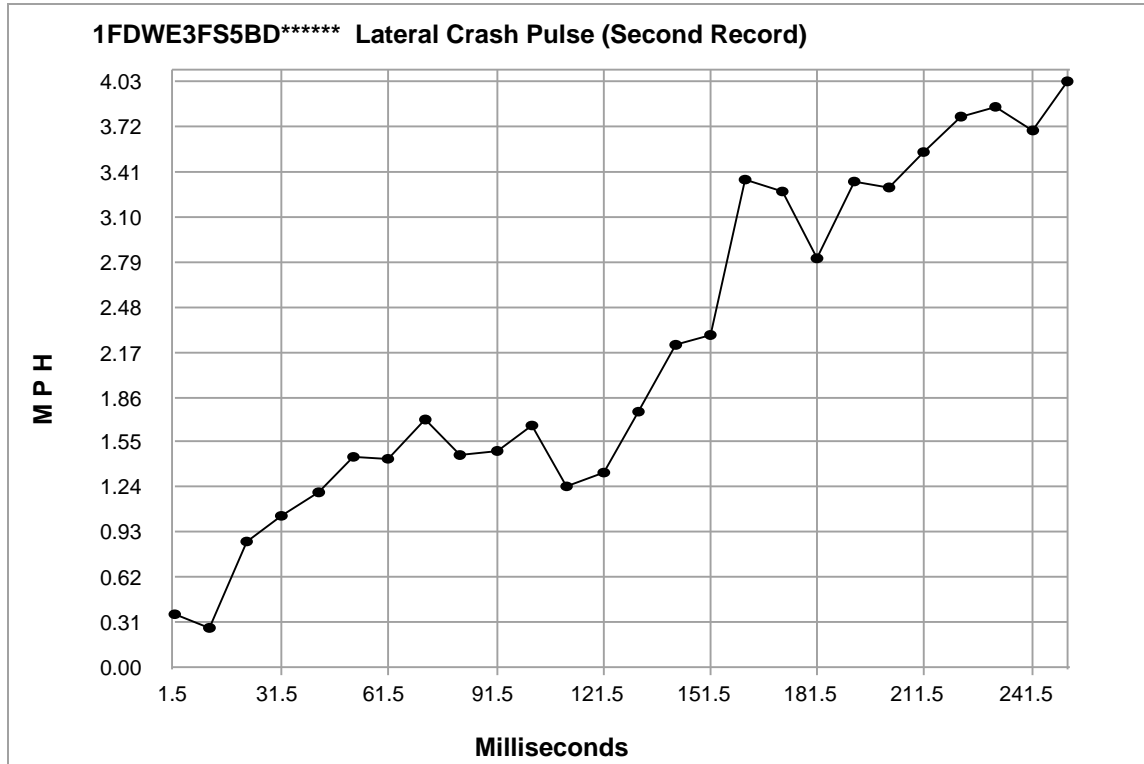
**Lateral Crash Pulse (Second Record)**

Time (msec)	Delta-V, lateral (MPH)	Delta-V, lateral (km/h)
1.5	0.36	0.58
11.5	0.27	0.43
21.5	0.86	1.38
31.5	1.04	1.67
41.5	1.20	1.93
51.5	1.45	2.34
61.5	1.43	2.31
71.5	1.70	2.74
81.5	1.46	2.34
91.5	1.49	2.39
101.5	1.67	2.68
111.5	1.24	2.00
121.5	1.33	2.15
131.5	1.76	2.83
141.5	2.22	3.57
151.5	2.28	3.67
161.5	3.35	5.40
171.5	3.28	5.27
181.5	2.82	4.53
191.5	3.34	5.38
201.5	3.30	5.31
211.5	3.54	5.70
221.5	3.79	6.09
231.5	3.85	6.20
241.5	3.69	5.94
251.5	4.03	6.49
