ON-SITE AMBULANCE CRASH INVESTIGATION

CASE NUMBER - IN11023

VEHICLE - 2010 CHEVROLET EXPRESS G3500 TYPE III AMBULANCE

CRASH DATE - July 2010

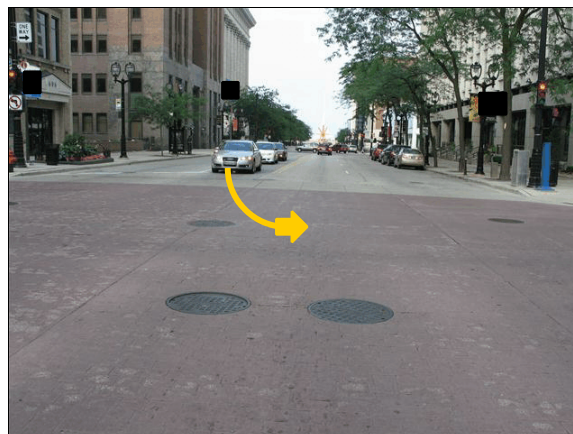
Pre-Crash: The ambulance was traveling east (Figure 2) in the second lane from the right and the driver was intending to proceed straight through the intersection. The ambulance was on a non-emergency transfer and the emergency lights and siren were not activated. The Honda was traveling west in the second lane from the right and the driver was intending to turn left at the intersection to proceed southbound. The driver of the ambulance stated during the SCI interview that he steered right and applied the brakes in an attempt to avoid the crash. The ambulance was equipped with an Event Data Recorder (EDR), which recorded 2.5 sec of pre-crash data. The EDR reported the vehicle's speed as 78.8 km/h (49 mph) at 2.5 sec prior to Algorithm Enable (AE) decelerating to 69.2 km/h (43 mph) at 0.5 seconds prior to AE, which was the limit of the recording. The EDR reported the brake switch circuit as "On" from 2.5 sec to 0.5 sec prior to AE. The EDR report is attached at the end of this report.

Figure 2: Eastbound approach of ambulance into the intersection; arrow shows approach of Honda turning left

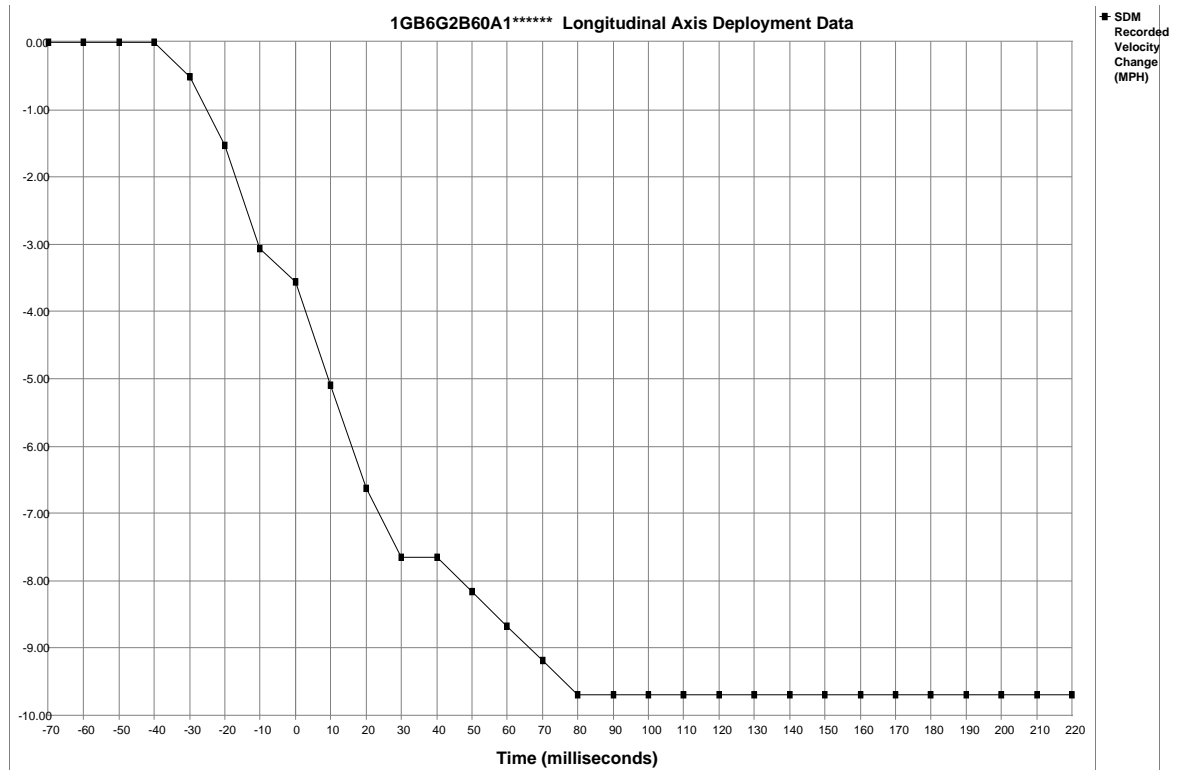
| SDM Longitudinal Axis Recorded Velocity Change (MPH) | 0.00 | 0.00 | 0.00 | 0.00 | -0.51 | -1.53 | -3.06 | -3.57 | -5.10 | -6.63 | -7.65 | -7.65 | -8.16 | -8.67 | -9.18 |
| SDM Longitudinal Axis Recorded Velocity Change (MPH) | -9.69 | -9.69 | -9.69 | -9.69 | -9.69 | -9.69 | -9.69 | -9.69 | -9.69 | -9.69 | -9.69 | -9.69 | -9.69 | -9.69 | -9.69 |

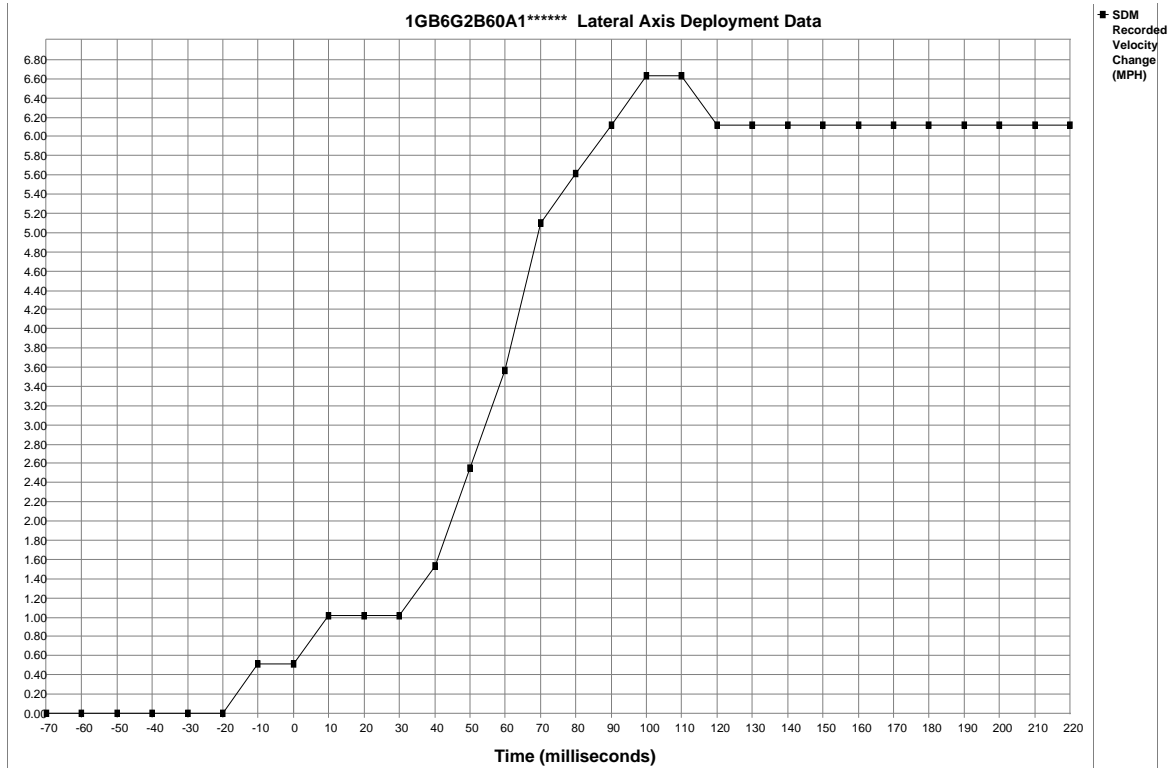
| SDM Lateral Axis Recorded Velocity Change (MPH) | 0.00 | 0.00 | 0.00 | 0.00 | 0.00 | 0.00 | 0.51 | 0.51 | 1.02 | 1.02 | 1.02 | 1.53 | 2.55 | 3.57 | 5.10 |

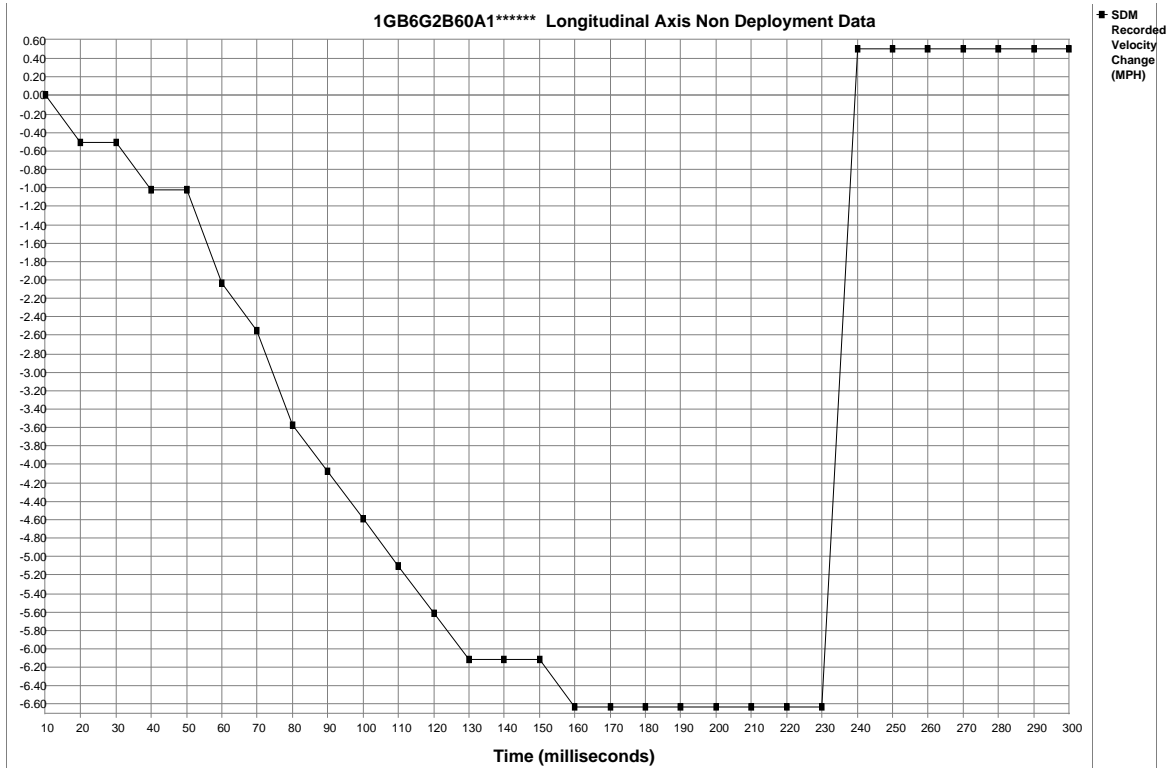
| SDM Longitudinal Axis Recorded Velocity Change (MPH) | 0.00 | -0.51 | -0.51 | -1.02 | -1.02 | -2.04 | -2.55 | -3.57 | -4.08 | -4.59 | -5.10 | -5.61 | -6.12 | -6.12 | -6.12 |
| SDM Longitudinal Axis Recorded Velocity Change (MPH) | -6.63 | -6.63 | -6.63 | -6.63 | -6.63 | -6.63 | -6.63 | -6.63 | 0.51 | 0.51 | 0.51 | 0.51 | 0.51 | 0.51 | 0.51 |

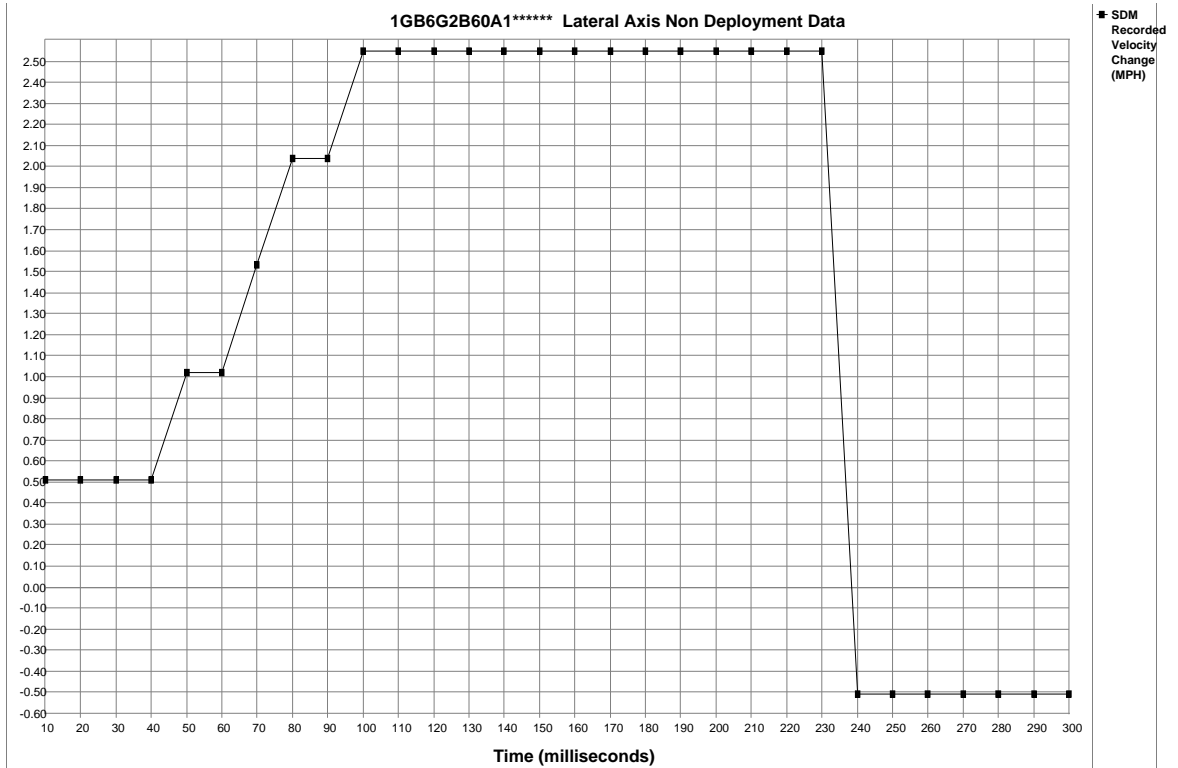
| SDM Lateral Axis Recorded Velocity Change (MPH) | 0.51 | 0.51 | 0.51 | 0.51 | 1.02 | 1.02 | 1.53 | 2.04 | 2.04 | 2.55 | 2.55 | 2.55 | 2.55 | 2.55 | 2.55 |
