### ON-SITE AMBULANCE CRASH INVESTIGATION

CASE NUMBER - IN14035

VEHICLE - 2010 FORD ECONOLINE E-350 TYPE II AMBULANCE

CRASH DATE - June 2014

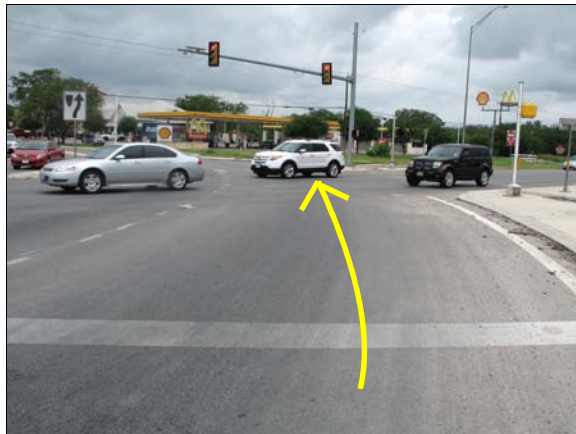
**Figure 2:** Initial position of Ford and northwest travel path

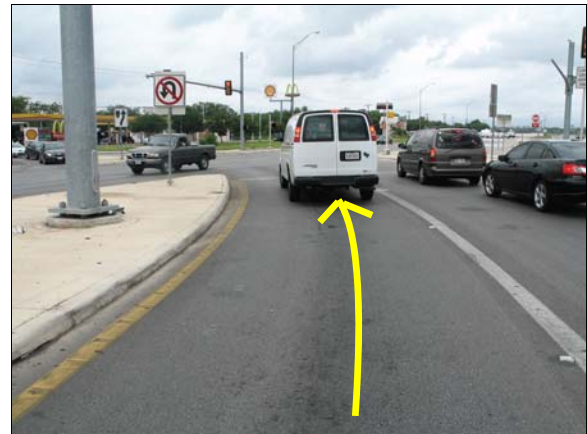
**Figure 3:** Initial position of Chevrolet and travel path

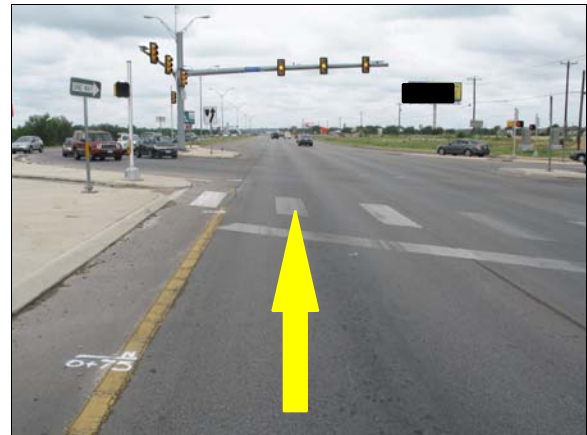
**Figure 4:** Toyota travel path

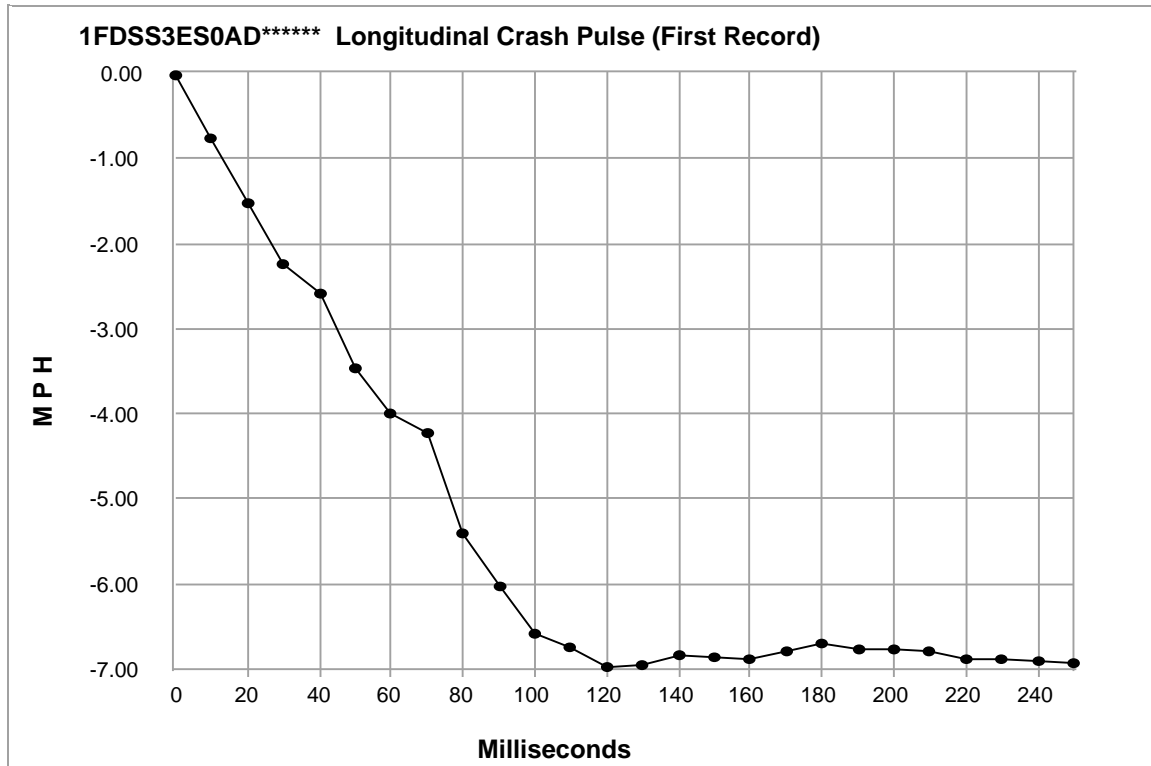
**Longitudinal Crash Pulse (First Record)**

Time (msec)	Delta-V, longitudinal (MPH)	Delta-V, longitudinal (km/h)
0	-0.03	-0.04
10	-0.75	-1.21
20	-1.52	-2.45
30	-2.24	-3.61
40	-2.59	-4.17
50	-3.47	-5.58
60	-3.99	-6.42
70	-4.22	-6.79
80	-5.41	-8.70
90	-6.04	-9.72
100	-6.58	-10.59
110	-6.75	-10.86
120	-6.97	-11.22
130	-6.95	-11.18
140	-6.84	-11.01
150	-6.87	-11.06
160	-6.88	-11.08
170	-6.78	-10.91
180	-6.70	-10.78
190	-6.77	-10.90
200	-6.76	-10.88
210	-6.80	-10.94
220	-6.89	-11.08
230	-6.90	-11.10
240	-6.92	-11.13
250	-6.92	-11.14

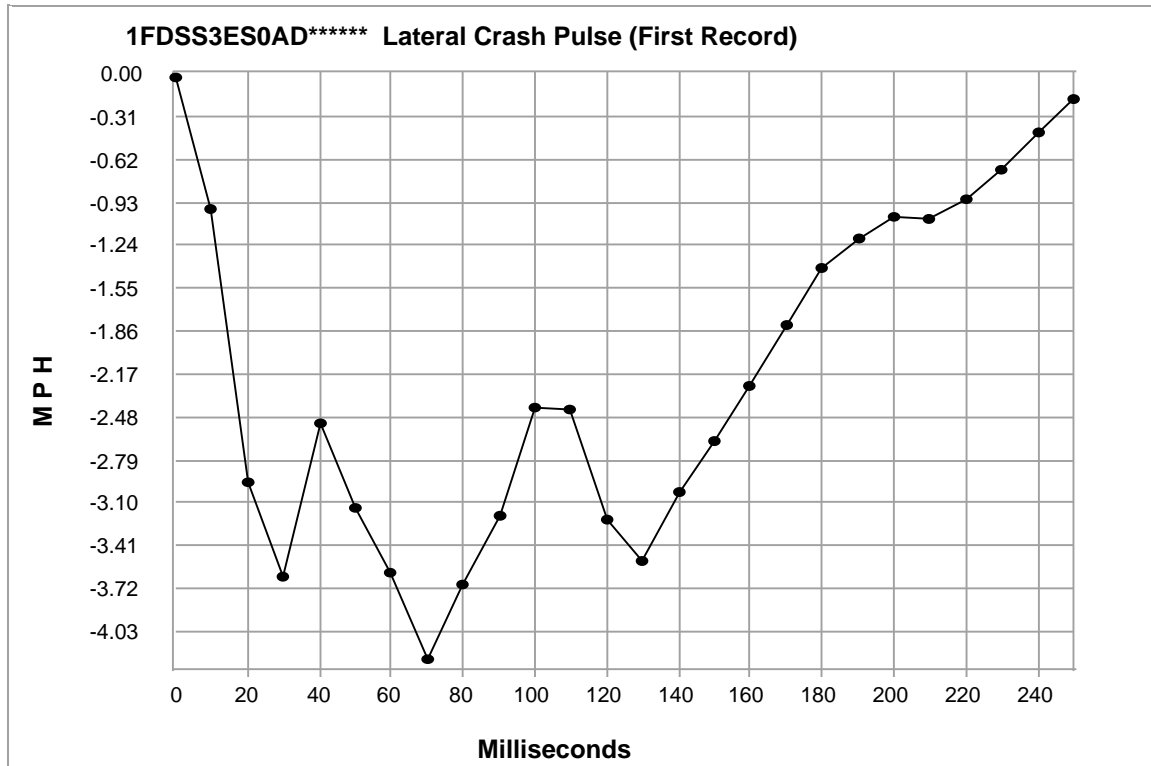
**Lateral Crash Pulse (First Record)**

Time (msec)	Delta-V, lateral (MPH)	Delta-V, lateral (km/h)
0	-0.03	-0.05
10	-0.98	-1.58
20	-2.95	-4.75
30	-3.64	-5.85
40	-2.52	-4.06
50	-3.14	-5.05
60	-3.60	-5.80
70	-4.22	-6.80
80	-3.68	-5.93
90	-3.20	-5.15
100	-2.41	-3.87
110	-2.43	-3.91
120	-3.22	-5.18
130	-3.53	-5.67
140	-3.02	-4.86
150	-2.66	-4.27
160	-2.26	-3.63
170	-1.82	-2.93
180	-1.40	-2.25
190	-1.19	-1.91
200	-1.03	-1.66
210	-1.05	-1.68
220	-0.91	-1.46
230	-0.69	-1.11
240	-0.43	-0.69
250	-0.18	-0.29

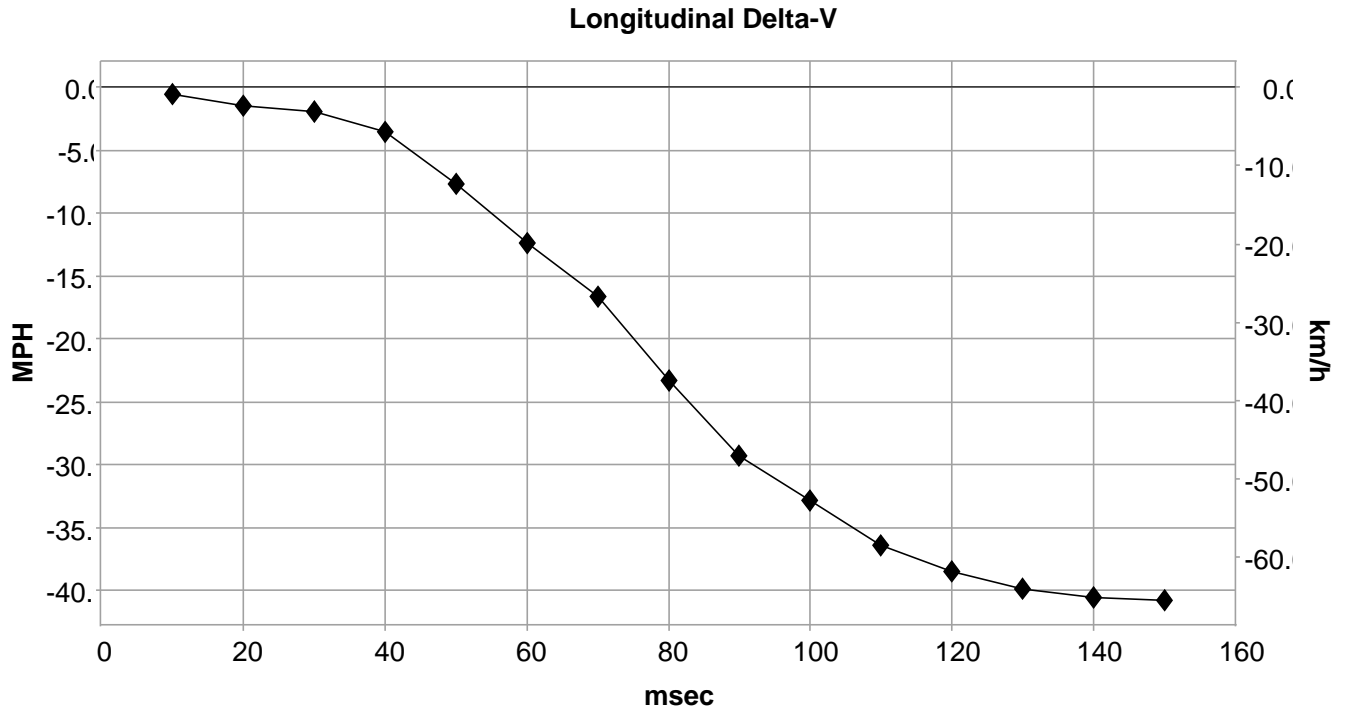
**Longitudinal Crash Pulse (Most Recent Frontal/Rear Event, TRG 6 - table 2 of 2)**

Max Longitudinal Delta-V (MPH [km/h])	-40.7 [-65.5]
---------------------------------------	---------------

Time (msec)	Longitudinal Delta-V (MPH [km/h])
10	-0.5 [-0.9]
20	-1.5 [-2.4]
30	-1.9 [-3.1]
40	-3.5 [-5.7]
50	-7.7 [-12.4]
60	-12.3 [-19.8]
70	-16.6 [-26.7]
80	-23.2 [-37.4]
90	-29.2 [-47.1]
100	-32.9 [-52.9]
110	-36.4 [-58.6]
120	-38.5 [-61.9]
130	-39.8 [-64.1]
140	-40.5 [-65.2]
150	-40.7 [-65.5]

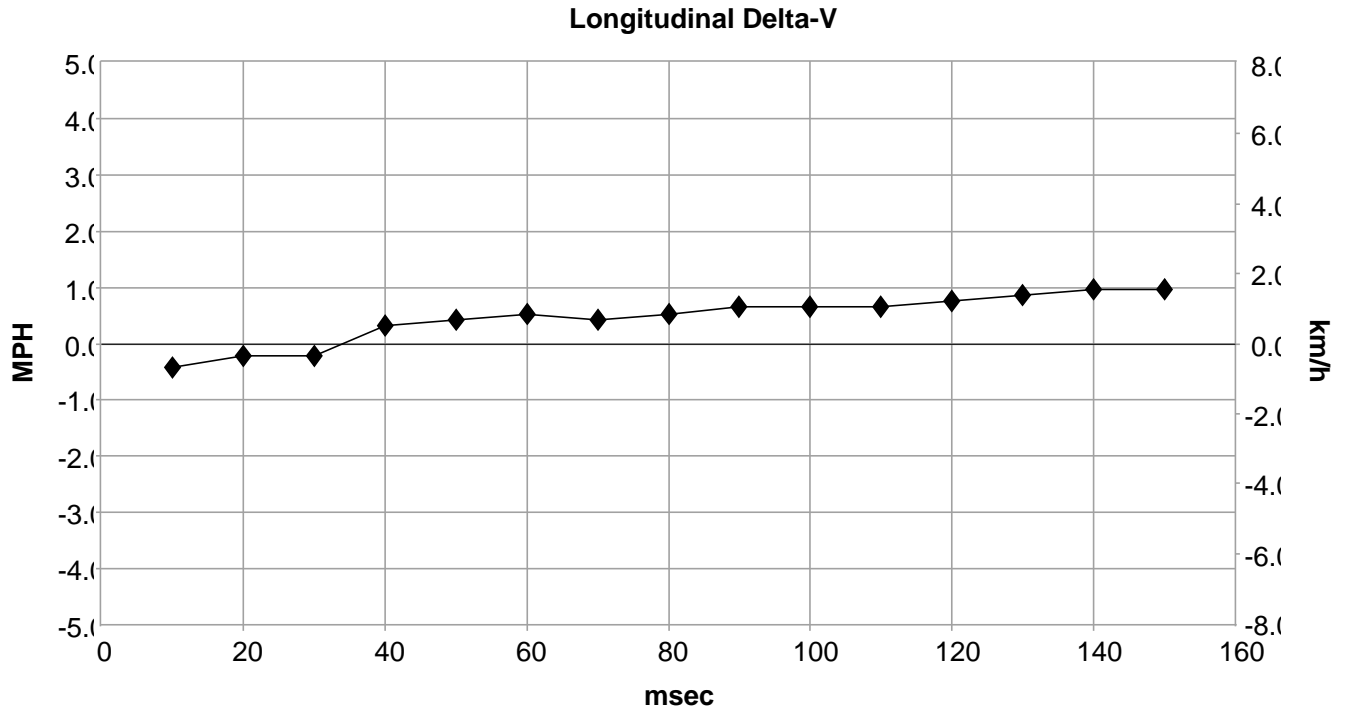
**Longitudinal Crash Pulse (1st Prior Frontal/Rear Event, TRG 5 - table 2 of 2)**

Max Longitudinal Delta-V (MPH [km/h])	1.0 [1.6]
---------------------------------------	-----------

Time (msec)	Longitudinal Delta-V (MPH [km/h])
10	-0.4 [-0.7]
20	-0.2 [-0.3]
30	-0.2 [-0.3]
40	0.3 [0.5]
50	0.4 [0.7]
60	0.5 [0.9]
70	0.4 [0.7]
80	0.5 [0.9]
90	0.6 [1.0]
100	0.6 [1.0]
110	0.6 [1.0]
120	0.8 [1.2]
130	0.9 [1.4]
140	1.0 [1.6]
150	1.0 [1.6]

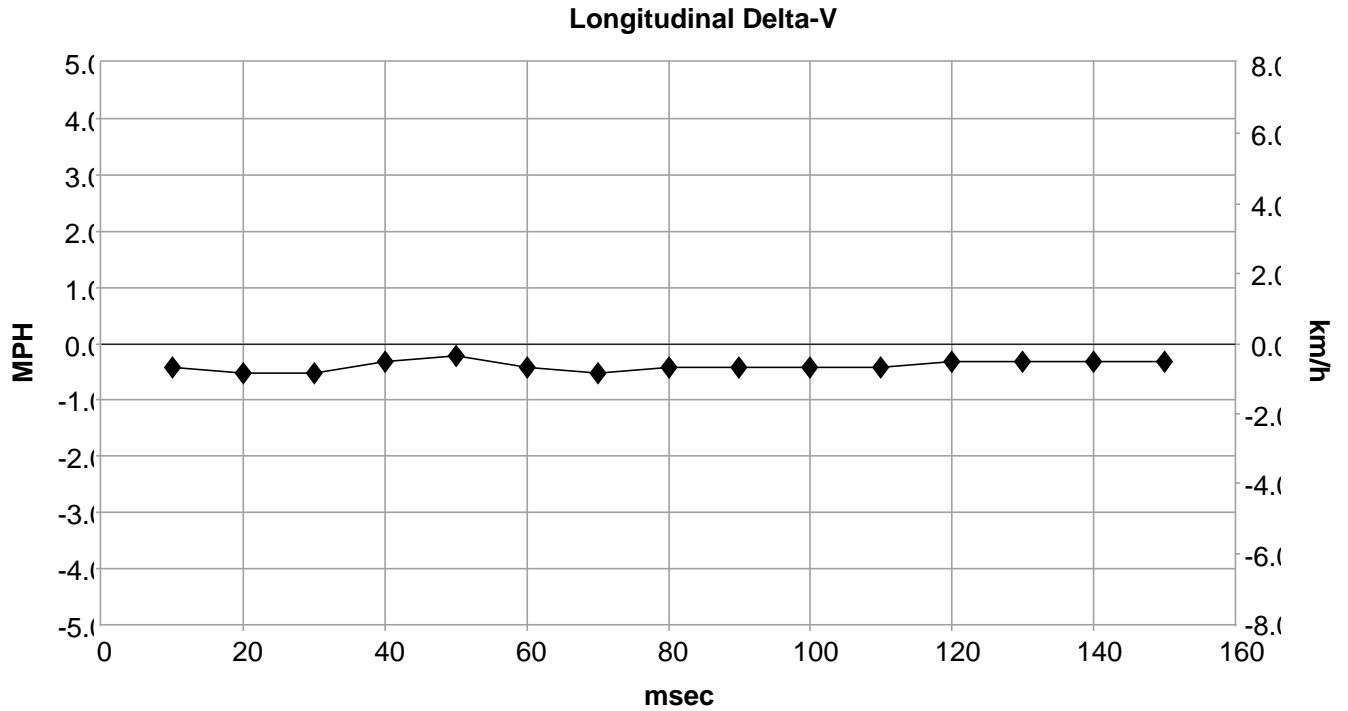
**Longitudinal Crash Pulse (Prior Frontal/Rear Event, TRG 3 - table 2 of 2)**

Max Longitudinal Delta-V (MPH [km/h])	-0.5 [-0.9]
---------------------------------------	-------------

Time (msec)	Longitudinal Delta-V (MPH [km/h])
10	-0.4 [-0.7]
20	-0.5 [-0.9]
30	-0.5 [-0.9]
40	-0.3 [-0.5]
50	-0.2 [-0.3]
60	-0.4 [-0.7]
70	-0.5 [-0.9]
80	-0.4 [-0.7]
90	-0.4 [-0.7]
100	-0.4 [-0.7]
110	-0.4 [-0.7]
120	-0.3 [-0.5]
130	-0.3 [-0.5]
140	-0.3 [-0.5]
150	-0.3 [-0.5]
