SPECIAL CRASH INVESTIGATIONS

CASE NO: CR14002

ON-SITE AMBULANCE CRASH INVESTIGATION

VEHICLE: 2012 FORD E-350 CUTAWAY

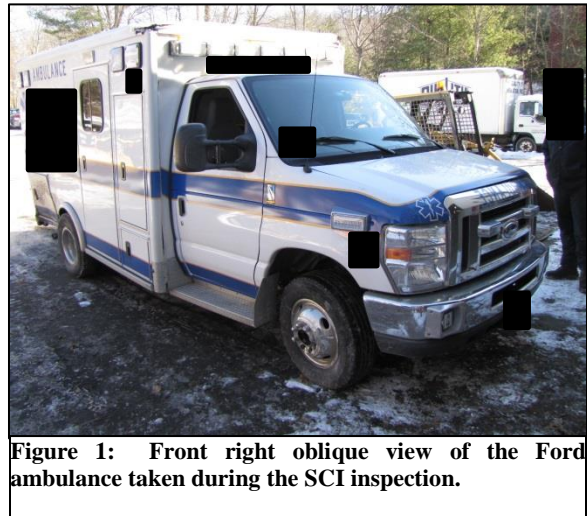
Figure 1: Front right oblique view of the Ford ambulance taken during the SCI inspection.

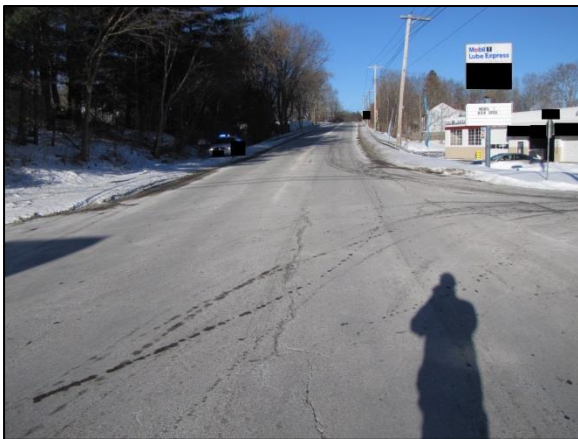
Figure 2: Northwest trajectory view of the ambulance at the intersection.

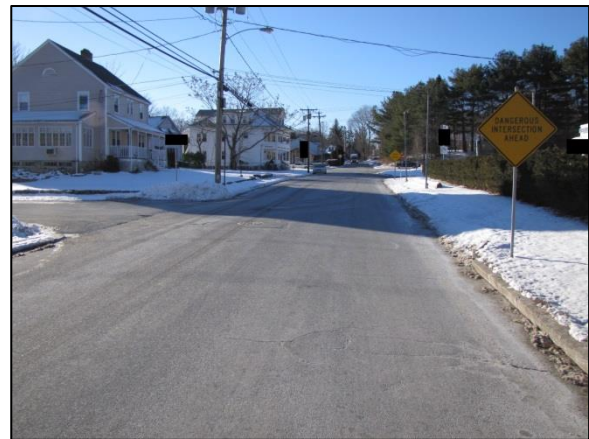
Figure 3: Southbound trajectory view of the Mercedes 85 m (280 ft) north of the intersection depicting the two warning signs.

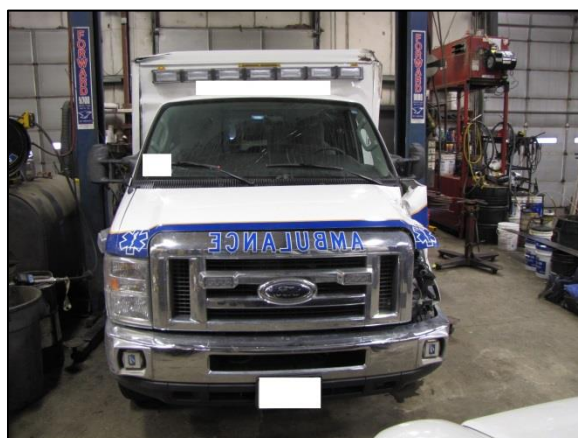
Figure 5: Front view of the 2012 Ford E-350.

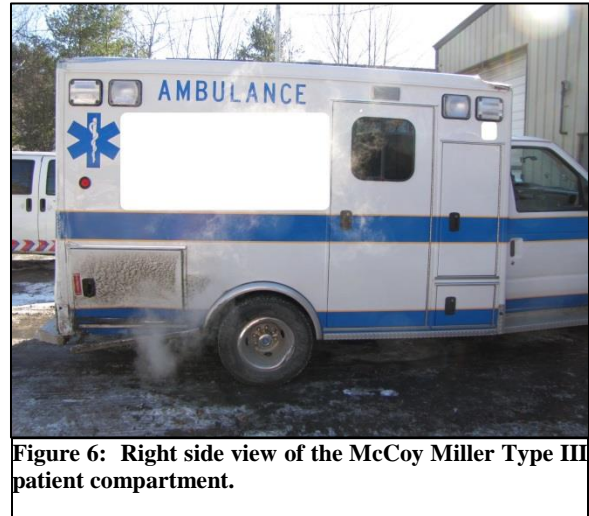
Figure 6: Right side view of the McCoy Miller Type III patient compartment.

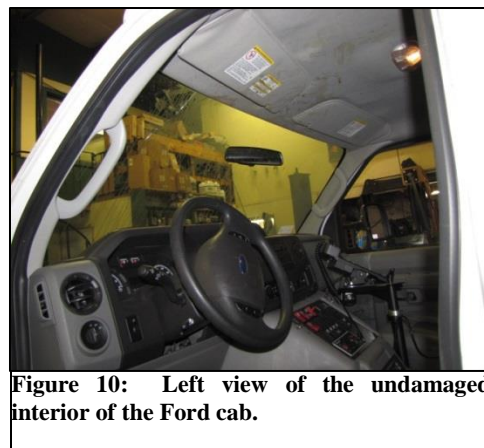
Inspection of the forward occupant compartment of the ambulance was unremarkable for damage or intrusion (**Figure 10**). There was no observed evidence of interior occupant contact points. The absence of contact points was attributed to the driver's use of the available manual safety belt system. A fluid spill was observed across the forward center aspect of the headliner. The fluid spill had the appearance and the odor of coffee. The two-spoke tilt steering wheel was adjusted to the center position. There was no steering wheel rim deformation. There was no separation of the steering column's shear capsules. The at-crash position of the driver seat was unknown. The seat's position had been altered between the time of the crash and the SCI vehicle inspection by multiple employees of the tow company as the vehicle was moved about the yard.

Figure 10: Left view of the undamaged interior of the Ford cab.

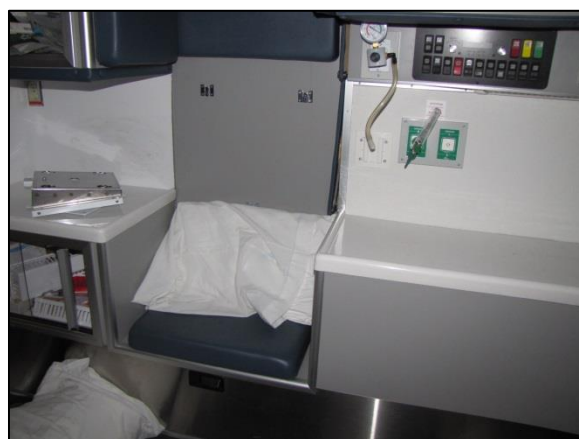
The ambulance supplies housed along the left wall of the patient compartment remained within the storage cabinets. The horizontal sliding doors remained closed. The cardiac monitor remained in its secured position on the left counter. The oxygen supply system, radio and accessories at the counter forward of the CPR seat were not damaged (**Figure 12**).

Figure 12: View of the CPR seat and the undamaged left side of the compartment of the ambulance.

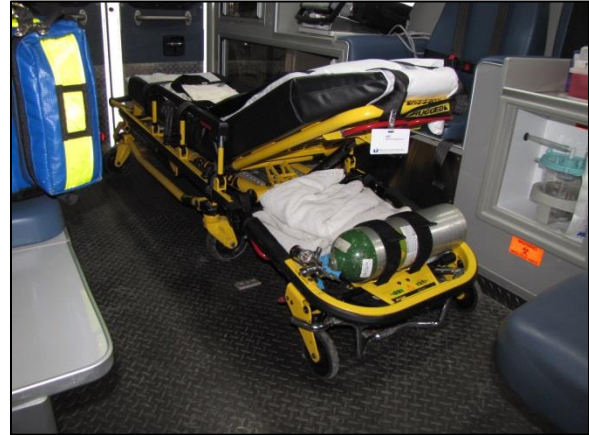
When secured in the ambulance for transport, the forward lower frame work, supporting the cot's auxiliary set of front wheels and oxygen tank, nested in the antler bracket that was attached to the floor of the patient compartment. **Figure 16** is an image of an exemplar cot nested into the antler bracket. The antler bracket was secured to the floor of the patient compartment by two knurled-head 10 mm (3/8 in) cap screws at the time of the inspection. The bracket was not damaged or deformed.

Figure 16: View of an exemplar cot nested into an antler bracket for transport.
