ON-SITE AMBULANCE CRASH INVESTIGATION

SCI CASE NO: CR13021

VEHICLE: 2012 CHEVROLET G4500 CUTAWAY

AMBULANCE: AMERICAN EMERGENCY VEHICLES TRAUMA HAWK TYPE III

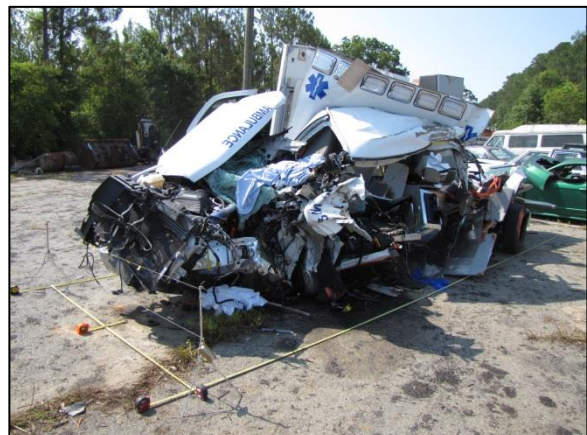
Figure 6: Left front oblique view of the Chevrolet G4500 Type III ambulance.

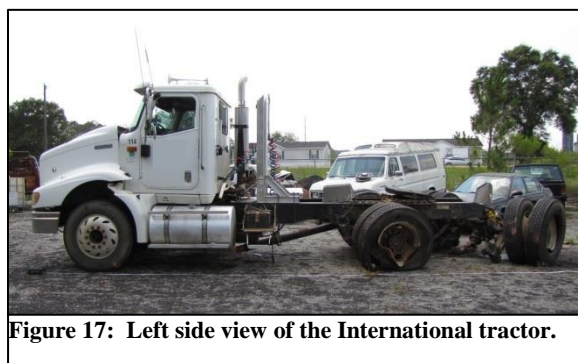
Figure 17: Left side view of the International tractor.

The tractor semi-trailer was impacted at the left drive axles and left front corner of the trailer. The force of the impact fractured the suspension components at both left drive axles. There was complete separation of the second axle and drive shaft. The outer rims at both axles were deformed. The drive tires aired out and debaded. The ladder frame of the tractor was deformed to the right from the force of the impact.
