ON-SITE AMBULANCE CRASH INVESTIGATION

CASE NUMBER - IN14004

VEHICLE - 2012 FORD E-450 TYPE III AMBULANCE

CRASH DATE - January 2014

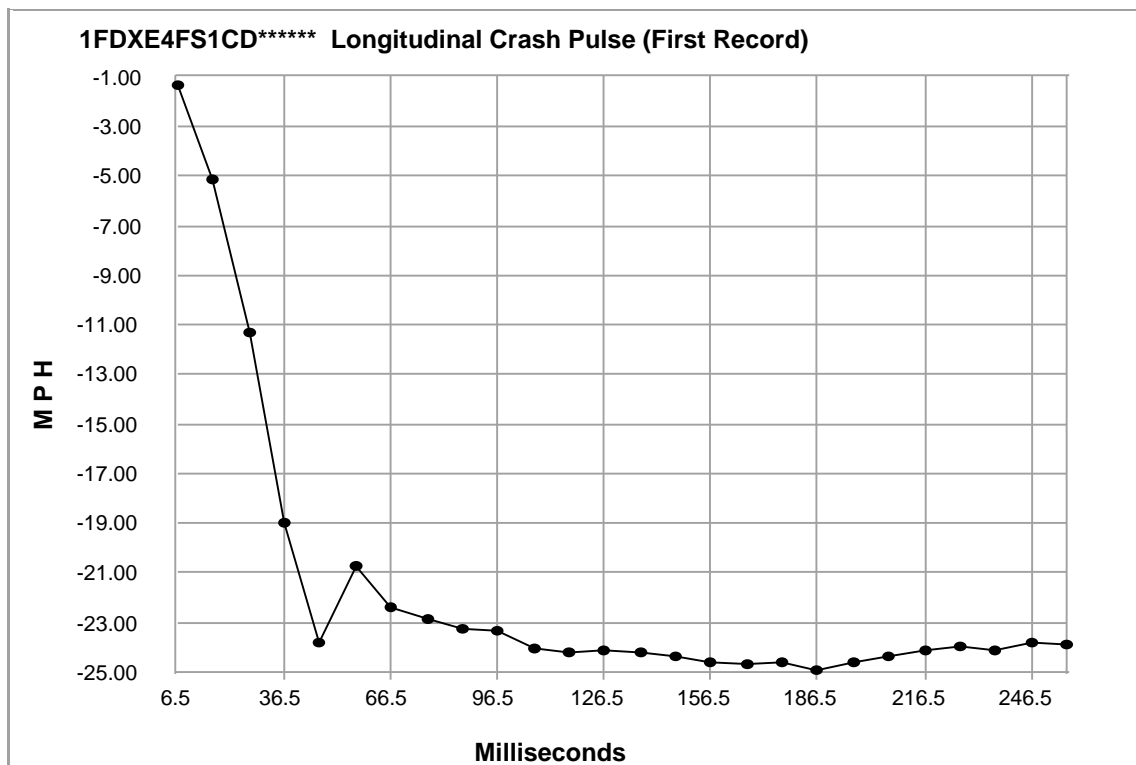
Longitudinal Crash Pulse (First Record)

Time (msec)	Delta-V, longitudinal (MPH)	Delta-V, longitudinal (km/h)
6.5	-1.30	-2.10
16.5	-5.15	-8.29
26.5	-11.31	-18.21
36.5	-18.98	-30.55
46.5	-23.77	-38.26
56.5	-20.74	-33.38
66.5	-22.37	-36.00
76.5	-22.88	-36.83
86.5	-23.24	-37.41
96.5	-23.37	-37.62
106.5	-24.07	-38.74
116.5	-24.18	-38.91
126.5	-24.12	-38.82
136.5	-24.19	-38.92
146.5	-24.40	-39.27
156.5	-24.61	-39.60
166.5	-24.68	-39.72
176.5	-24.58	-39.56
186.5	-24.91	-40.08
196.5	-24.61	-39.60
206.5	-24.39	-39.26
216.5	-24.13	-38.84
226.5	-23.96	-38.56
236.5	-24.10	-38.78
246.5	-23.84	-38.37
256.5	-23.92	-38.49

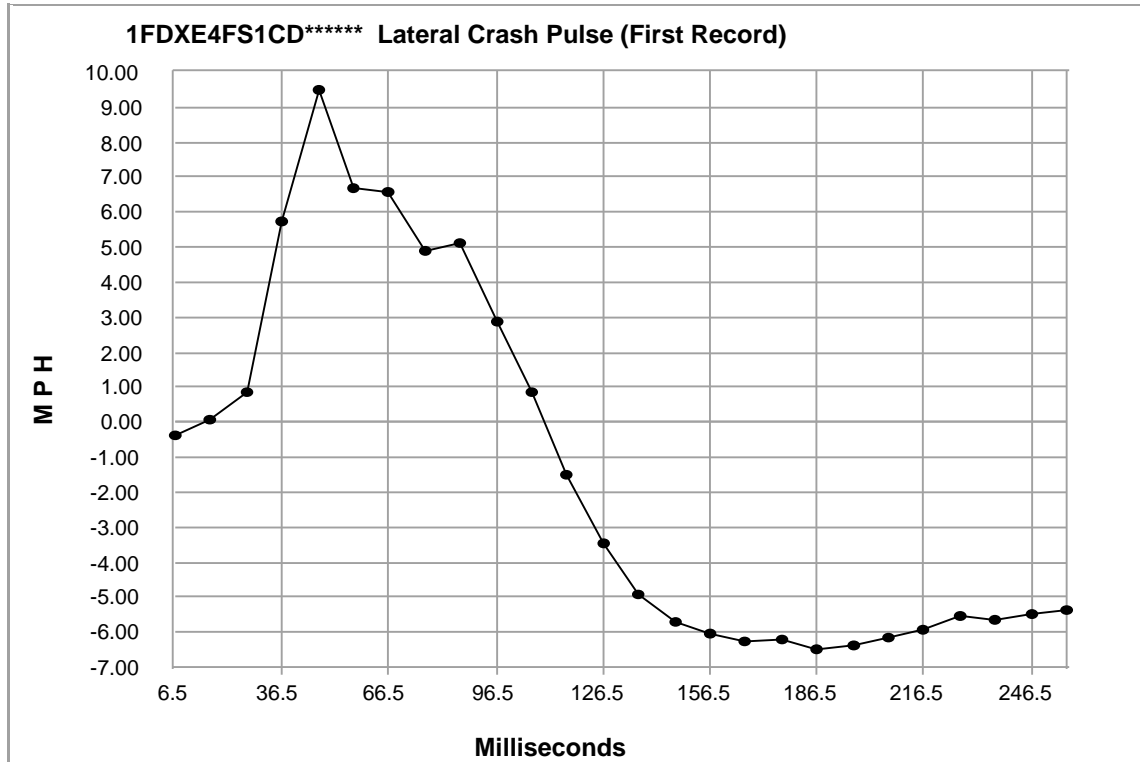
Lateral Crash Pulse (First Record)

Time (msec)	Delta-V, lateral (MPH)	Delta-V, lateral (km/h)
6.5	-0.39	-0.62
16.5	0.09	0.15
26.5	0.83	1.34
36.5	5.72	9.21
46.5	9.47	15.24
56.5	6.67	10.73
66.5	6.57	10.57
76.5	4.87	7.84
86.5	5.12	8.25
96.5	2.89	4.65
106.5	0.84	1.35
116.5	-1.52	-2.45
126.5	-3.45	-5.55
136.5	-4.95	-7.97
146.5	-5.72	-9.20
156.5	-6.06	-9.76
166.5	-6.29	-10.12
176.5	-6.22	-10.01
186.5	-6.51	-10.47
196.5	-6.37	-10.26
206.5	-6.14	-9.88
216.5	-5.91	-9.52
226.5	-5.56	-8.95
236.5	-5.63	-9.06
246.5	-5.49	-8.84
256.5	-5.36	-8.63

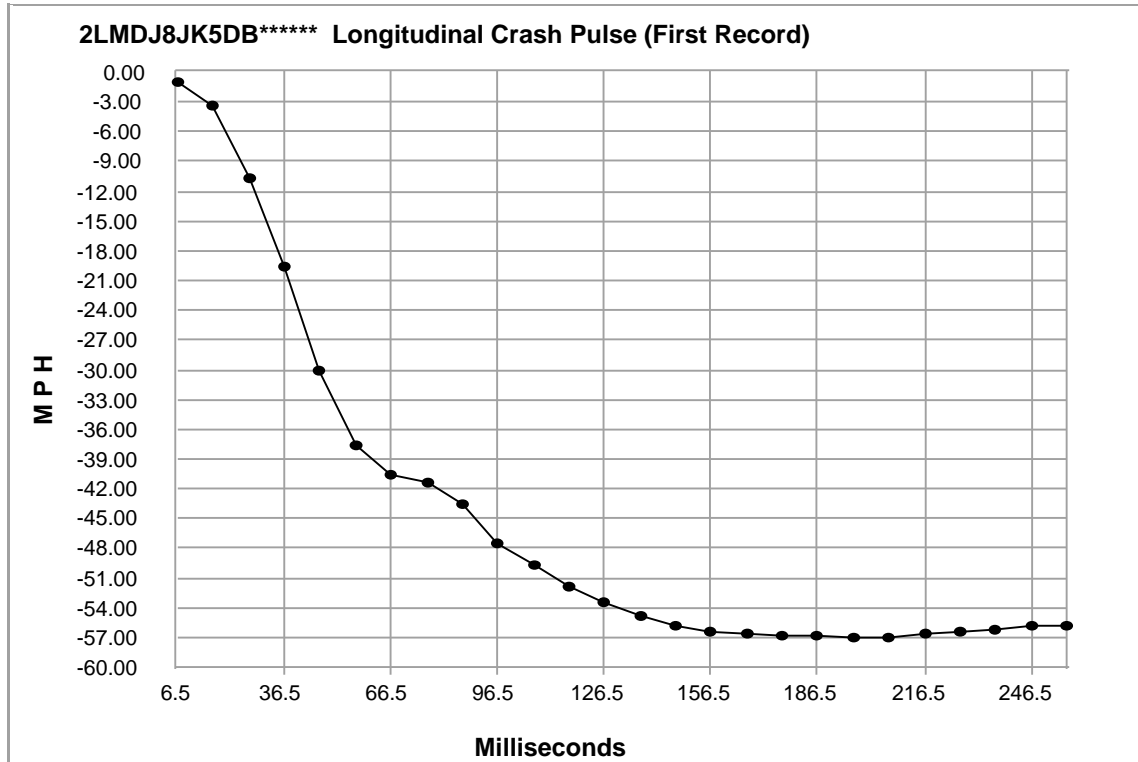
Longitudinal Crash Pulse (First Record)

Time (msec)	Delta-V, longitudinal (MPH)	Delta-V, longitudinal (km/h)
6.5	-0.94	-1.51
16.5	-3.28	-5.29
26.5	-10.76	-17.31
36.5	-19.68	-31.68
46.5	-30.08	-48.41
56.5	-37.67	-60.63
66.5	-40.51	-65.19
76.5	-41.33	-66.51
86.5	-43.61	-70.18
96.5	-47.62	-76.64
106.5	-49.73	-80.03
116.5	-51.80	-83.36
126.5	-53.39	-85.92
136.5	-54.86	-88.29
146.5	-55.85	-89.88
156.5	-56.38	-90.73
166.5	-56.63	-91.14
176.5	-56.81	-91.43
186.5	-56.91	-91.59
196.5	-57.00	-91.74
206.5	-56.97	-91.68
216.5	-56.73	-91.30
226.5	-56.39	-90.75
236.5	-56.17	-90.39
246.5	-55.88	-89.93
256.5	-55.76	-89.74

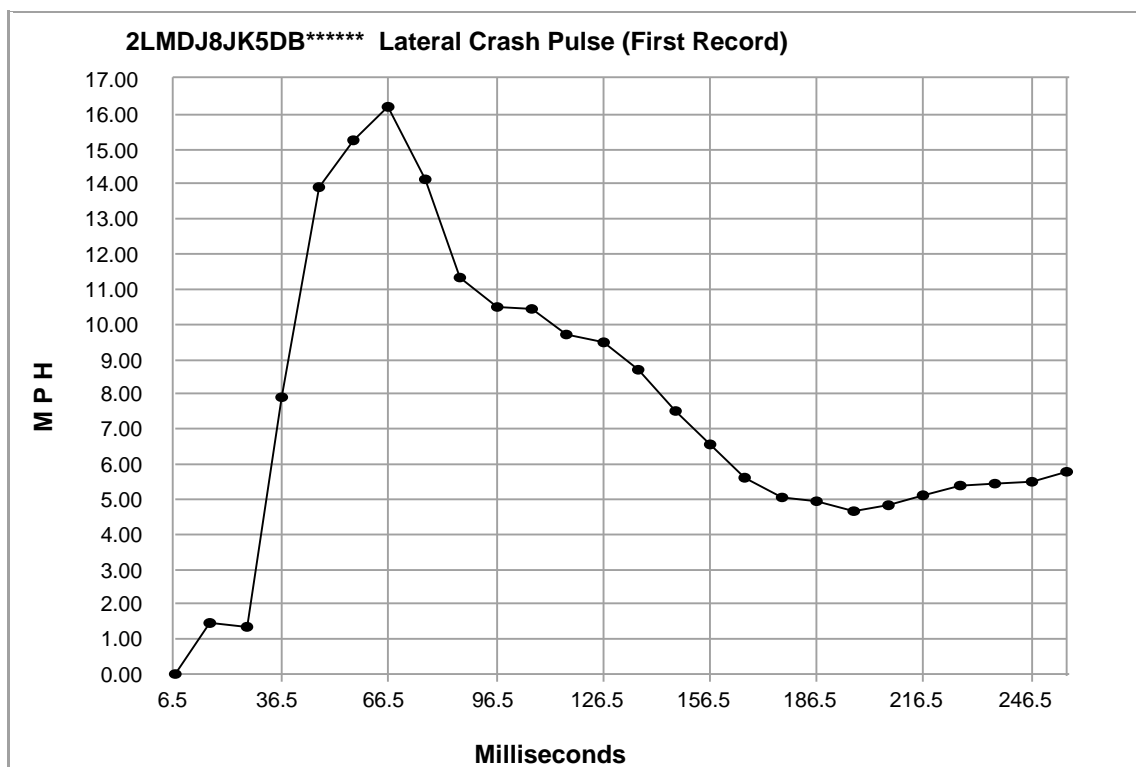
Lateral Crash Pulse (First Record)

Time (msec)	Delta-V, lateral (MPH)	Delta-V, lateral (km/h)
6.5	0.03	0.04
16.5	1.44	2.31
26.5	1.33	2.14
36.5	7.92	12.75
46.5	13.90	22.37
56.5	15.28	24.60
66.5	16.22	26.10
76.5	14.15	22.76
86.5	11.34	18.25
96.5	10.50	16.90
106.5	10.46	16.84
116.5	9.73	15.66
126.5	9.51	15.30
136.5	8.67	13.96
146.5	7.53	12.11
156.5	6.58	10.59
166.5	5.62	9.05
176.5	5.05	8.12
186.5	4.94	7.95
196.5	4.66	7.50
206.5	4.85	7.80
216.5	5.09	8.19
226.5	5.36	8.63
236.5	5.42	8.72
246.5	5.50	8.85
256.5	5.79	9.33

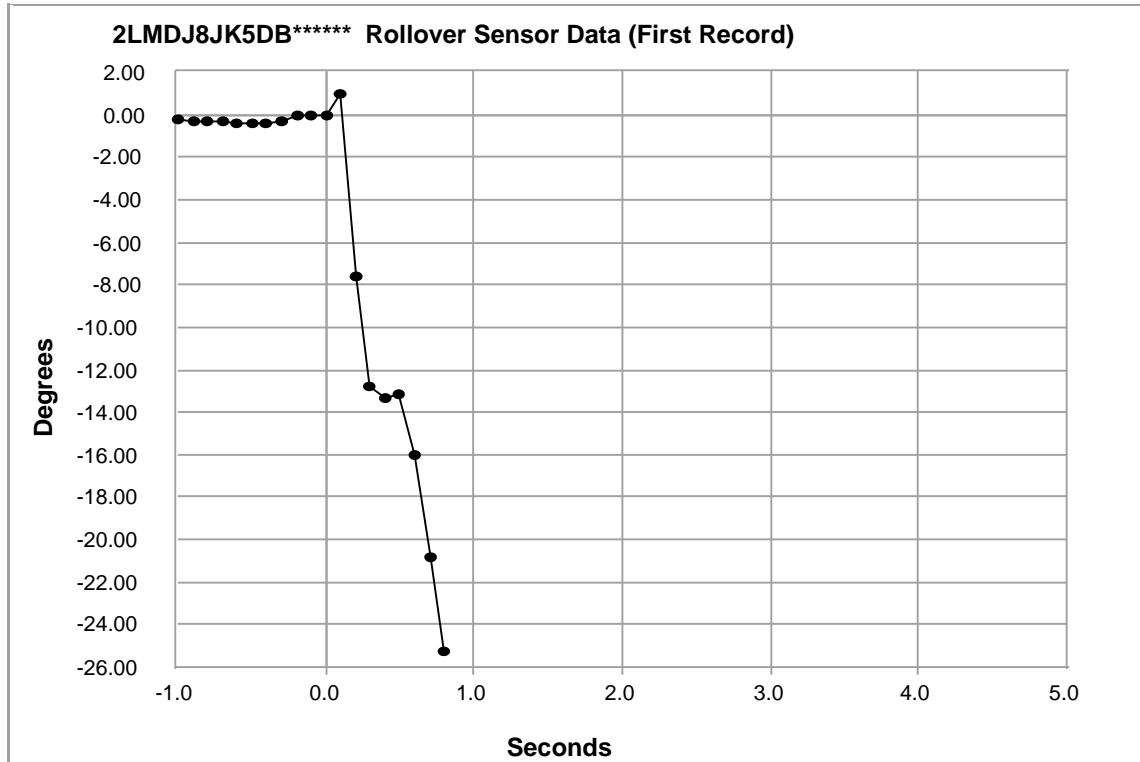
Rollover Sensor Data (First Record)

Time (sec)	Vehicle roll angle (degrees)
-1.0	-0.23
-0.9	-0.34
-0.8	-0.34
-0.7	-0.34
-0.6	-0.39
-0.5	-0.42
-0.4	-0.42
-0.3	-0.28
-0.2	-0.08
-0.1	-0.07
0.0	-0.02
0.1	1.01
0.2	-7.57
0.3	-12.78
0.4	-13.31
0.5	-13.2
0.6	-15.98
0.7	-20.84
0.8	-25.22
0.9	N/A
1.0	N/A
