On-Site Ambulance Crash Investigation

SCI Case Number DS14016

Vehicle: 2013 Leader Type II Mercedes-Benz Sprinter Ambulance

Crash Date: April 2014

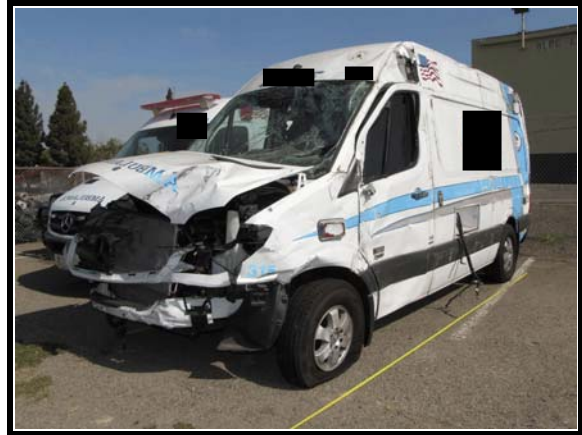
The focus of this investigation is the vehicle-to-vehicle impact with subsequent rollover of a 2013 Leader Type II Mercedes-Benz Sprinter ambulance (**Figure 1**). All three occupants of the ambulance were injured. The crash was identified by a Dynamic Science, Inc. crash investigator from a news report. Notification was forwarded to the Special Crash Investigations (SCI) group of the National Highway Traffic Safety Administration (NHTSA) on April 21, 2014. NHTSA's Office of Emergency Medical Services (OEMS) was contacted and the team was instructed to pursue this case on April 22, 2014. The SCI team contacted the investigating police agency and obtained the police report. Cooperation to inspect the vehicle was obtained and the inspection took place on June 6, 2014. The vehicle is not supported by the Bosch Crash Data Retrieval tool, but SCI did obtain a copy of the ZOLL Road Safety data report for this event. This is discussed later in this report.

Figure 1. 2013 Mercedes-Benz Sprinter ambulance

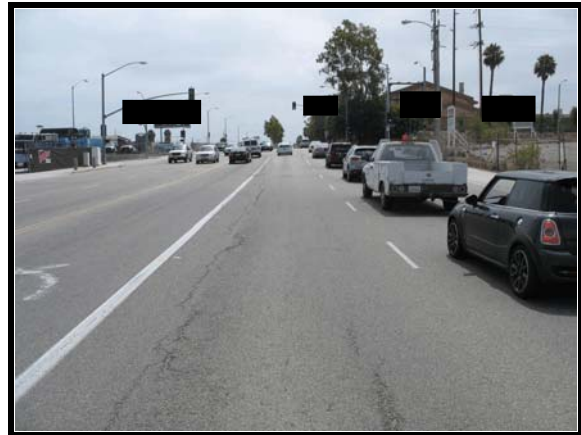
The crash site was within the intersection of a north/south local road and an east/west local road. The eastbound leg of the intersection consisted of two eastbound through lanes, a marked left turn lane, and two westbound through lanes (**Figure 2**). The asphalt roadway was straight with a positive 2 percent grade. The speed limit was 72 km/h (45 mph). The southbound leg consisted of a marked right turn lane, a southbound through lane, a marked left turn lane, and two northbound through lanes (**Figure 3**). The asphalt roadway was straight with a positive 3percent grade. The speed limit was 64 km/h (40 mph). It was dark at the time of the crash with spot illumination by streetlights. The weather at the nearest reporting station was 16° C (60° F), humidity 82 percent, visibility 10 km (6 miles), and the winds were calm. A Crash Diagram is included at the end of this technical report on page 12.

Figure 2. Eastbound approach, 2013
Mercedes-Benz Sprinter ambulance

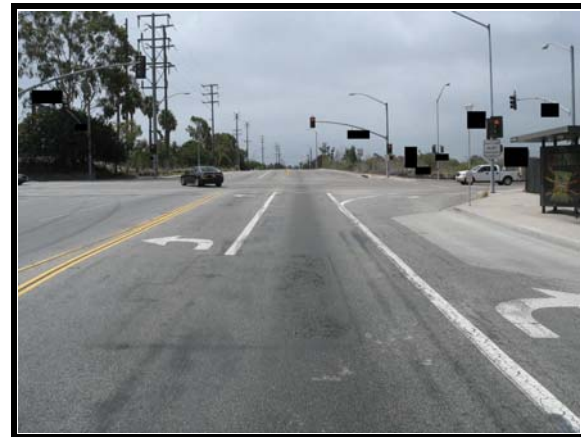
Figure 3. Southbound approach, 2005
Lincoln Town Car

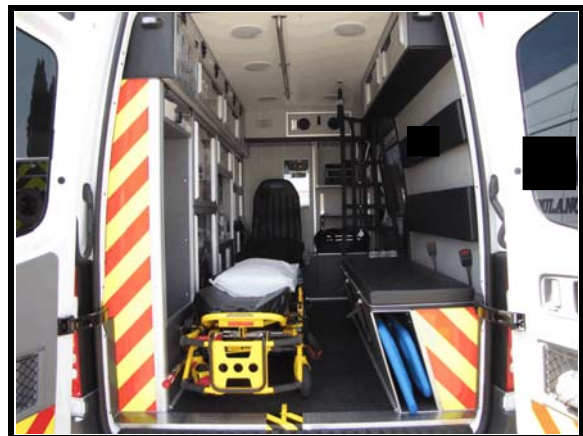
Secondary manufacturing of the vehicle consisted of installation of the patient compartment module and installation of emergency services operational equipment (warning lights, sirens, and radio communications). Completed as a Type II certified ambulance, the vehicle was configured with a forward cab and rear patient compartment equipped for the treatment of medical emergencies in a mobile environment (**Figure 5**).

Figure 5. Exemplar patient compartment, 2013 Mercedes-Benz Sprinter ambulance

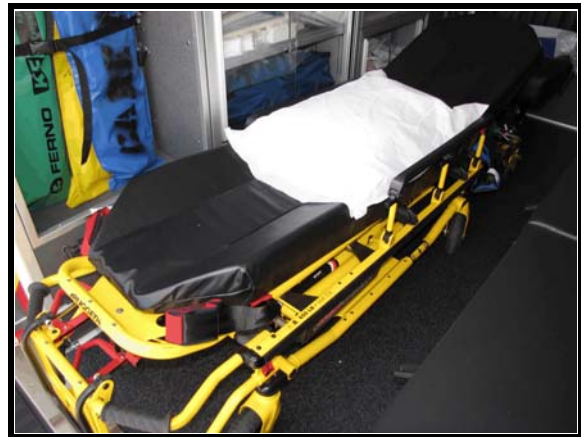
The patient cot was a Rugged MX-PRO Ambulance Cot that was manufactured by Stryker. The cot involved in the crash was undamaged and placed back into service. The ambulance company was unable to locate the involved cot. An exemplar cot was examined (**Figure 9**). The cot was constructed of a tubular aluminum frame with circumferential weld joints and steel hardware fasteners. The X-frame supporting the mattress platform featured manual height adjustment capabilities and the mattress platform featured 0-73 degrees of backrest articulation. Its length was 203 cm (80 in) and the width was 58 cm (23 in). Labeling declared that the load capacity limit of the cot was a maximum of 227 kg (500 lbs). The cot was equipped with two lap belts and one four-point shoulder restraint. The cot was secured in place within the passenger compartment via a 6371 Stryker antler design floor-mount cot fastener system. The system consisted of a forward antler bracket and rearward side mounted locking-clamp mechanism (**Figure 10**). The antler bracket cradled the forward portion (location of the patient's head area) of the cot's frame, while the vertically-oriented locking mechanism clamped around a pin protruding from the cot's lower frame rail. According to interviewees, the cot remained locked in place and the patient remained secured during the crash. There was no reported damage to the cot or the fastening system.

Figure 9. Exemplar Stryker Rugged MX-PRO Ambulance Cot

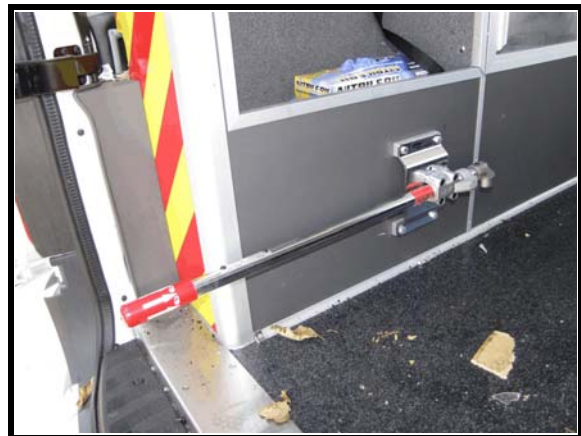
Figure 10. 6371 Stryker cot fastener system
