**ON-SITE AMBULANCE CRASH INVESTIGATION**

**SCI CASE NO: CR13004**

**VEHICLE: 1999 FORD E-350 CHASSIS**

**AMBULANCE BODY: AMERICAN EMERGENCY VEHICLES TYPE II**

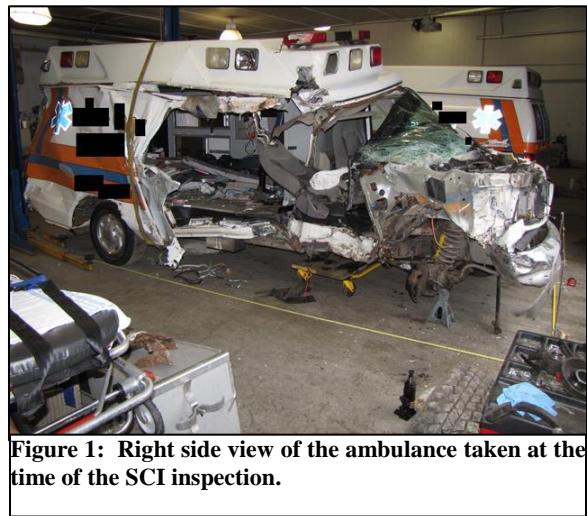
This on-site investigation focused on the offset front-to-rear crash of a 1999 Ford E-350/American Emergency Vehicle (AEV) Type II ambulance (**Figure 1**) and the injury source(s) for the fatally injured 26-year-old male Emergency Medical Technician (EMT) occupying the front right passenger seat. The front plane of the ambulance struck the back plane of a loaded 2006 Freightliner tractor/flatbed semi-trailer.

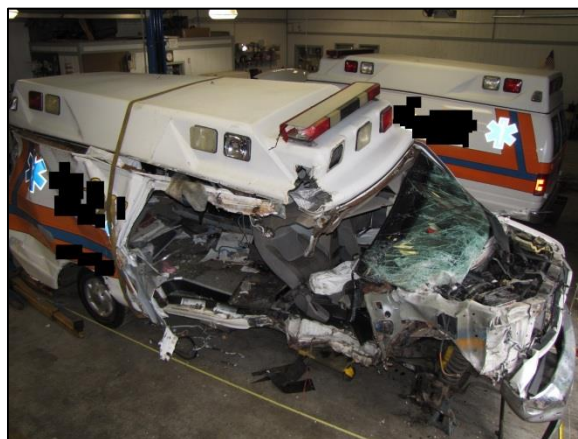
Figure 7: Overhead view of the ambulance.

Position	Measured Pressure	Measured Tread Depth	Restriction	Damage
LF	434 kPa (63 PSI)	7 mm (9/32 in)	No	No
LR	427 kPa (62 PSI)	6 mm (7/32 in)	No	No
RR	441 kPa (64 PSI)	4 mm (5/32 in)	No	No
RF	Tire flat	7 mm (9/32 in)	No	Sidewall cut, tire debaded

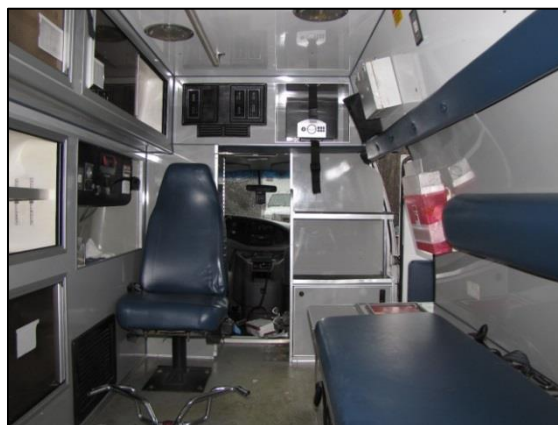
For reference, the interior of a similar AEV Type II ambulance was inspected (**Figure 13**). The cabinet located immediately behind the front right seat measured 61 cm x 38 cm x 127 cm (24 in x 15 in x 50 in), width by depth by height. The cabinet was manufactured of 19 mm (3/4 in) plywood. The front right seat was adjusted to a position 3 cm (1 in) forward of full-rear consistent with the front right seat of the involved ambulance. In this mid-to-rear track adjustment, the position of the cabinet limited the recline angle of the seat back to 12 degrees aft of vertical.

**Figure 13:** Rear interior view of an exemplar AEV Type II patient compartment.

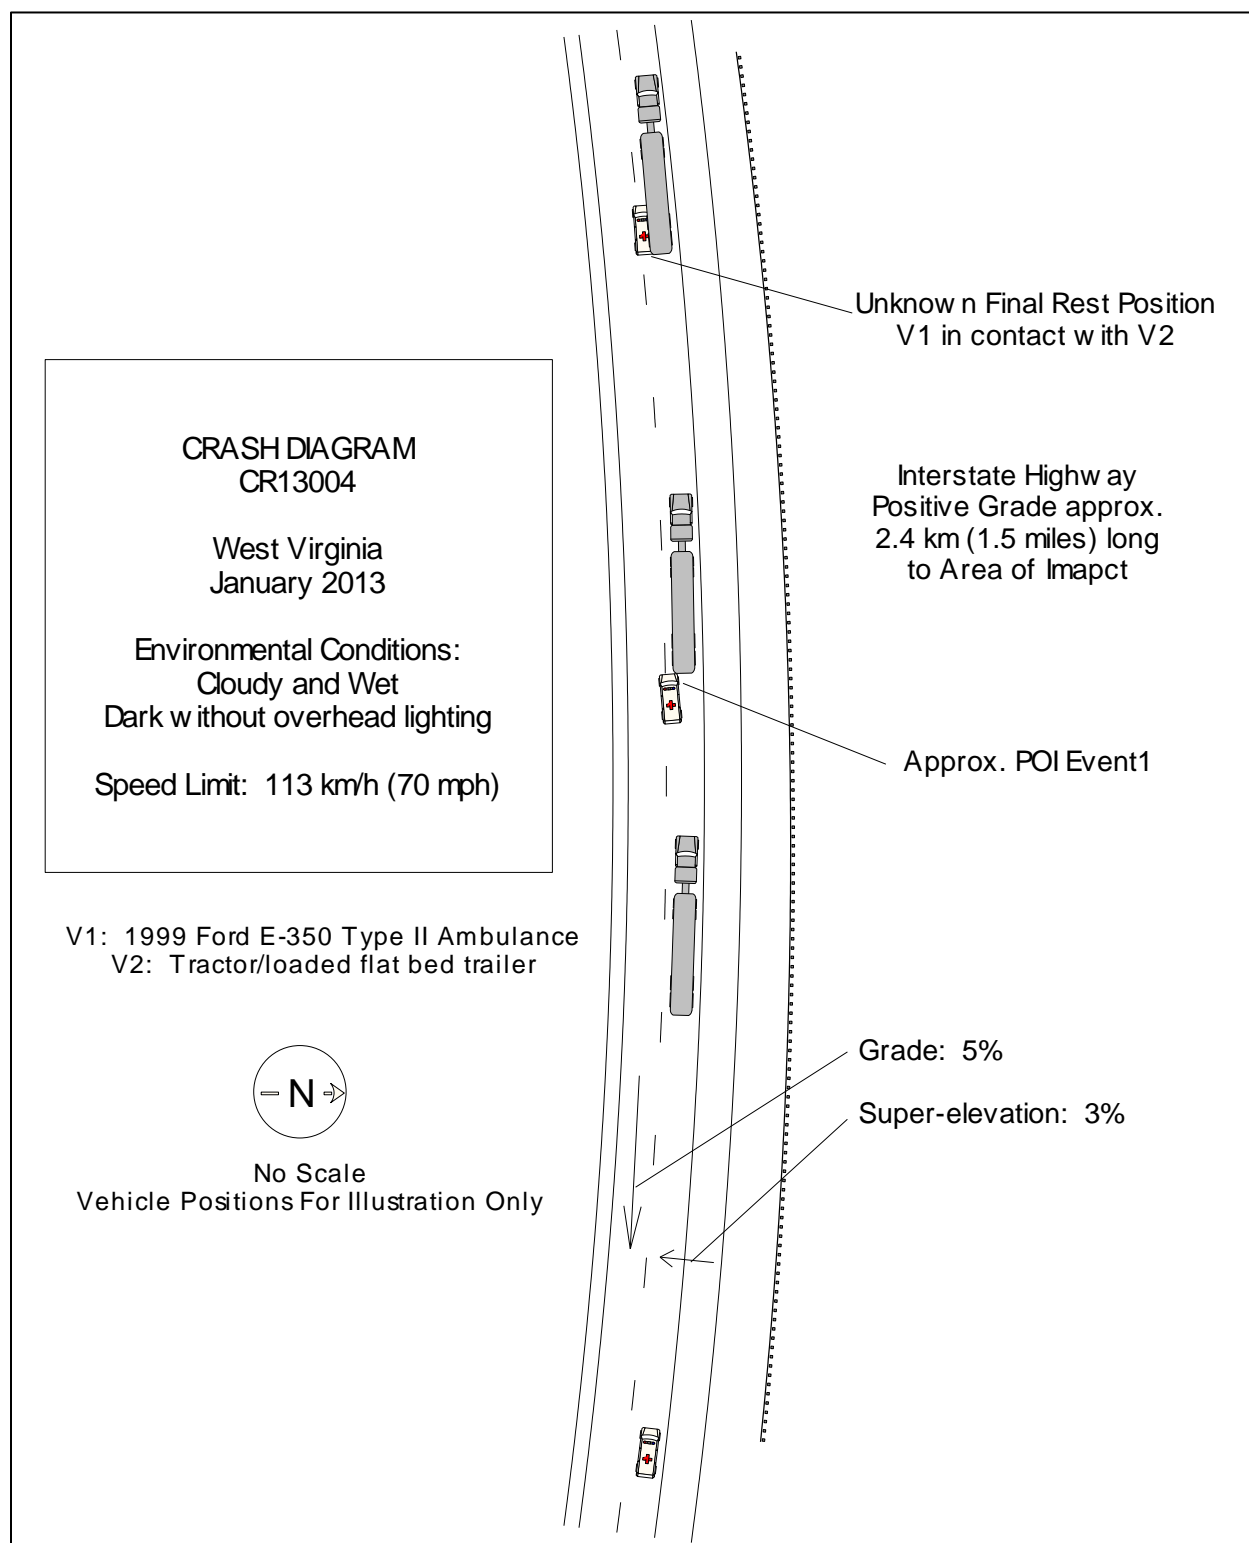
**CRASH DIAGRAM**

The front right corner of the ambulance impacted the back left corner of the loaded flatbed trailer. The direct contact damage to the ambulance's front bumper was located to the right of the frame rail. The relatively soft structures of the front profile of the ambulance engaged the

rigid structure of the trailer's back profile. The frontal air bags in the ambulance deployed and the front seat safety belt pretensioners actuated. The left aspect of the trailer's rear impact guard deflected forward. As the right plane of the ambulance engaged against the trailer's load, the side structure completely separated. The right interior components of the patient compartment fractured and were deposited onto the roadway. The side structure of the ambulance deformed, folding rearward, hinging at the right D-pillar. The ambulance remained in contact with the trailer as it decelerated. The Freightliner driver applied the brakes and came to a controlled stop in the right lane of the interstate. At final rest the ambulance remained engaged against the left side of the flatbed trailer and its load (**Figure 6**). A Crash Diagram is included at the end of this technical report on Page 15.
