3D4 Structural Analysis and Stability FTR

Louis Zeng (lz406)
Fitzwilliam College March 2021

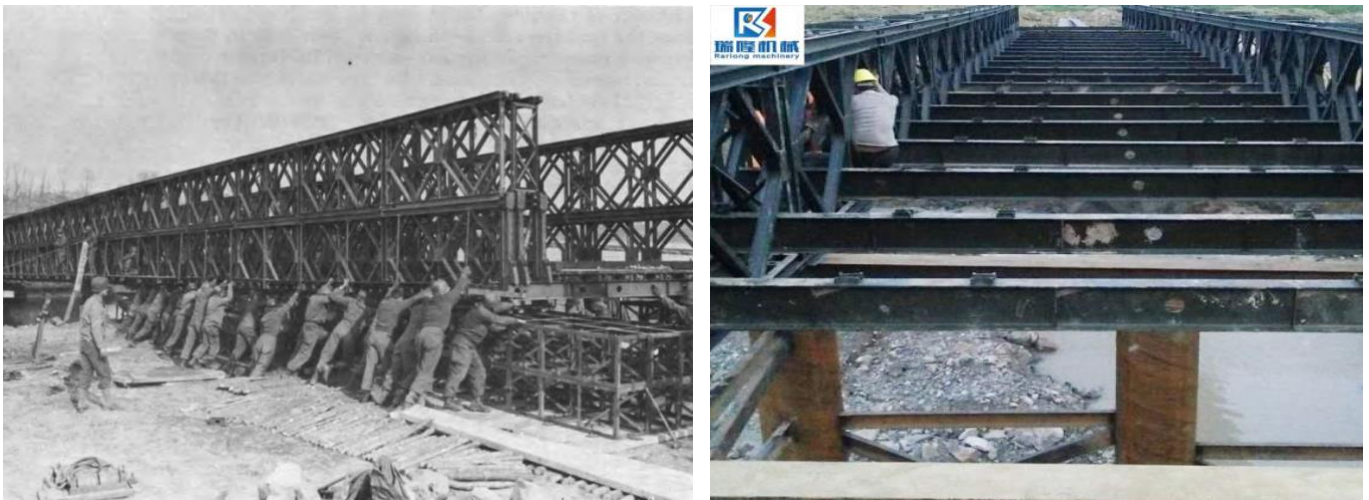
Figure 1. (Left) Doubled sections of Bailey bridging assembled by hand in WW2.
(Right) Transoms of a Bailey bridge (made of I beams) are subjected to vertical loading.

Post WW2, the use of Bailey bridges is dramatically diminished. As shown in the Figure 1. (right), vertical frames and transoms of a Bailey bridge (made of I beams) have their upper (compression) flanges free to displace laterally and rotate. And therefore, when an applied vertical load is large enough to cause both lateral displacement and twisting of a transom or chord, “lateral torsional buckling” occurs, which causes the Bailey bridge susceptible to buckling failure.

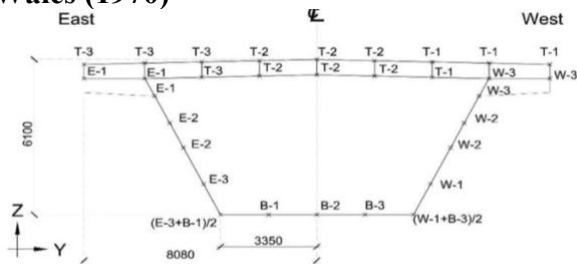
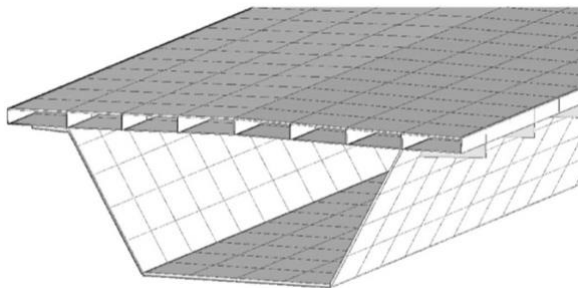
Figure 4. (Left) A sketch of the trapezoidal box-girder cross section of the Cleddau Bridge, and a perspective view of the cross-section in the numerical model. (Right) Failure of the Cleddau Bridge (Milford Haven). Notice the bottom flange is buckled.

According to the later Australian Royal Commission report, as the supporting diaphragm over Pier 6 buckled, the overall depth of the steel box girder was shortened, which caused the bottom flange more likely to buckle due to the shortening of the inter-flange distance. (i.e., as the moment was now carried by a reduced lever arm, greater compression was acted on the bottom flange until the weakened deck box can no longer sustain the bending moment, and the cantilevered section rotates about the now formed virtual hinge.)

- The buckled support diaphragm which initiated the failure is likely have been as much as $\frac{3}{4}$ inch out of flat, which makes it susceptible to local buckling.
- The bearings in between the pier 6 and the box-girder superstructure were out of line with diaphragm's neutral axis and could have induced bending moment.
- Some bolts which were used to connect longitudinal stiffeners to the bottom flange were tightly installed in their corresponding oversized holes, instead of the designed loose installation. And under load movement, the bolts could have torn off the longitudinal stiffeners from the bottom flange, causing more instabilities under compression.

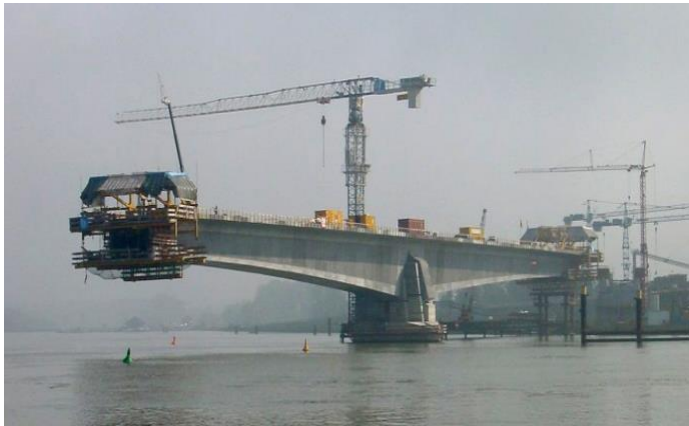
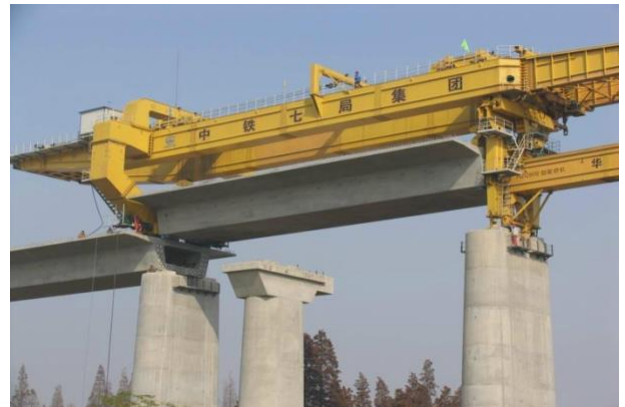
Figure 5. (Left) cantilever construction method for box-girder bridge. (used for the Cleddau Bridge)
(Right) incremental launch method for box-girder bridge. (used for the West Gate Bridge, Melbourne, Australia)

- The Cleddau bridge consists of welded steel trapezoidal box-girder superstructure as shown in Figure 4. (Left).
- As shown in Figure 5. (Left), Figure 6. The construction method adopted for the Cleddau Bridge was to cantilever out pre-assembled deck sections from each side of the river. The bending moment and stresses on the deck is in general much greater in the cantilevered state than after erection.
- The collapse occurred when the last deck section (40) between pier 5 & 6 was moving out along the cantilever.
- It was pointed out by the Merrison Committee of Inquiry that the buckling of the support diaphragm at the root of the erected cantilever initiated the failure, as shown in Figure 4. (Right). After the diaphragm was torn away from the bottom part of the web, bottom flange and the web were allowed to buckle. (shown in Figure.7)
