# Flare inspection by Unmanned Aerial Vehicle (UAV) at GC7

Wutthinan Petchpeng  
Senior Plant Reliability Engineer  
U-TM-RM

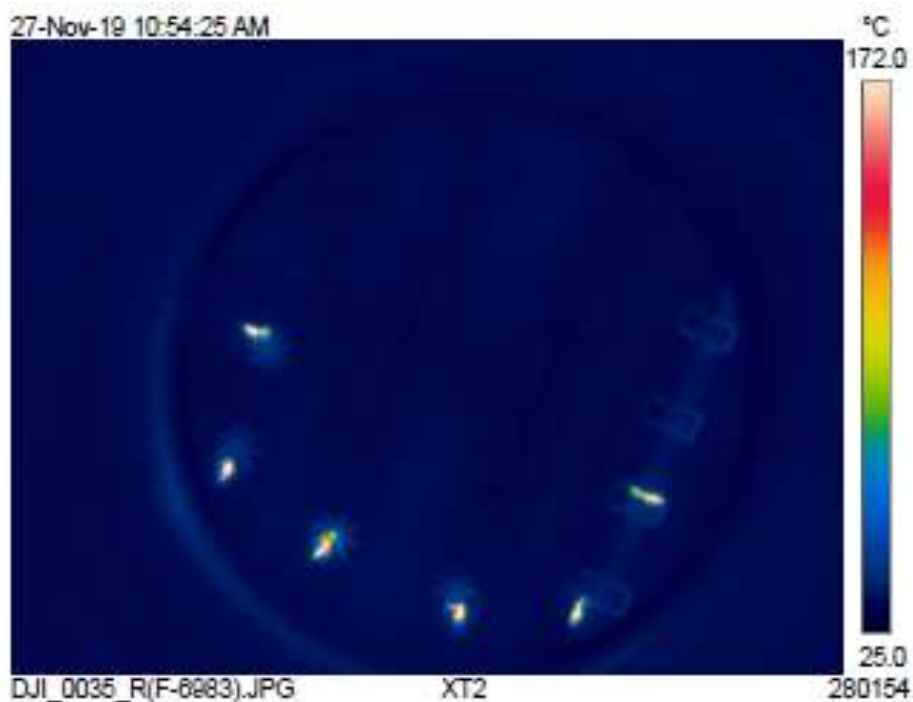
27-Nov-19 10:54:25 AM

Parameters	
Emissivity	0.96
Ref. temp.	36 °C
Geolocation	
Location	N 12° 40' 49.06", E 101° 7' 43.10"
	<a href="http://maps.google.com/?z=17&amp;hl=es&amp;q=12.6803,101.1161">http://maps.google.com/?z=17&amp;hl=es&amp;q=12.6803,101.1161</a>
Note	
F-6983
