ISEC2076 ASSIGNMENT #1

Physical Security Assessment

Steylen, Lucas

Facility Name	Munden's Moving
Location	45 Lovett Lake Ct, Halifax, NS B3S 1B8
Business Opened	June 1 st 1984
Company Contact	Phone: +1 877-289-9120 Local Phone: 902-450-1323 Email: mundens@mundensmoving.com
Owner	Robert J Munden
Office Manager	Justin Munden
Vice President	Sheila Mont

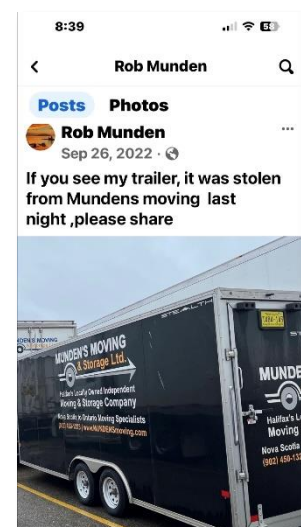
Figure 6 (Munden, 2022)

I also found a Facebook post as seen in Figure 6, from the owner Robert Munden posted on September 26, 2022, pictured in Figure 6, asking people to keep an eye out for one of Munden moving's trailers that was stolen from the site the night prior. This might be a hint that they need some security upgrades.

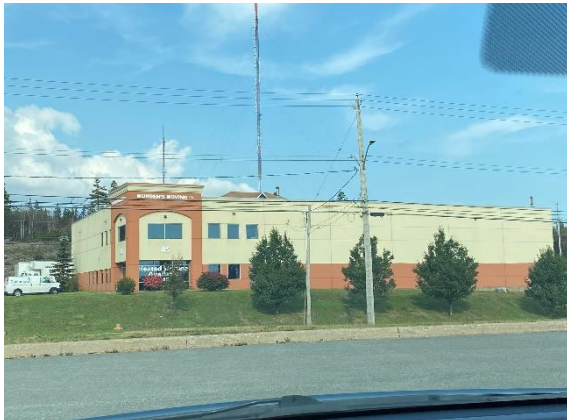
Figure 10

The building has decent natural barriers, especially from the rear of the building. As you can see in Figure 13 and 14 there is a steep almost cliff like drop off from the road to the back parking lot/loading area. The vegetation is quite unkept and messy, this ideally should be cleaned out and replaced by a hedge trimmed to 36 inches to adhere to CPTED Landscaping recommendations. There is also a very small but steep incline from the sidewalk up to the front door and parking lot with a line of trees where the incline levels out to enforce a natural property line as seen in Figure 10. The property has very good and clear visibility for the front and the sides of the building seen in Figure 11. With no unnecessary nooks or crannies or shrubbery that blocks visibility.

Solution: A hedge should be planted around the rear and the west side of the building and should be trimmed and maintained at 36 inches from the ground. If the step is taken to implement the outer fence mentioned above, then this step will not be necessary. The business should however have a vegetation/landscape planting and maintenance program.

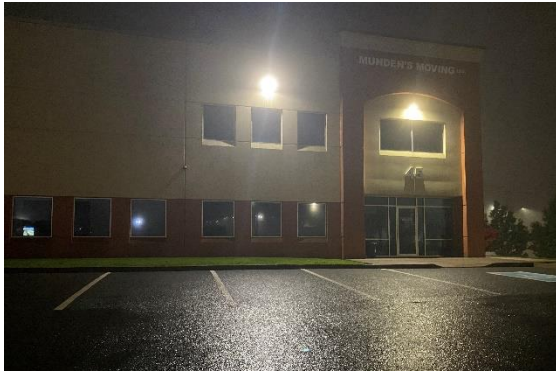
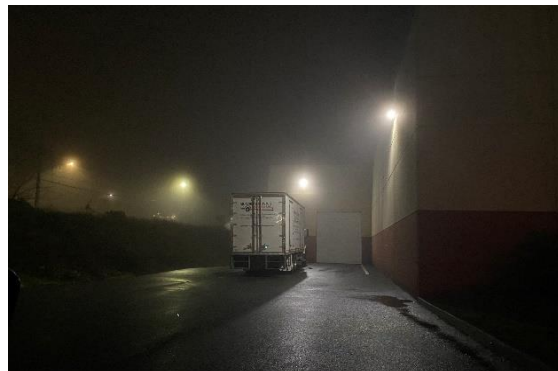
Overall, the property is well lit, and three of the four existing cameras have adequate lighting, at the front of the building, the east side and the unloading dock as seen in Figure 19, 20 and 21 above. However, I would suggest that the existing lighting be updated to more powerful flood lights. Also, in Figure 21 the red

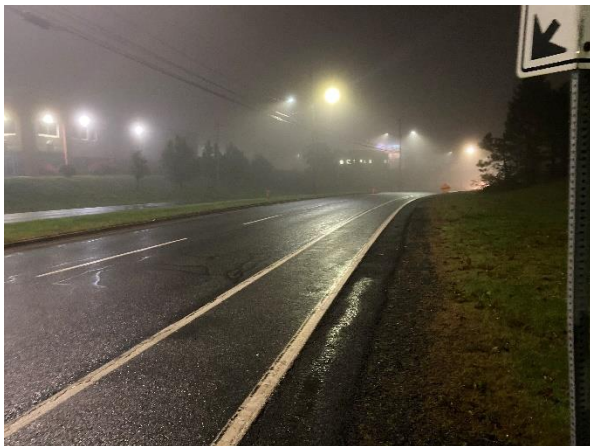
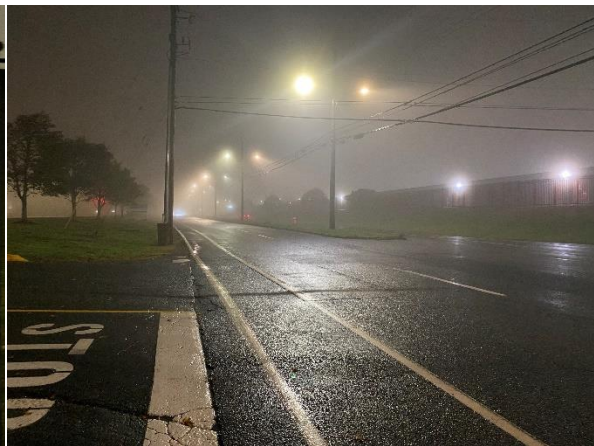
shown in Figure 25 and Figure 26, has adequate lighting for the entire stretch of road visible from the building.
