Date	PC APP software:	BOB Firmware:	Donlight Firmware:	Github hash
07/07/2022	1.3.2 +Gerderland detup	+1.00.06	2.0.0	9c5dd7e6e79d4a42567d73da661bcd3da96c2c06

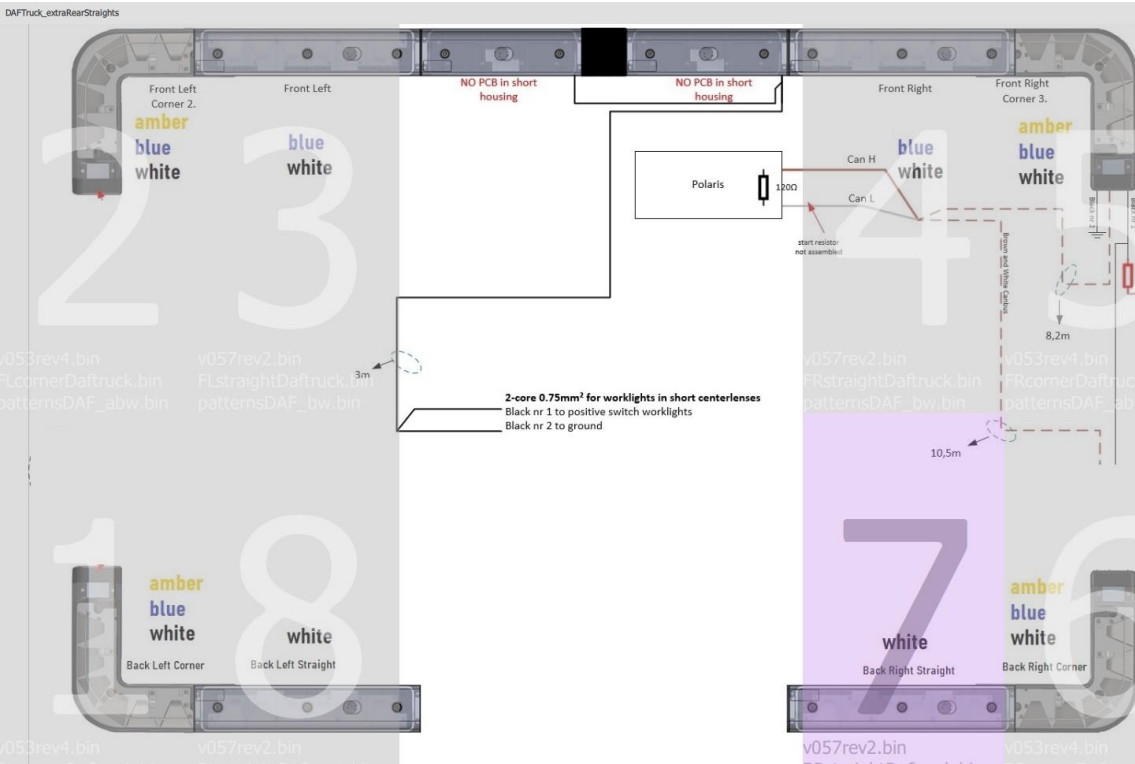
After Wesley’s request:  
Added DAFTruck\_extraRearStraights setup, based on DAFTruck\_amberbluewhite setup with two extra white straights on the rear.
