POST-TENSION INVESTIGATION AND 5 YEAR PLAN – JURAVINSKI CONCESSION GARAGE

HAMILTON HEALTH SCIENCES

Project No.: 2025-0534-10

December 2nd 2025

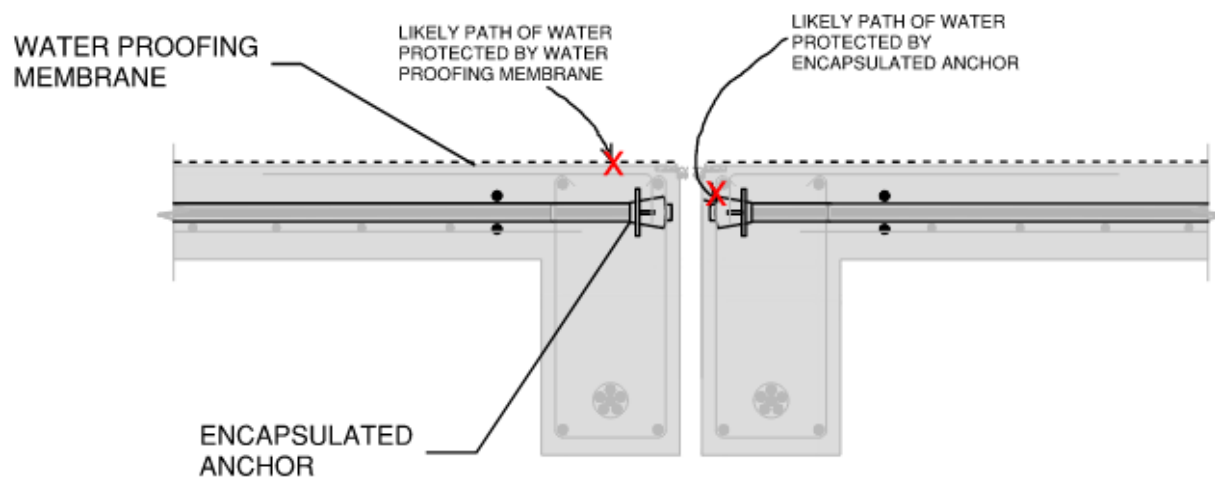
Figure 1: Water Infiltration Protection Mechanism at Expansion Joints.

The leaking expansion joints at the roof deck has saturated the concrete beams below on either side. Although this leak did not appear to be penetrate the unbonded tendons in the slab, its likely to be saturating the bonded post-tensioning in the beams and/or its corrugated metal duct. If this leak is not addressed, in our opinion it's likely that the bonded tendon in the beam will be corroded and lose strength over time. Its also possible that water may migrate into the encapsulated tendons in the slab over time.

- Replace leaking traffic deck expansion joint at roof deck, complete with polyurethane waterproofing tie-in to existing membrane (Do not use epoxy traffic coating).
- Replace leaking membrane-based expansion joint around stair/elevator cores. The current membrane joint is more susceptible to leaks than a compression foam expansion joint or rubberized gland joint. We recommend one of these two systems in this application.
- Repair damaged waterproofing at perimeter concrete curb.
- Provide waterproof coating over exposed stressing pockets around roof deck.
