Brittle Fracture Analysis of a Bicycle Chain Tool

Carlos Cabrera, Fernando Davis, Nicolás Meyer, Juan Ignacio Odone, Martín Salinas

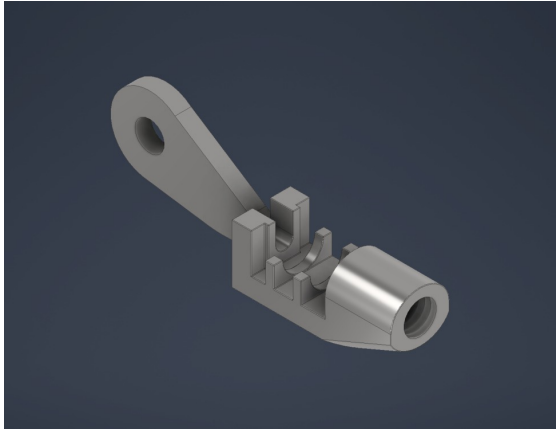
Fig. 2. CAD model of the analyzed part.

The geometry of the part was recreated in three dimensions using Autodesk Inventor 2025, based on measurements taken directly from the failed mechanical component. This CAD model aims to provide a precise digital representation to facilitate further analysis and simulation. The specific dimensions of the part can be found in the technical drawing included in the appendix of this document.

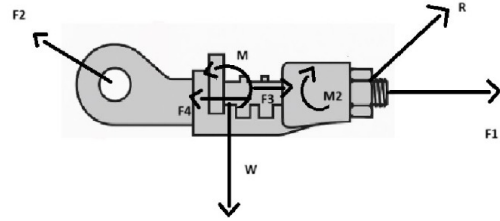
Fig. 5. Free body diagram of the analyzed part.

1) *FBD*: The forces considered in the tool analysis are illustrated in Figure 5. These include the weight of the tool (W), the force F_2 exerted by the cylindrical support of the multi-tool holding the chain tool, the friction force in the threaded section (F_1), the normal force on the thread (R), the force F_4 applied by the screw tip onto the chain link pin, its reaction (F_3), the applied moment on the tool (M), and its corresponding reaction moment on the internal thread of the screw (M_2).

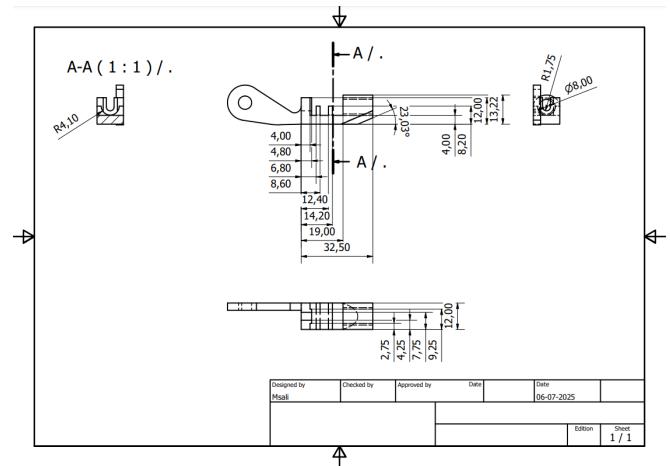
A.1. Technical drawing of the part with detailed dimensions.

The following technical drawing shows all the relevant dimensions of the part analyzed used to create the 3D CAD model.
