# Use of the Wolfson stability guidance for appraising the operational stability of small fishing vessels

Matteo Scarponi, *Wolfson Unit MTIA, University of Southampton*, [M.Scarponi@soton.ac.uk](mailto:M.Scarponi@soton.ac.uk)

This paper describes the use of the Wolfson guidance and other stability criteria in the context of two recent accident investigations on small fishing vessels: 11.4m scallop dredger JMT and 9.9m stern trawler Stella Maris. Both vessels capsized and sank whilst handling their catch in benign weather conditions. The Wolfson guidance, which is suitable for all types of fishing vessels including those with no stability information, enables estimation of the safe operational limits for both JMT and Stella Maris. Also, given the probable loss scenarios and residual stability characteristics, the Wolfson guidance predicted that both vessels were operating outside such limits at the time of each loss.

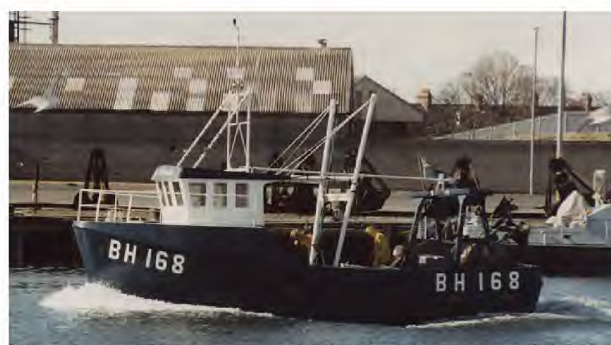
Figure 2 – Lady Patricia (Credit: trawlerpictures.net)

JMT (previously Lady Patricia) was built in 1988 as a conventional stern trawler and was fitted with a forward wheelhouse, amidships 'scotch poles' and a stern gantry (Figure 2). Between 2003 and 2013 the vessel's stern gantry was raised and a port side shelterdeck was added. Subsequently, the vessel was converted for scallop dredging, which involved fitting winches and outriggers for handling the scallop gear, removing the shelter deck, raising the stern gantry further and replacing the scotch poles with a goalpost gantry. The latter vessel configuration (Figure 3) was approved by Seafish Marine Survey in 2013 and, subsequently, by the MCA.
