Experimental Investigations into Accidents of Two Japanese Fishing Vessels

135GT PURSE SEINER ACCIDENT

113GT STERN TRAWLER ACCIDENT

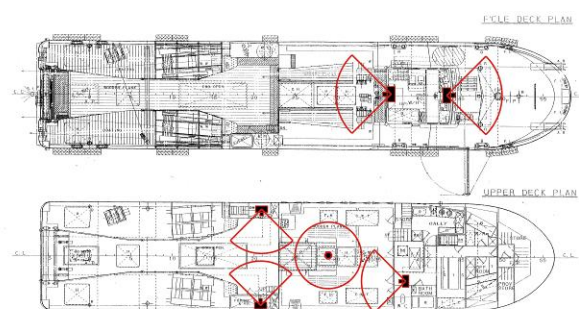
Fig. 4: Opened watertight doors.

minutes later, she was lost from the radar of the consort trawler. The foundered trawler was salvaged to investigate conditions and damages. There was no serious damage of hull and some water tight doors were opened.

The subject ship model used in this research is the 1/16 scaled. The principal particulars are shown in Table 5. According to the investigation of salvaged trawler, two watertight doors were opened. Opened doors are shown in Fig. 4. For recording shipping water and flowing point, the model ship was installed with 5 video cameras and 360 degrees video camera. The positions of cameras are shown in Fig. 5. The 360 degrees camera recorded situation in the working room as shown in Fig. 6.

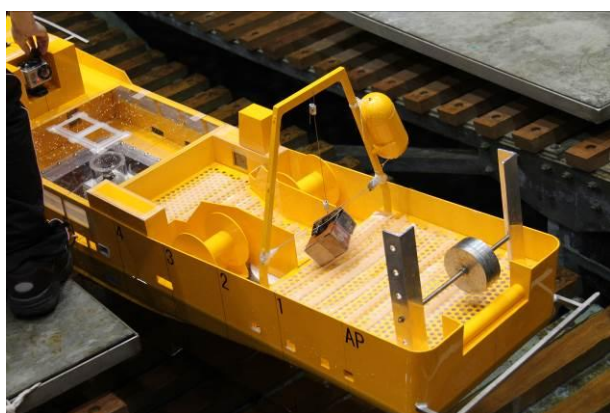
Fig. 10: Model with hanging weight

Free running model experiments were implemented with hanging weight for simulating of flooded water. The model is shown in Fig. 10.
